AMERICA DRIVE CANAL SEDIMENT ABATEMENT STUDY

**BUREAU
VERITAS**
Berryman & Henigar

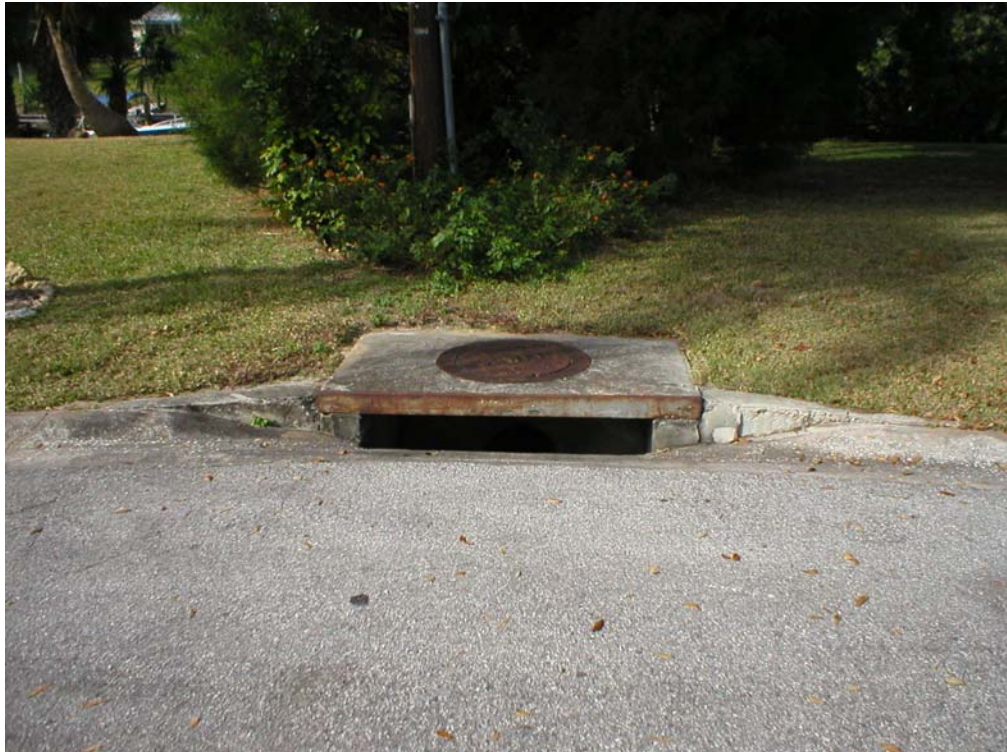
An 18" Reinforced Concrete Pipe (RCP) pipe, outfall AD1, discharges to the northern end of the canal. This pipe drains 3.8 acres of single family residential property into an inlet at the end of Merrimac Drive (Figure 4). This drainage basin area has no stormwater treatment system. The pipe discharges above the water line and there was no sediment build up observed at the outfall.

Figure 4.
AD1 - Inlet in cul-de-sac in Basin B1.

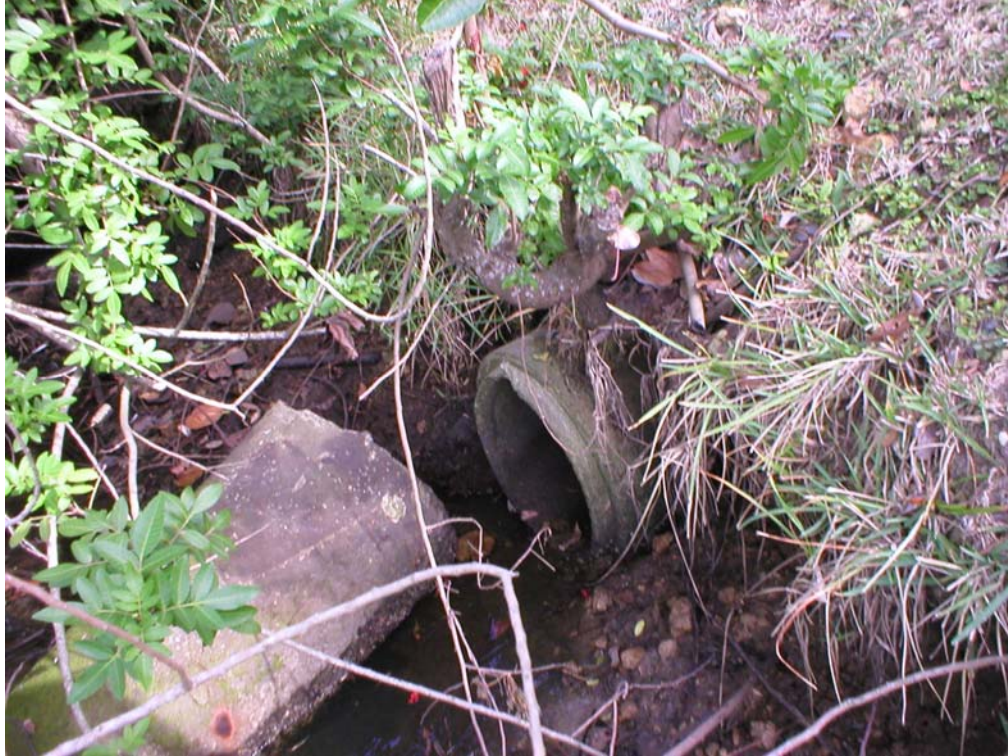
Steep slopes with apparent erosion were observed in this area. At the outlet it appears that the side of the canal has washed away. The end section of the outlet pipe has separated as shown in Figure 5.

Figure 5.
Outlet AD1 in Basin B1. Note culvert lying in canal and steep bank erosion.

Merrimac Drive has an inlet that drain to the eastern end of the canal through Outfall AD1. No BMPs are recommended for this outfall because of the small basin size and generally clean system. However, due to the unstable condition of the canal side slopes near the outfall BHI recommends stabilization with riprap and mangroves to avoid further erosion.

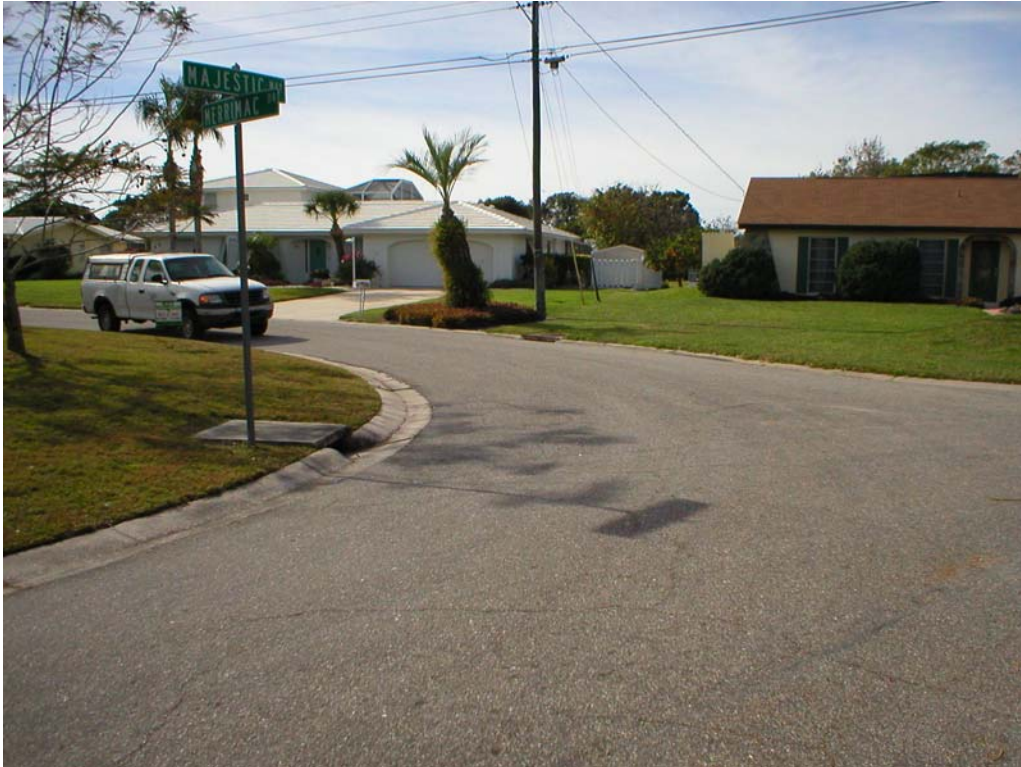
Figure 6.
AD2 - Inlets at the intersection of Majestic Way and Merrimac Drive, Basin B2.

The intersection of Majestic Way and Merrimac Drive has three inlets that drain to the eastern canal through Outfall AD2. One of these inlets was noted to contain debris, especially leaves. The inlets should be cleaned regularly to keep debris out of the canal, and an inlet trap installed to capture sediment and debris.

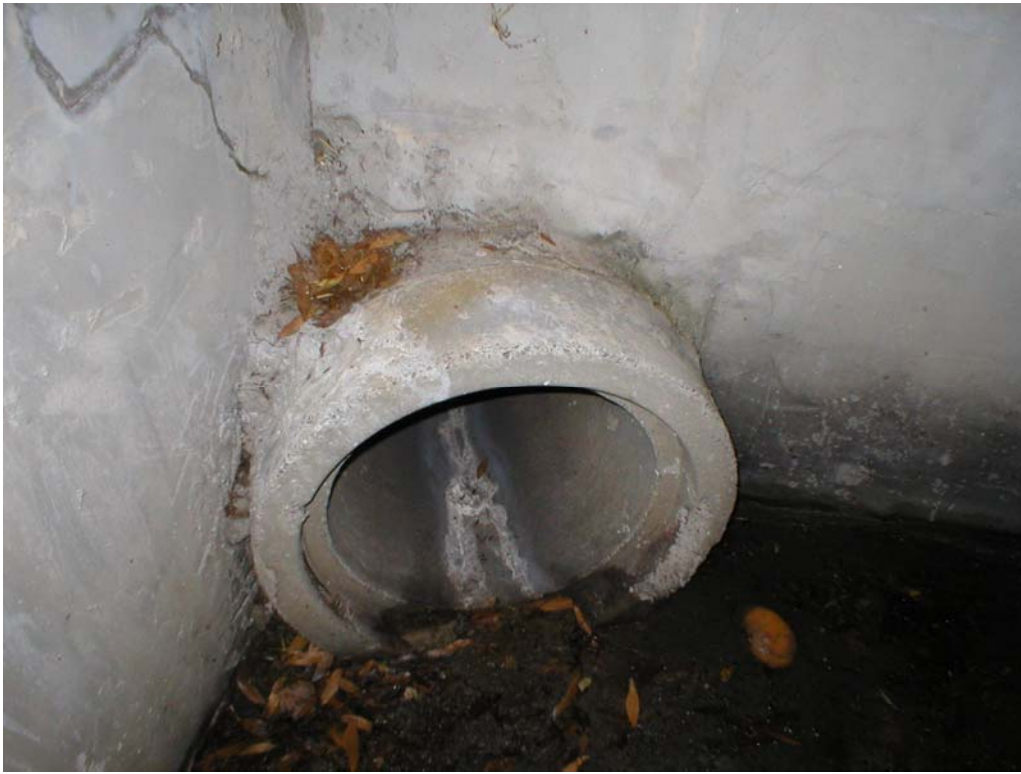
Outfall AD2 is a 24" RCP discharging south of AD1. This pipe drains 6.4 acres of single family residential property along Majestic Way and Merrimac Drive. This drainage basin area has no stormwater treatment system. There was no sediment build up observed along the shoreline at this outfall. The three grated inlets and roads appear to be in good clean condition (see Figure 6), but further inspection inside the downstream most inlet showed some leaf and grass accumulation (see Figure 7).

Figure 7.
Inside AD2 - inlet in Basin 2. Note leaf and grass loads.

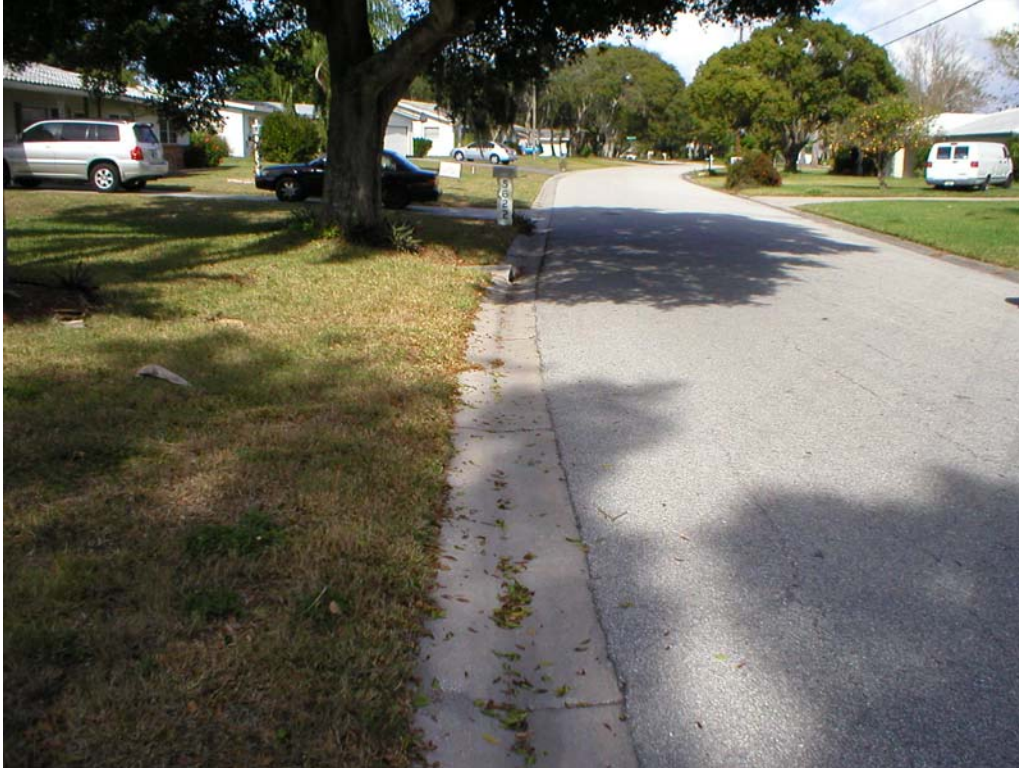
About half of America Drive drains to two curb inlets discharging at outfall AD3 (Figure 8), which discharges east of the America Drive bridge. The drainage basin consists of 5.7 acres of single family residential property. This drainage basin area has no stormwater treatment system. There was no sediment build up observed along the shoreline at this outfall.

Figure 8.
AD3 - West side America Drive in Basin 3.

America Drive has two inlets that drain to the eastern canal through Outfall AD3. Because this basin is small and the inlets appear clean, no BMP is recommended.

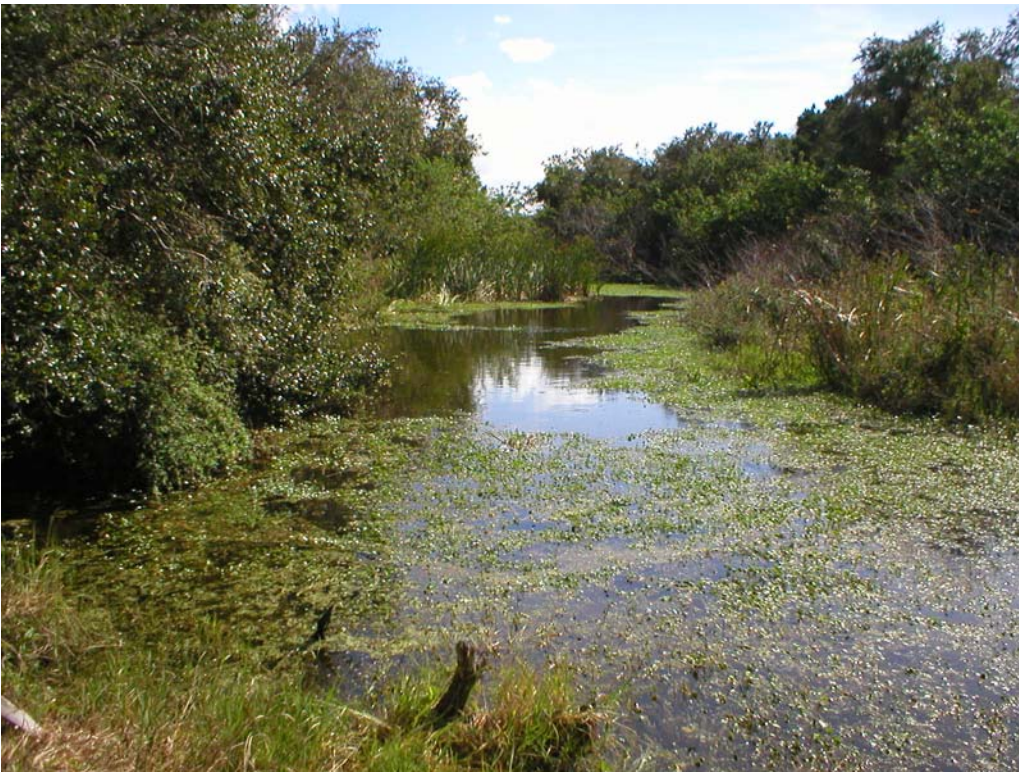
Figure 9.
Open water system in Basin B4, upstream of outfall AD4.

This is the largest drainage basin (B4) discharging to the canal and has an existing natural depression with standing water. Almost half of the basin is tributary to the pond, which provides sediment attenuation through flow velocity reduction and nutrient treatment by vegetative uptake and settling of particulate materials. The 55 percent of the basin that is downstream of the pond could be treated by using vegetated swales to capture runoff from the developed western portion of the basin. This BMP, with the continued operation of the pond, would greatly reduce sediment conveyance.

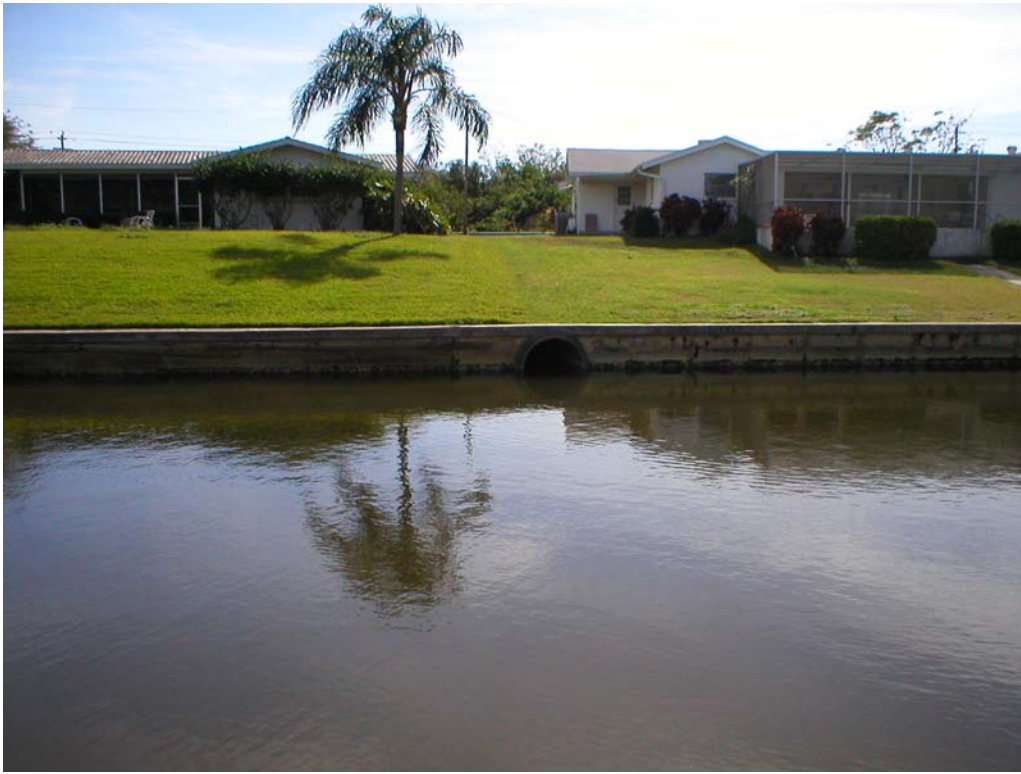
Outfall AD4 is a 48" RCP discharging west of America Drive bridge. This pipe drains 79.8 acres of single family residential, commercial, recreational and open space property including areas south of Constitution Boulevard. This is the largest drainage basin discharging to the canal system and has an existing natural depression with standing water (Figure 9). There are two inlets on Constitution Boulevard which connect to AD4 with no treatment. There was no sediment build up observed along the shoreline at this outfall (Figure 10).

Figure 10.
Outfall AD4.

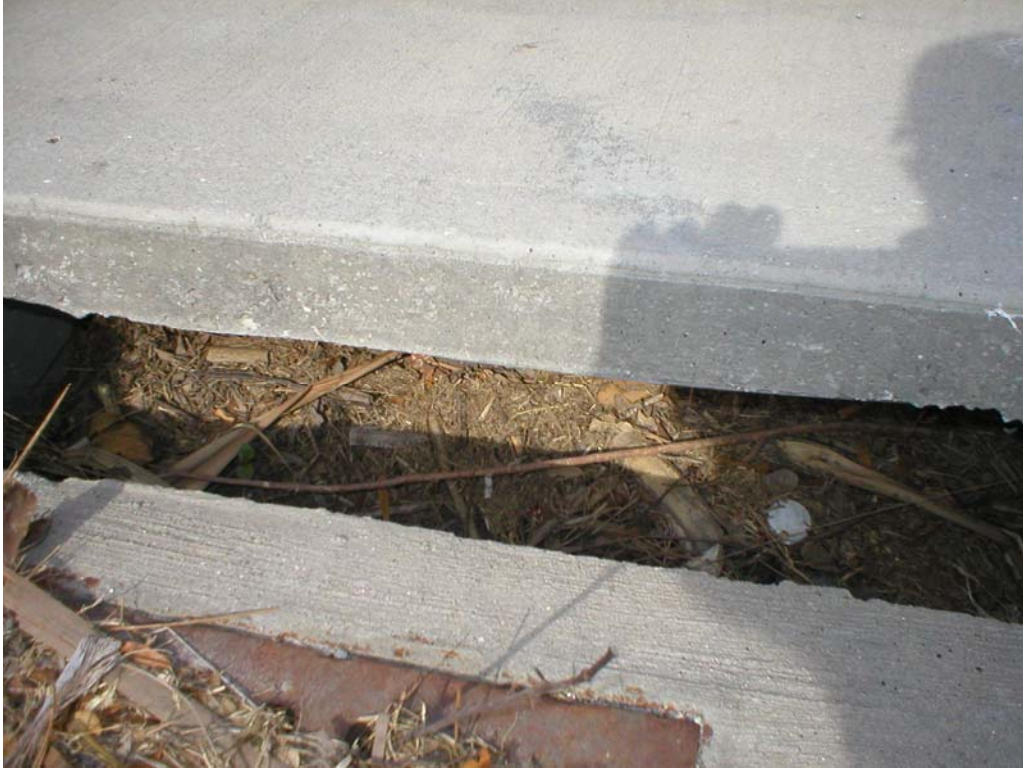
Outfall AD5 is an 18" RCP discharging downstream of Outfall AD4. This pipe drains 4.5 acres of single family residential property along Lusitania Drive. This drainage basin area has no stormwater treatment system. There was no sediment build up observed along the shoreline at this outfall, but one of the two grated inlets, the downstream most on the northeast side of the road, appeared to be clogged with leaves and debris (Figure 11).

Figure 11.
AD5 - Inlet clogged with leaves and debris in Basin 5.

Lusitania Drive has two inlets that drain to the western canal through Outfall AD5. These inlets are filled with debris, especially leaves. The inlets should be cleaned to keep debris out of the canal, but because of the small basin size no BMP is recommended.

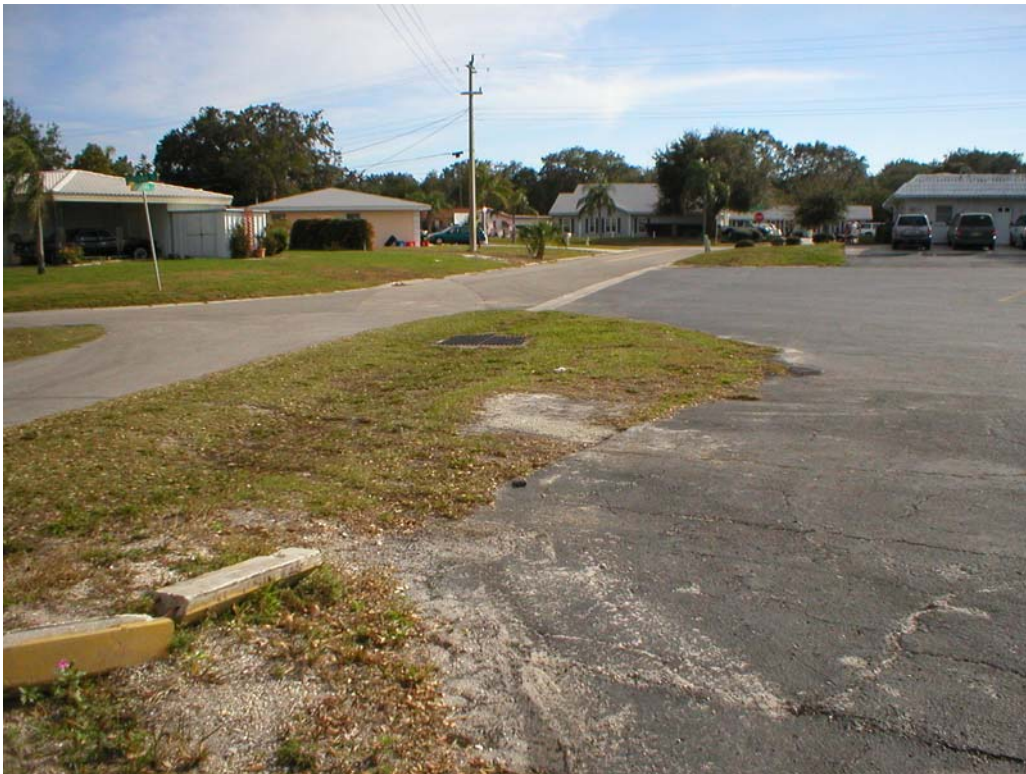
Outfall AD6 is a pipe discharging into the middle part of the west reach of the canal. This pipe drains 4.9 acres of single family residential and commercial property along Aquitania Drive and Constitution Boulevard (Figure 12). This drainage basin area has no stormwater treatment system. There was no sediment build up observed along the shoreline at this outfall.

Figure 12.
AD6 - Large inlet in Basin 6.

Outfall AD6 drains a large commercial area that has no stormwater treatment system. Construction of a BMP on this outfall pipe would be beneficial in reducing sediment entering the canal. Exfiltration BMPs will not work well in this area due to the poorly draining soils. There are several vault types of BMPs available which are effective in removing sediment, but a baffle box is being recommended for this outfall. An enhanced nutrient separating baffle box, which has an added benefit of reducing nutrient loads by trapping grass, leaves, and organic debris and keeping this material dry so that the nutrients do not leach out into the stormwater would also be appropriate for this site (BHI, 2004). Other vault-type BMPs do not have this feature. An added

feature of using this second BMP is that it would help the County achieve nutrient reductions recommended for Sarasota Bay.

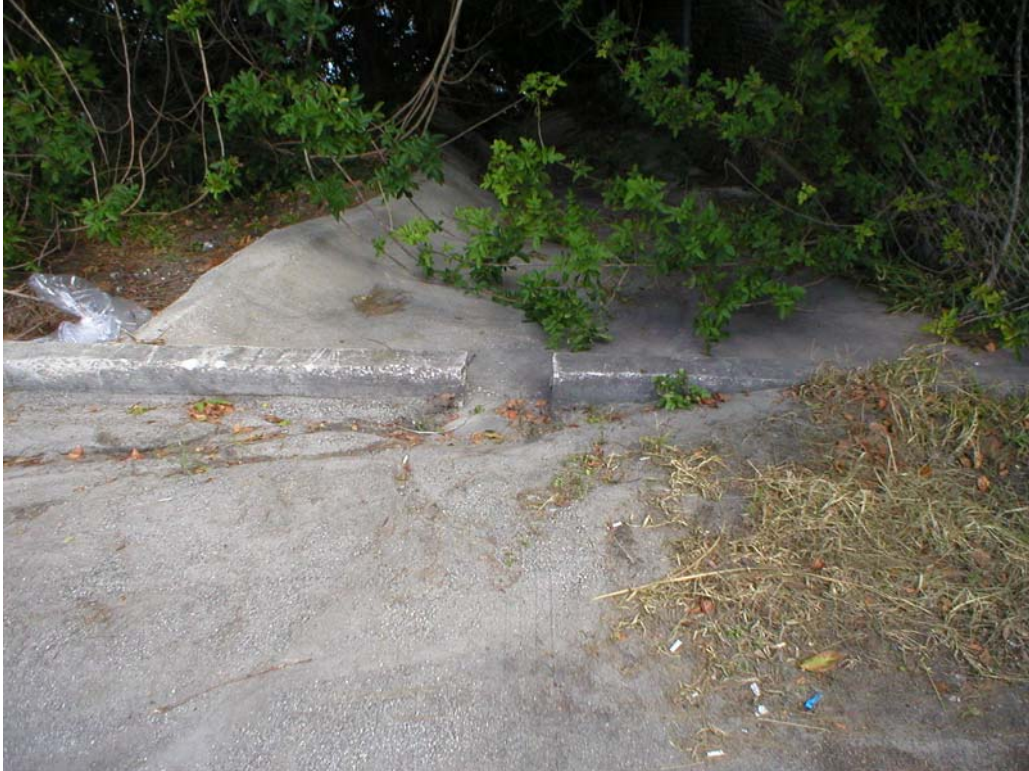
Outfall AD7 is a curb cut discharging into the lower part of the west reach of the canal. This curb cut drains 3.5 acres of commercial property along US41 (Figure 13). This drainage basin area has no stormwater treatment system. There was sediment build up observed along the curb near the outfall and an overflowing trash bin was found east of the outfall (Figure 14).

Figure 13.
AD7 – Curb cut in Basin 7. Note sediment build up next to curb.

Outfall AD7 drains a large commercial area that has no stormwater treatment system. Construction of a BMP and an inlet pipe system on this outfall, in addition to providing general housekeeping guidelines, would be beneficial in reducing sediment entering the canal. There are several vault types of BMPs available which are effective in removing sediment, but a baffle box is also being recommended for this outfall.

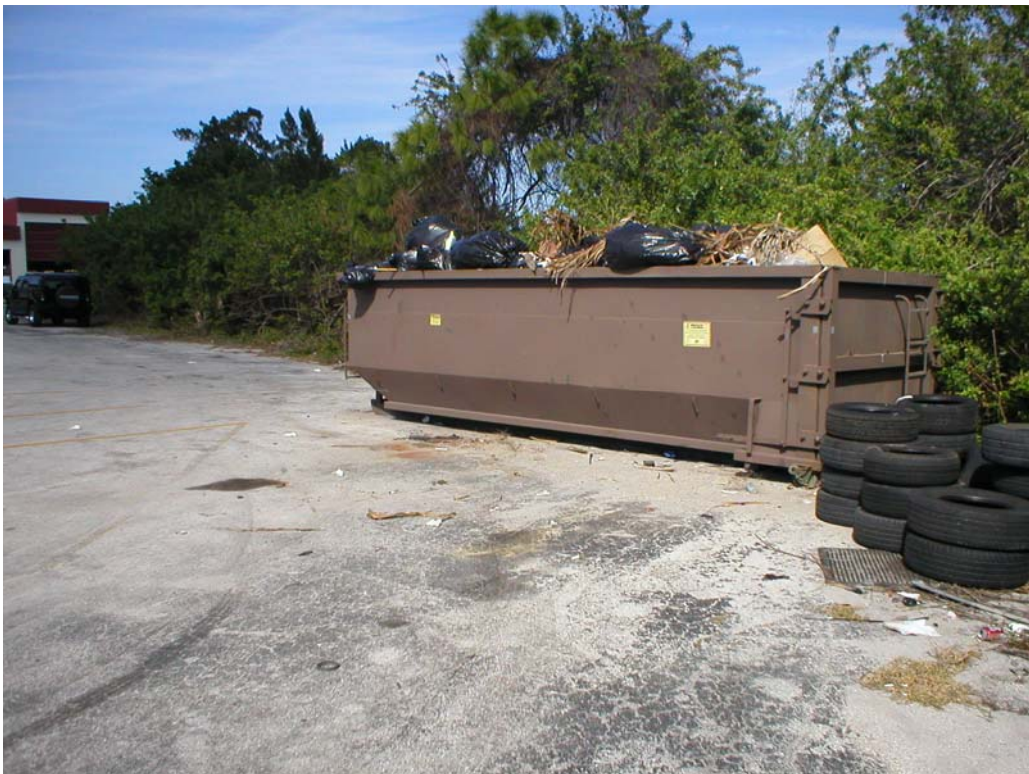
Figure 14.
AD7 – Overflowing trash bin in Basin 7

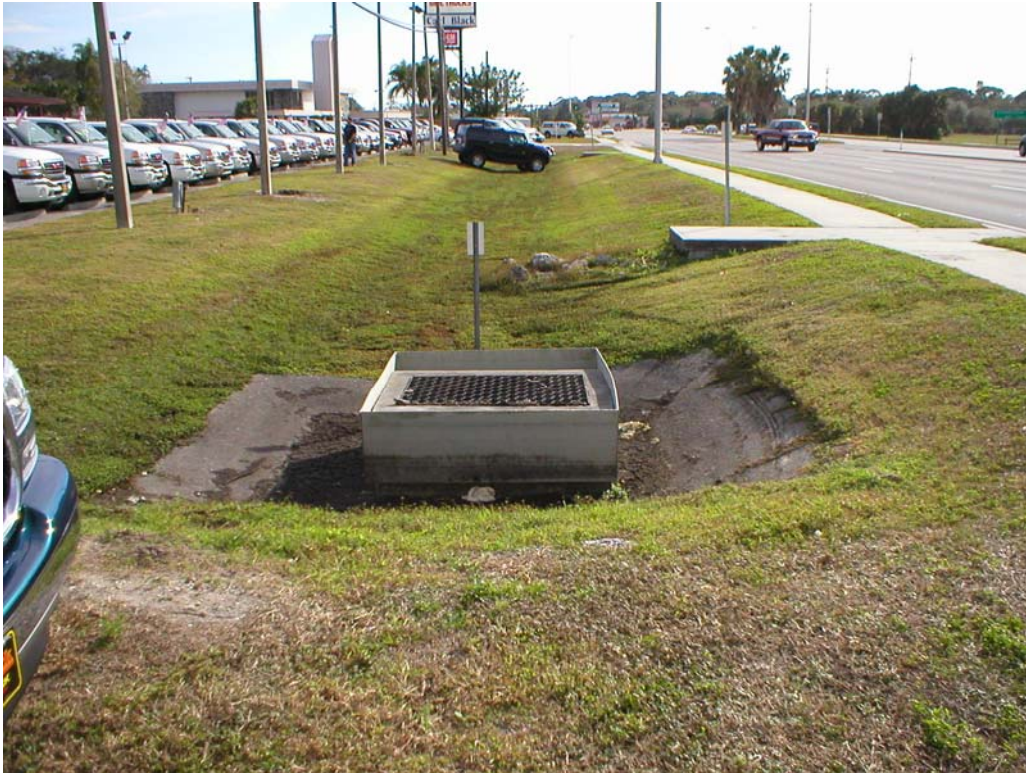
Figure 15.
AD8 - Roadway swales and raised inlet along US 41.

It should be noted that the swales along US 41 are well established with grass and the swales are broad, giving large contact areas for removal of pollutants in all but the largest storms. In addition, most of the swales have raised inlets for control structures which retain a volume of runoff and prevent much debris and sediment from entering the canal. These features provide a high level of treatment to runoff, so pollutant reduction factors for grassed swales were used where appropriate.

This outfall along US 41 discharges runoff from mostly roadway and commercial land uses. Roadway runoff is currently treated with existing vegetated swales with raised inlets. Although this is the second largest drainage basin, there is no evidence of sedimentation from this outfall so no BMP is recommended.

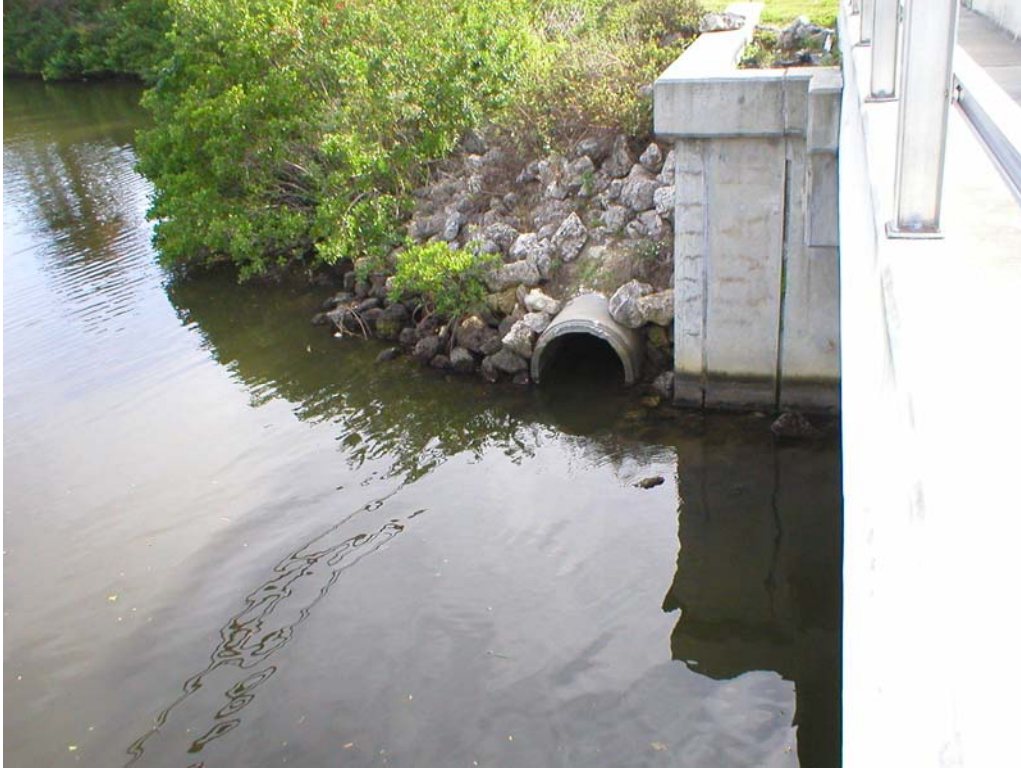
Outfall AD8 is a large pipe discharging at the downstream end of the canal. This pipe drains 48.0 acres of single family residential, residential multi family, commercial, and roadway along US 41 (Figure 15). This is the second largest drainage basin discharging to the canal system (Figure 16) and has an existing system of roadway swales to convey and treat roadway runoff. There was no sediment build up observed along the shoreline at this outfall.

Figure 16.
Outfall AD8 at base of US 41 bridge.

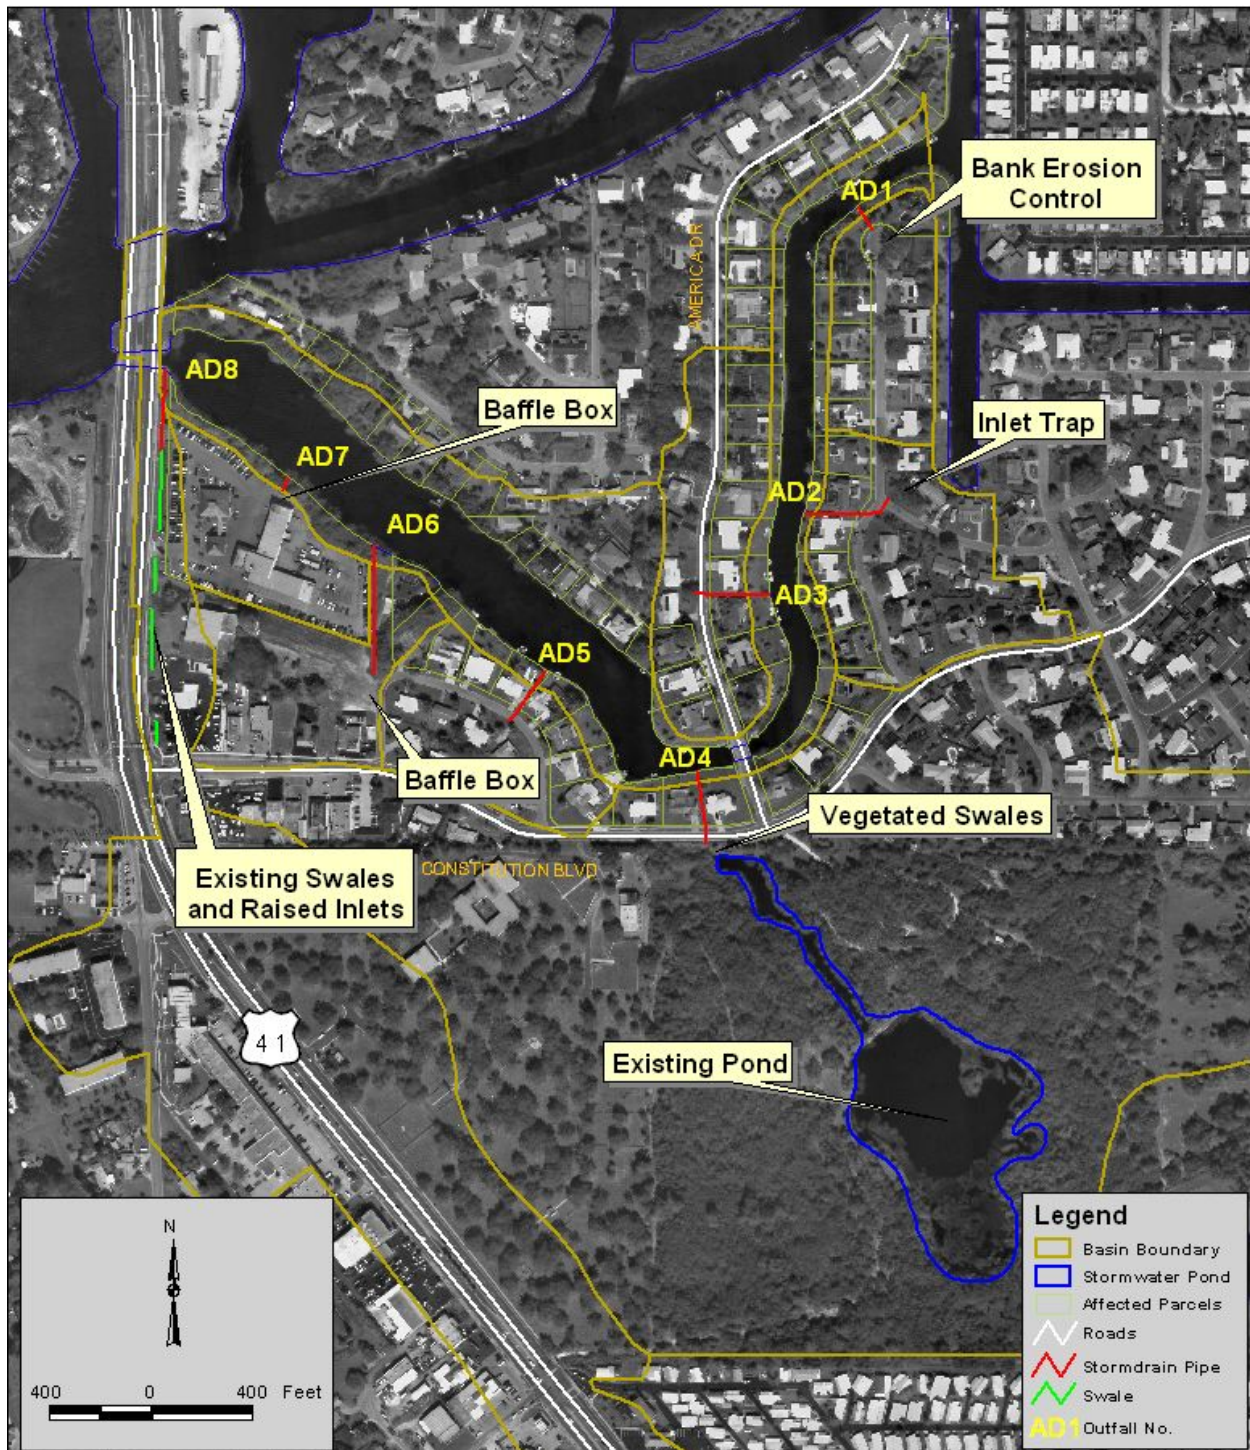
Figure 17

Recommended Sediment Abatement Facilities

There are eight stormwater outfalls to the canal. Based on the field investigations and analysis in this report, it is recommended that two baffle boxes be constructed, one on outfall pipe AD6 and another at a proposed inlet pipe system on AD7. In addition, it is recommended that inlet traps be installed in inlets for outfall AD2. Also, the outlet pipe for AD1 and the side slopes of the canal at that location should be stabilized with rip-rap and mangroves to avoid further erosion. Finally vegetated swales are proposed for outfall AD4. This is the largest drainage basin discharging to the canal system and has an existing pond that provides treatment for a portion of the basin. The swale will provide treatment for areas of this drainage basin downstream of the pond.
