# **PHILLIPPI COVE SEDIMENT ABATEMENT STUDY**

**Sarasota County  
Water Resources**

**Berryman & Henigar, Inc.  
1412 Tech Blvd  
Tampa, Florida 33619-7865**

**February 2005**

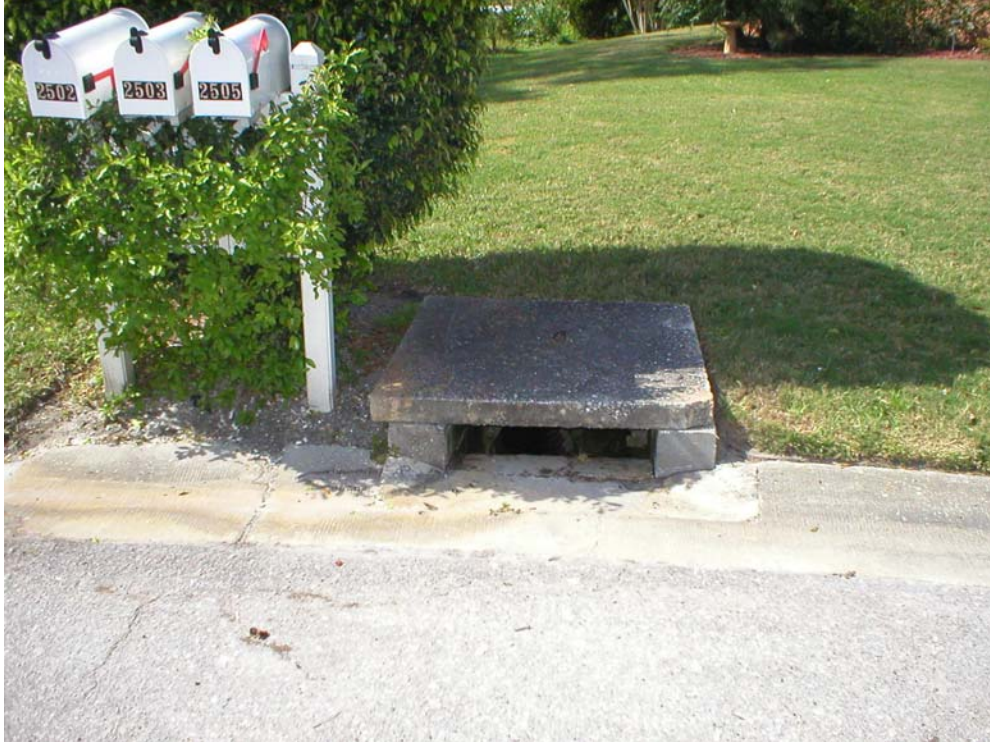
A 12" Reinforced Concrete Pipe (RCP) pipe, outfall PC1, discharges to the middle portion of the cove. This pipe drains 4.2 acres of single family residential property from an inlet at the end of Jamaica Street (Figure 4). This drainage basin area has a swale (Figure 6) downstream of the inlet with a control structure (Figure 7) and is performing well as a stormwater treatment system. The pipe discharges above the water line and there was no sediment build up observed at the outfall.

**Figure 4.**  
**PC1 - Inlet in cul-de-sac at the end of Jamaica St. in Basin B1.**

Jamaica Street has an inlet that drains to the middle portion of the cove through Outfall PC1. No new BMPs are recommended for this outfall because of the small basin size and because the existing swale is working properly.

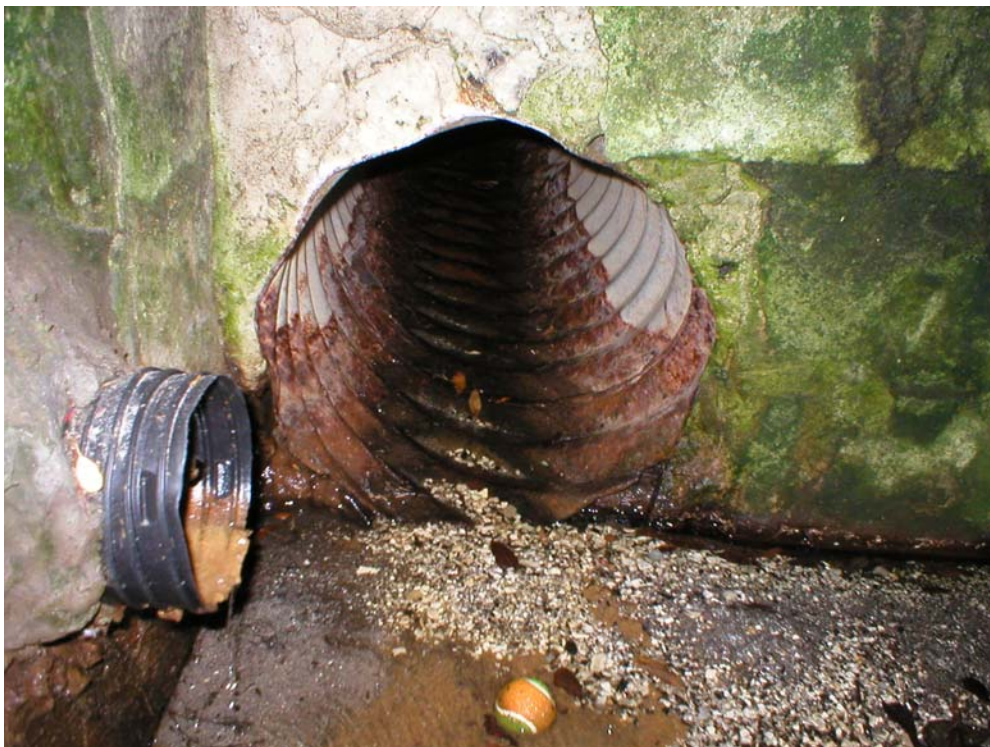
**Figure 5.**  
**Inside inlet PC1. Note sediment loads.**

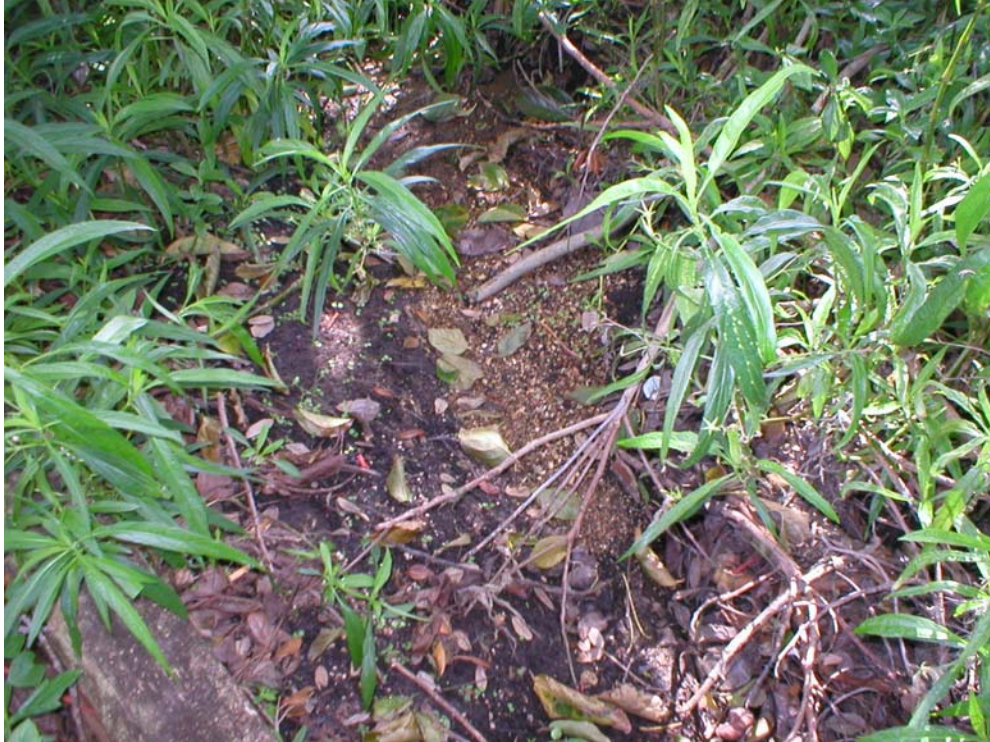
**Figure 6.**  
**Sediment trapped by the swale on PC1.**

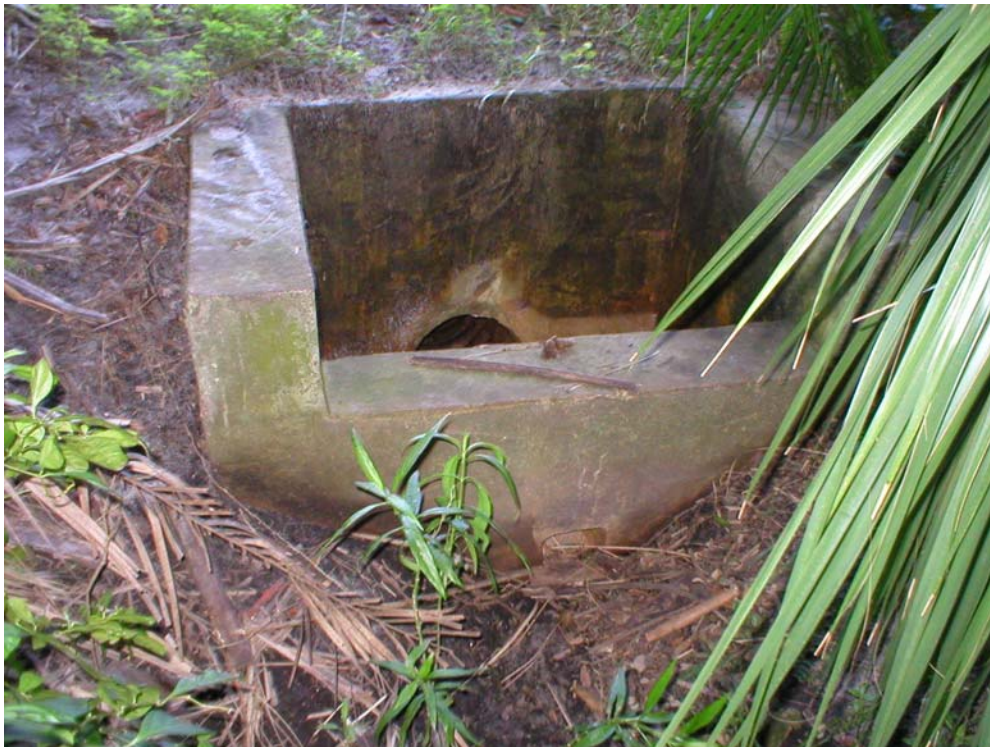
**Figure 7.**  
**Outlet structure at the end of the swale on PC1.**

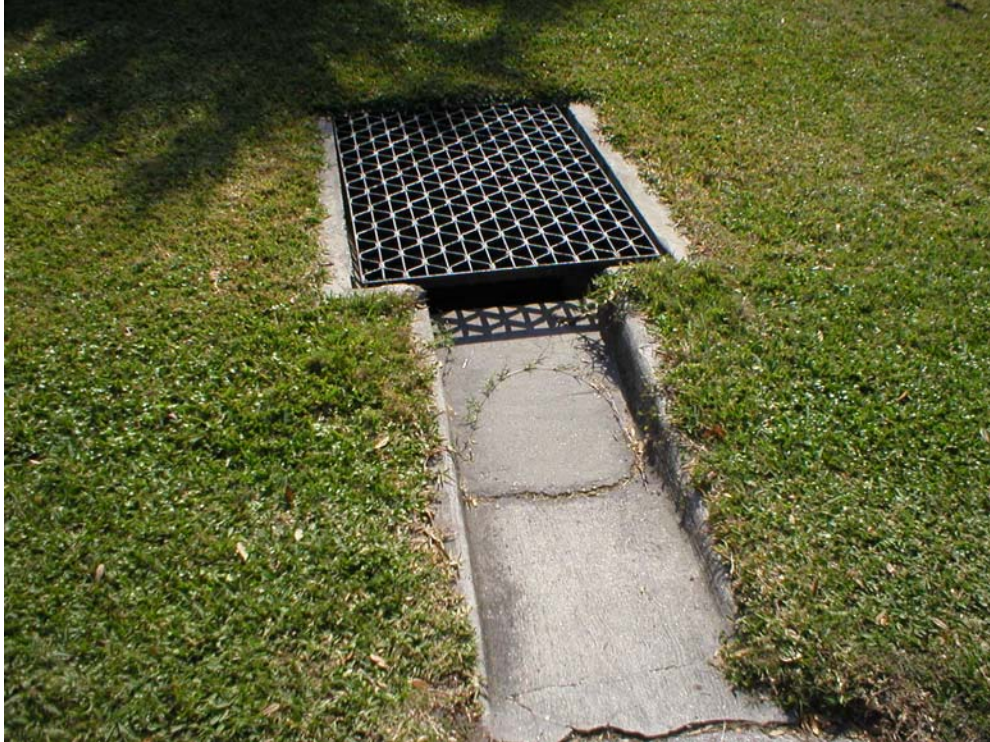
Outfall PC2 is an 18" RCP discharging north of PC1. This pipe drains 12.6 acres of single family residential property from a series of inlets at the end of Trinidad Street (Figure 8). This is the largest drainage basin discharging to the cove and has a series of roadside swales and driveway culverts (Figure 10) along Trinidad Street that act as stormwater treatment systems. There was no sediment build up observed along the shoreline at this outfall.

**Figure 8.**  
**PC2 - Inlet in cul-de-sac at the end of Trinidad St. in Basin B2**

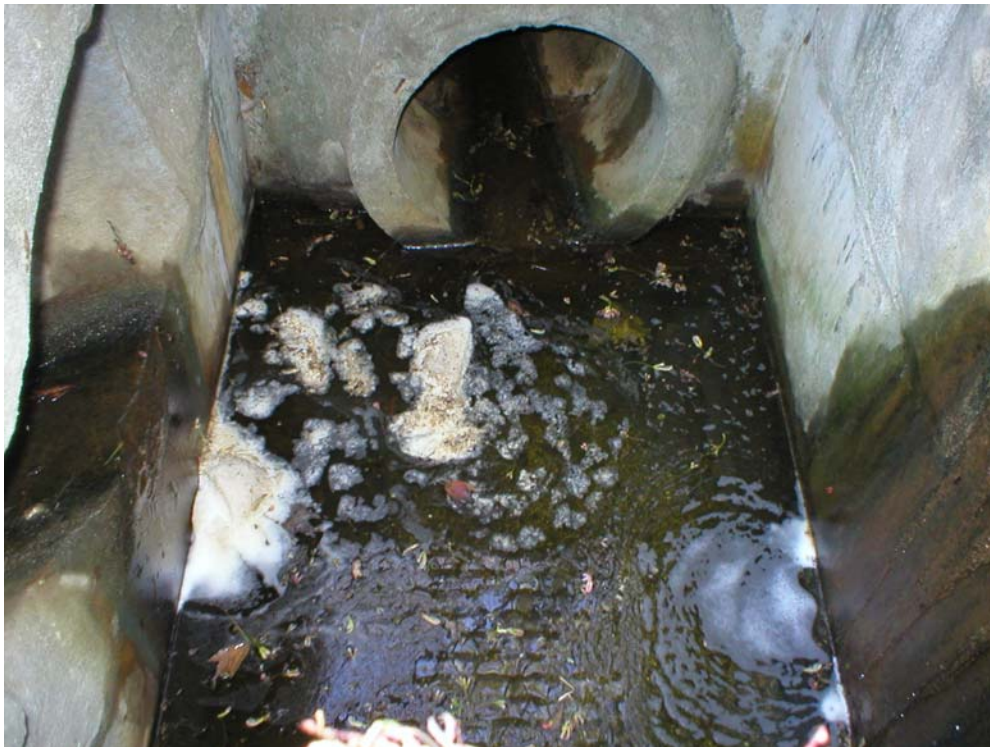
**Figure 9.**  
**Inside inlet PC2. Note foam floating at the bottom of the inlet.**

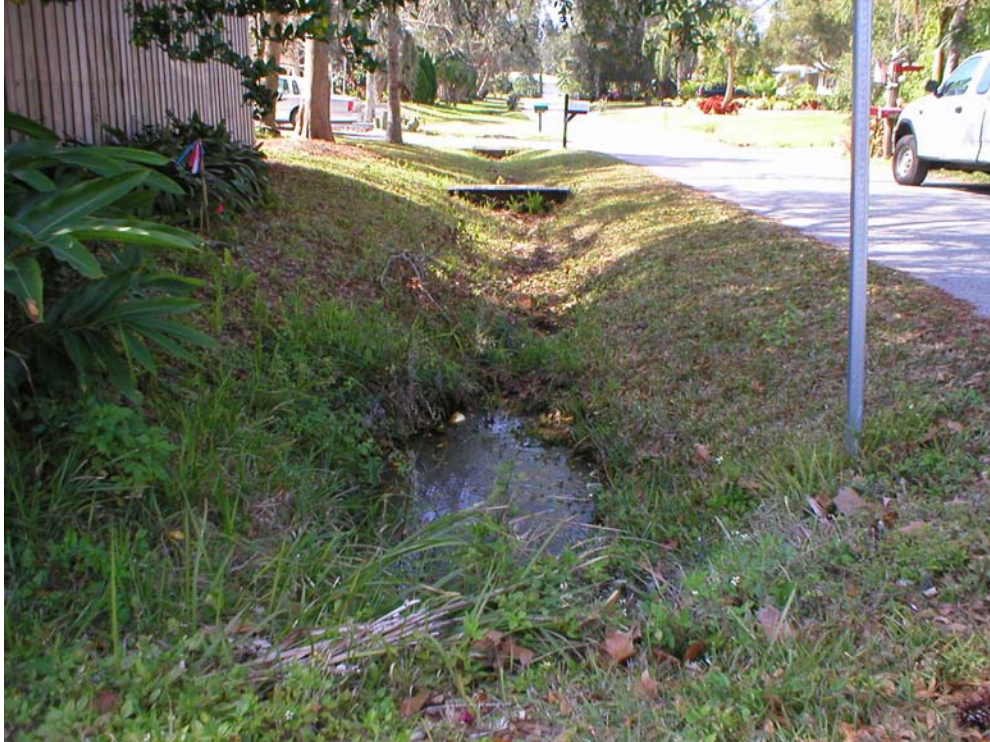
**Figure 10.**  
**Swales along Trinidad St. upstream of PC2.**

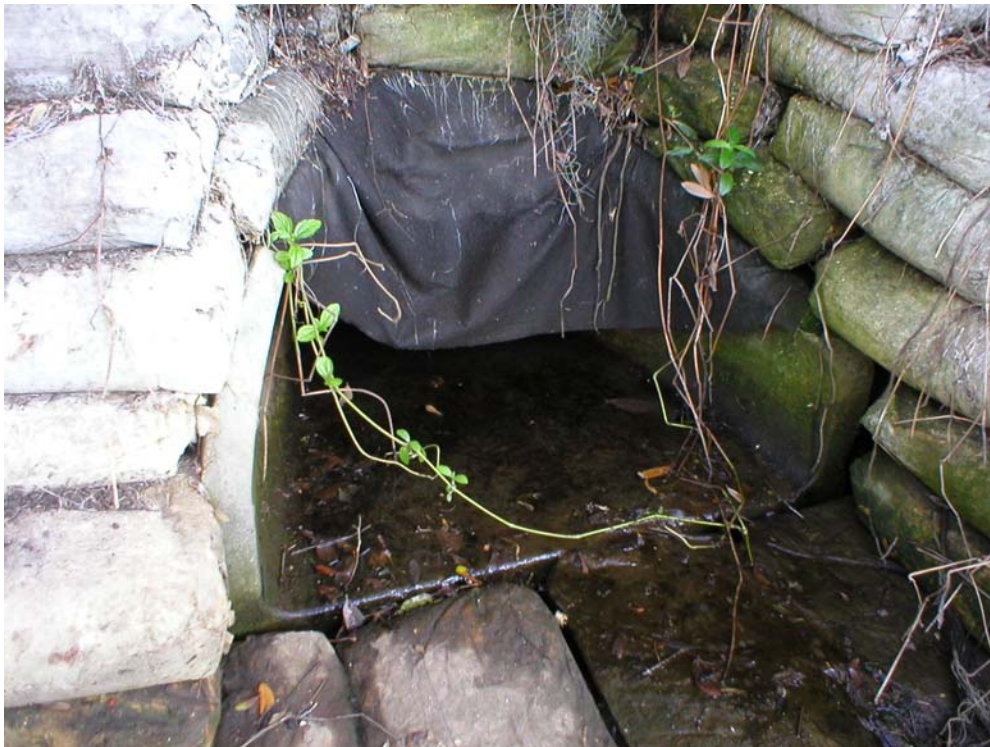
**Figure 11.**  
**PC2 outlet mitered end. Note thin layer of muck.**

A citizen in the Trinidad Street cul-de-sac mentioned that the series of inlets in the cul-de-sac were installed in the late 90's after some flooding occurred during the "el Niño" rainfall events. Steep slopes with apparent erosion were observed at the outlet in this area, but this might have happened before the new inlet systems were installed.

Trinidad Street has a series of inlets that drain to the middle upper portion of the cove through Outfall PC2. Although this is the largest drainage basin with the largest pollutants loadings, no new BMPs are recommended for this outfall because the existing system of roadside swales and driveway culverts are providing adequate treatment for the basin. However, due to the unstable condition of the cove side slopes near the outfall BHI recommends stabilization with riprap and mangroves to avoid further erosion.

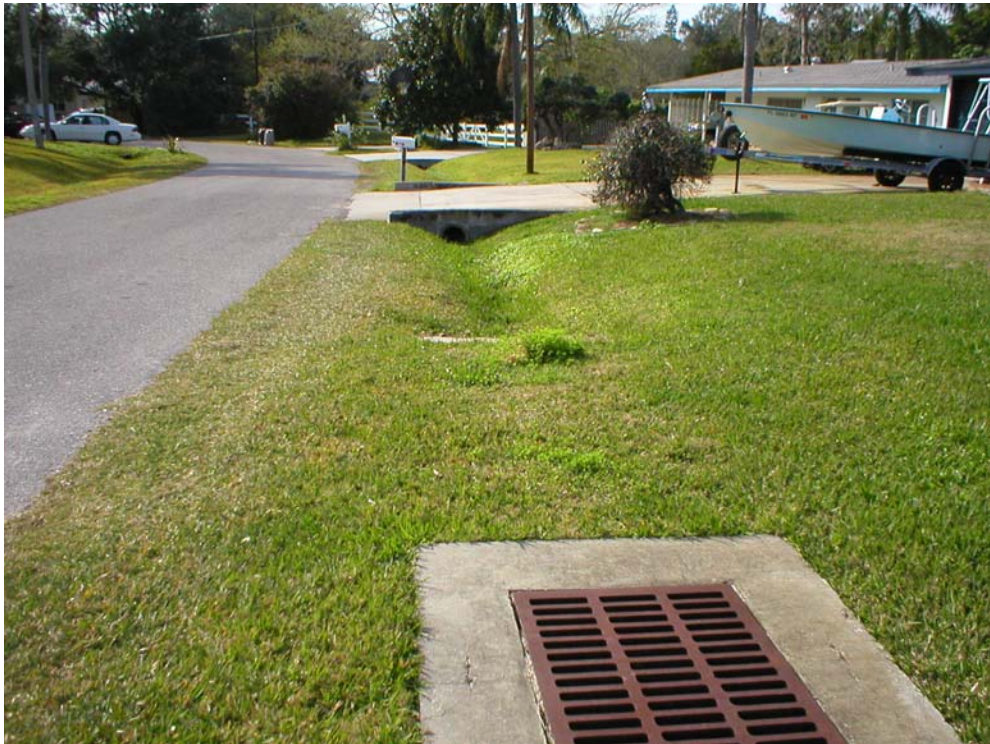
Outfall PC3 is a 14" x 21" Elliptical Reinforced Concrete Pipe (ERCP) discharging to the uppermost portion of the cove. This pipe drains 3.2 acres of single-family residential property into a series of inlets on Nassau Street (Figure 12) that discharges through a grate on a concrete boat ramp. This drainage basin has a series of roadside swales and driveway culverts (Figure 14) along Nassau Street that act as stormwater treatment systems. There was no sediment build up was observed along the shoreline at this outfall.

**Figure 12.**  
**PC3 inlet with diversion structure in Basin B3.**

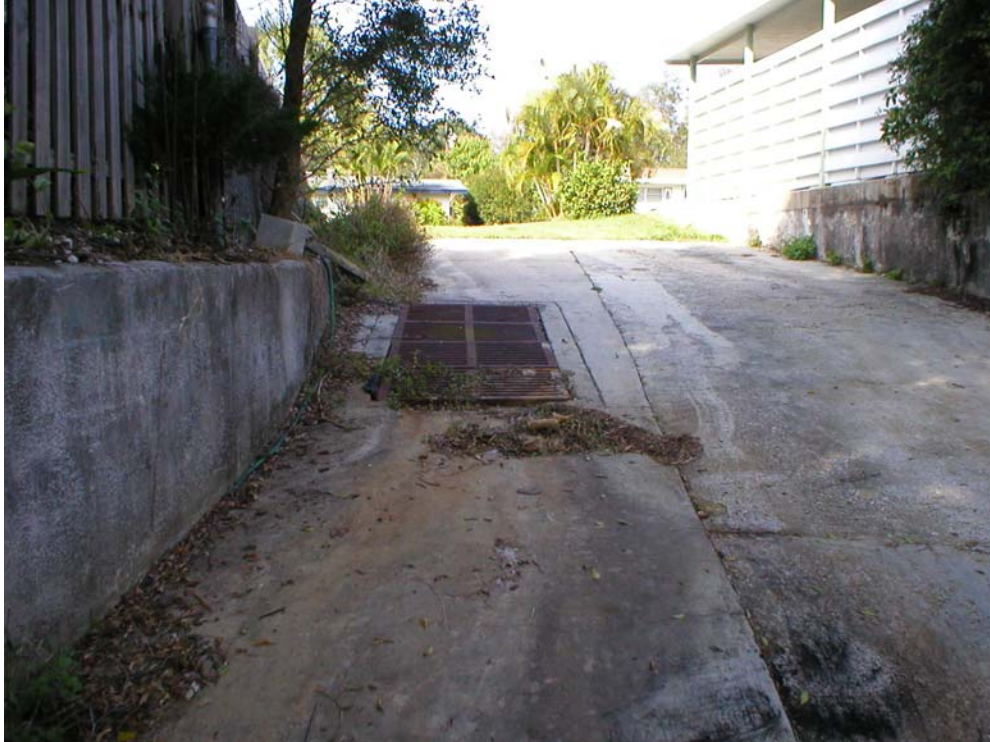
**Figure 13.**  
**PC3 outlet discharges through a grate on the boat ramp.**

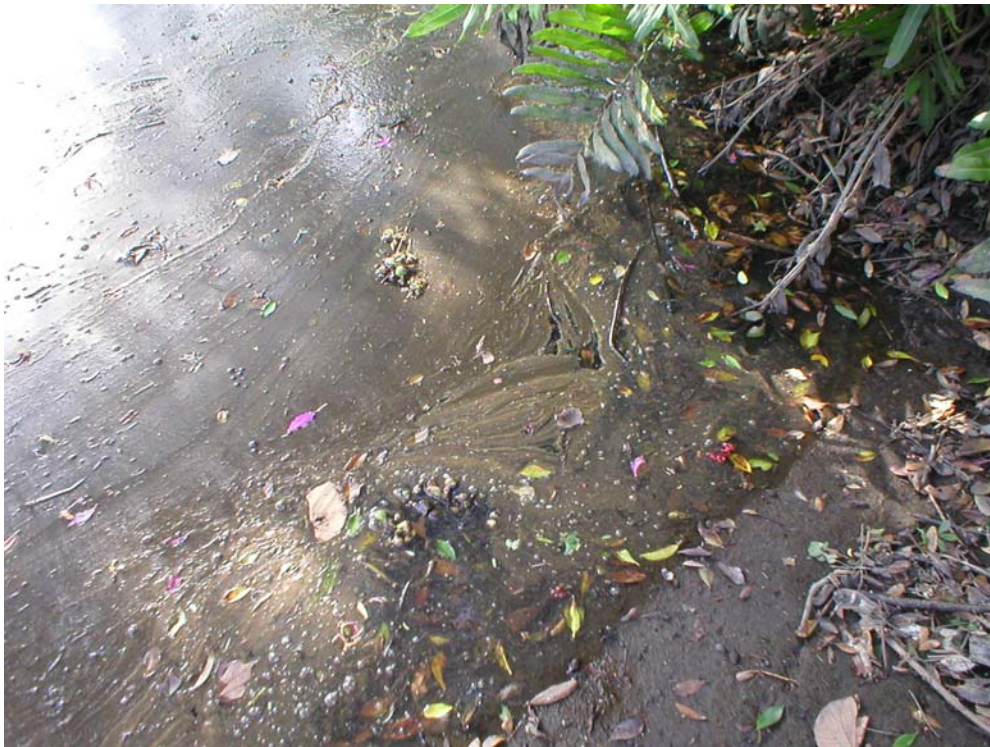
**Figure 14.**  
**Outfall PC3 at dead end.**

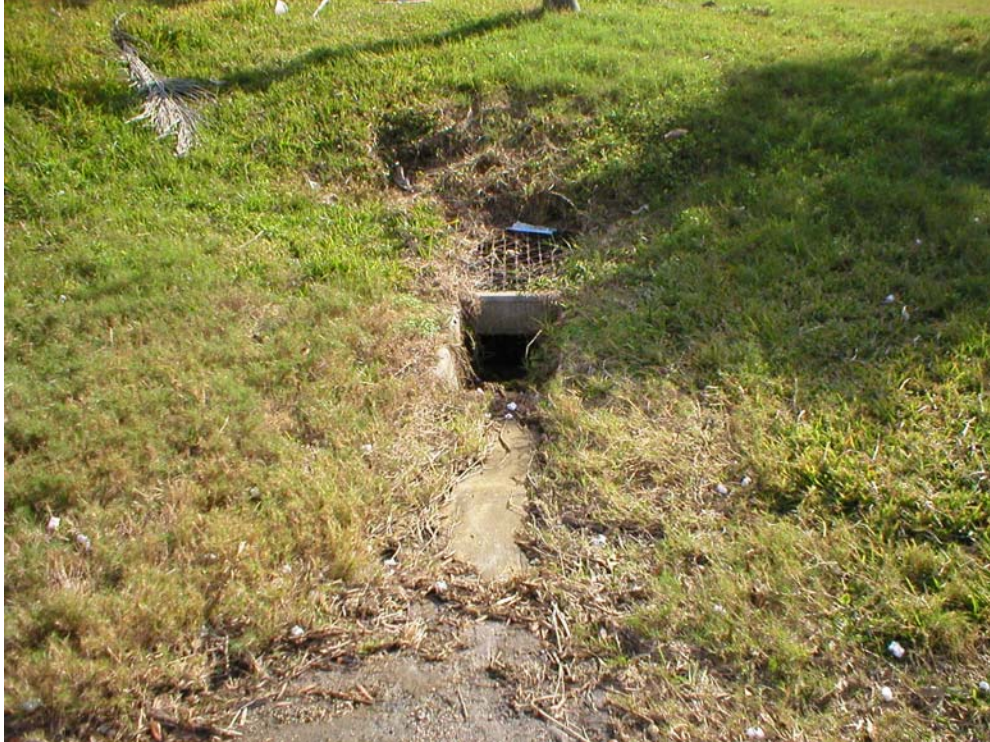
Outfall PC4 is a pipe discharging west of PC1 into the lower portion of the cove. This pipe drains 1.99 acres of single-family residential property from a series of inlets at the end of Nassau Street (Figure 15). This drainage basin has also a series of roadside swales and driveway culverts along Nassau Street that act as stormwater treatment systems. The pipe discharges below the water line and there was no sediment build up observed at the outfall (Figure 16). There was one observed failing sea wall near this outfall which could be a source of sedimentation (Figure 17).

**Figure 15.**  
**PC4 inlet at cul-de-sac at the end of Nassau St. in Basin B4**

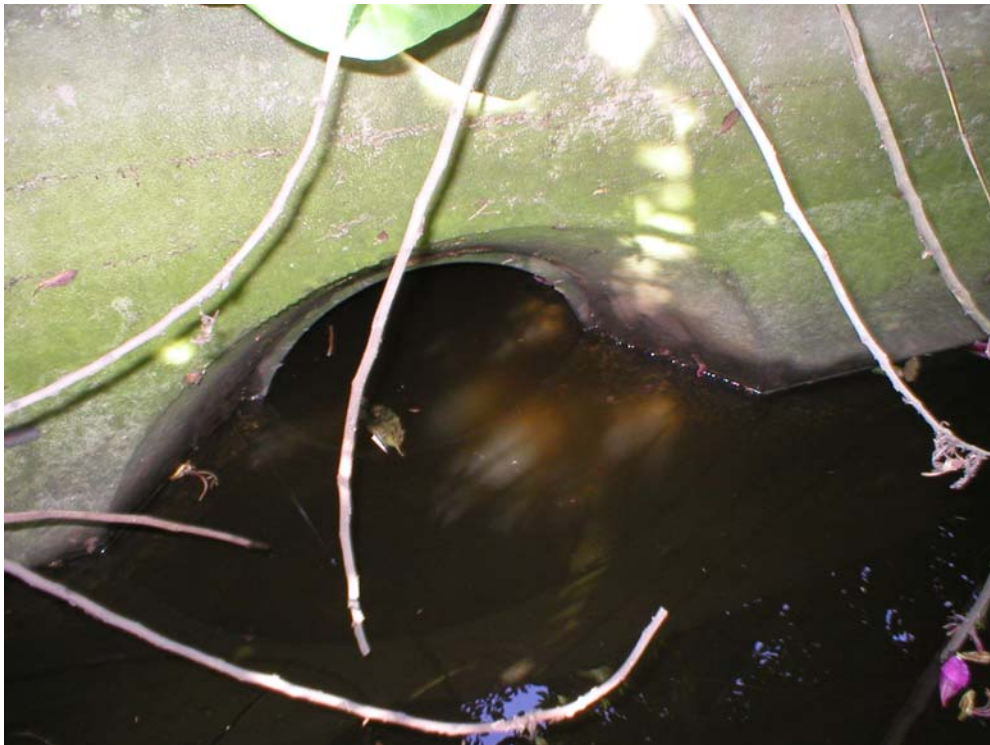
**Figure 16.**  
**PC4 submerged outlet pipe**

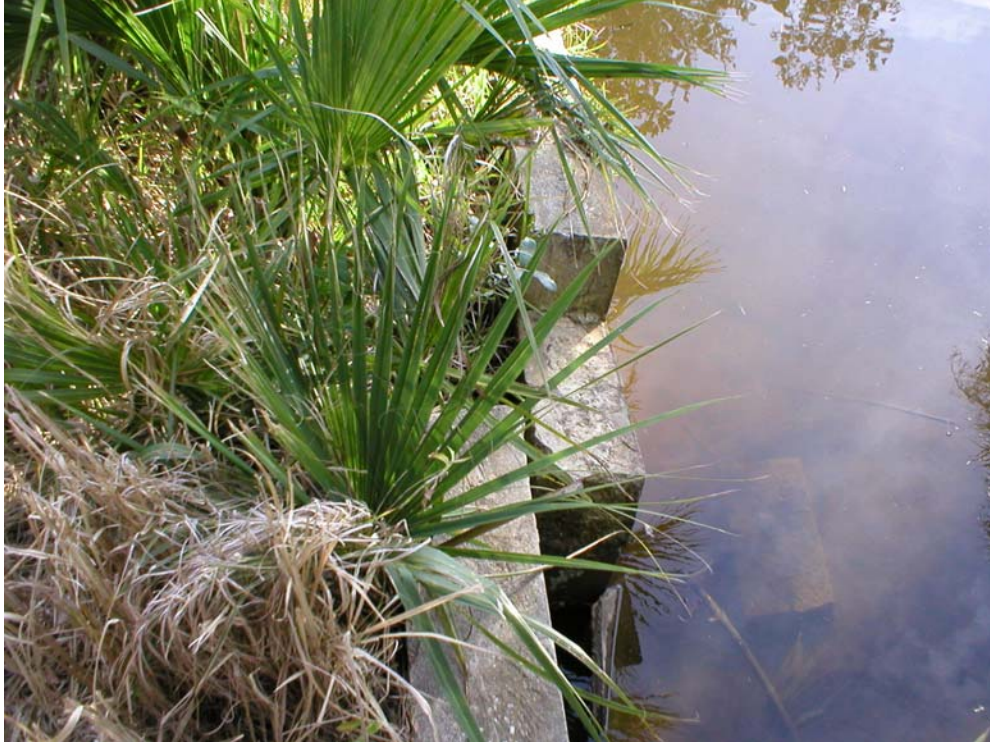
**Figure 17.**  
**Failing seawall near PC4 outfall**

The end of Nassau Street has a series of inlets that drain to the lower portion of the cove through Outfall PC4. No new BMPs are recommended for this outfall because of the small basin size and because the existing system of roadside swales and driveway culverts are working properly. However BHI recommends that the observed failing sea wall near this outfall be repaired to avoid possible sedimentation.

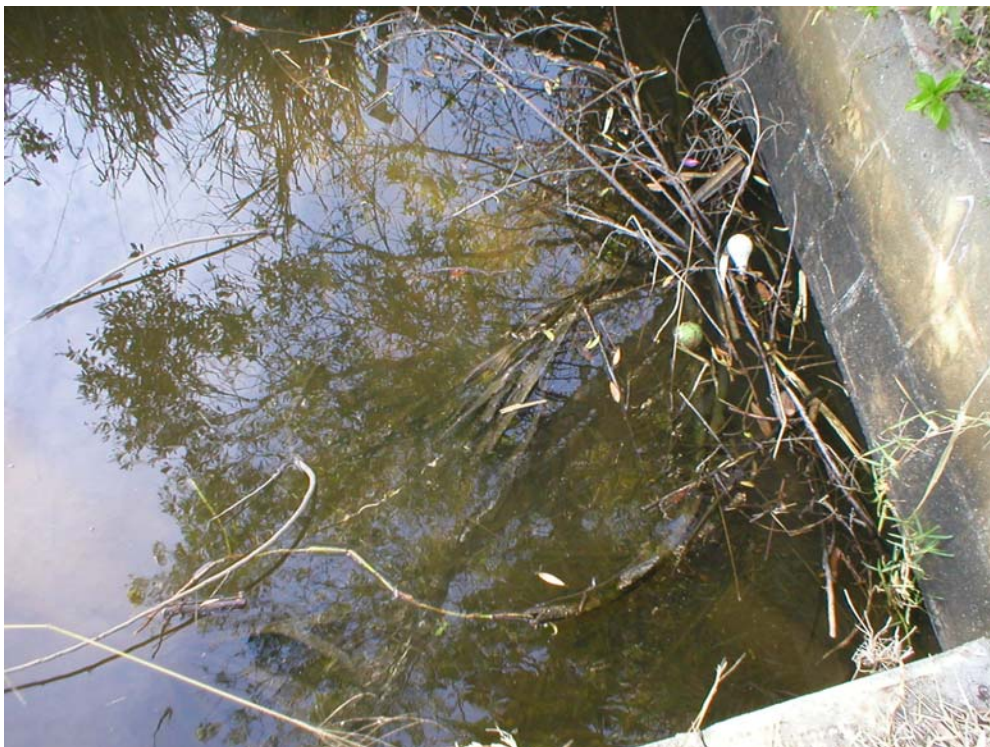
**Figure 18.**  
**Floating trash collecting near outfall PC4.**
