## **FIELD OBSERVATION REPORT**

**Date:** September 23-25, 2014  
**Project:** Lido Key Hurricane and Storm Damage Reduction Project  
Benthic Resource Investigation  
**Location:** Lido Key, Sarasota County, Florida  
**Commission No.:** 153076.03  
**Field Representatives:** Katy Brown (biologist), Judd French (field support), Ben Alcocer (field support), and Scott Tillman (captain)

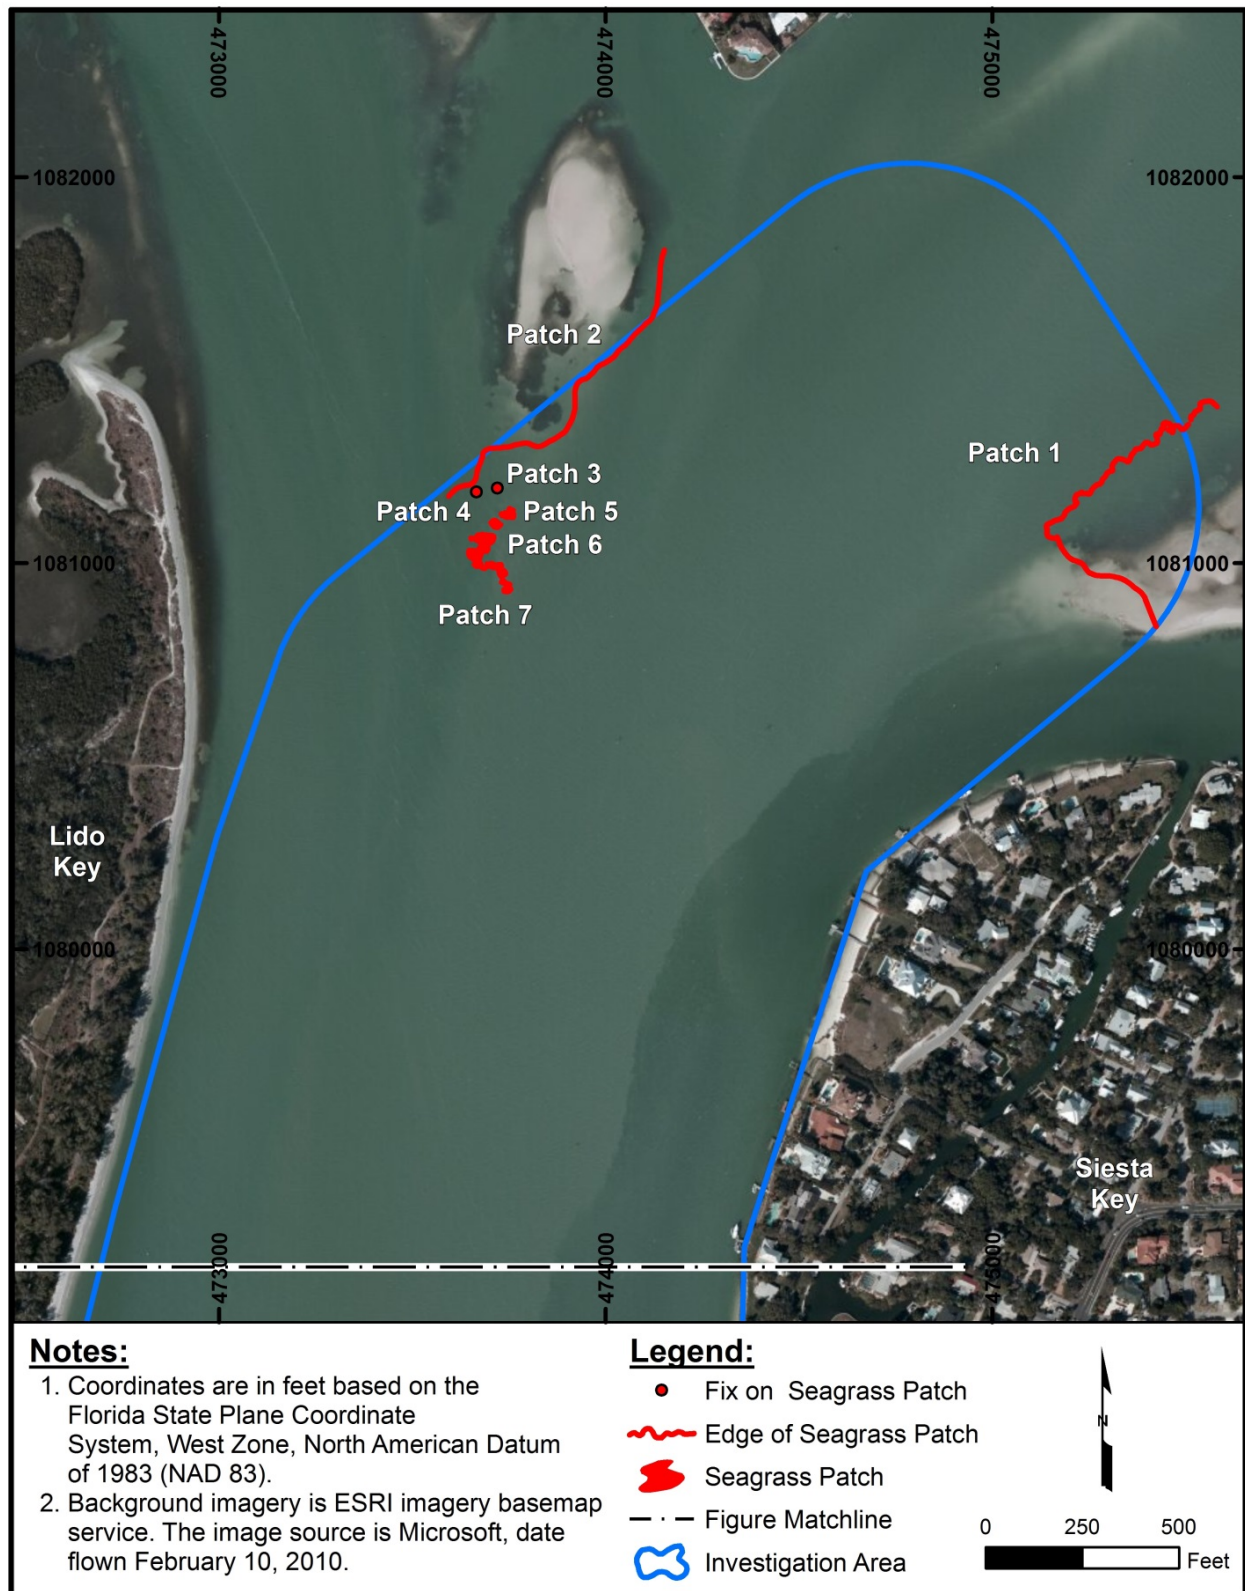
Figure 2a. Location of seagrass patches (Patches 1-7) observed inside Big Sarasota Pass.

Inside Big Sarasota Pass (Figure 2a), seagrass was present in the northeastern and northwestern sections of the investigation area and along the seawall located along the north end of Siesta Key. In the northeastern section a dense patch (Patch 1) of *Syringodium filiforme* (75-100% cover) was observed from the vessel and confirmed by diver verification. The patch was delineated using the diver-towed buoy equipped with a DGPS antenna. The depth was less than 1 m (~2 ft) and the patch extended outside of the investigation area. In the northwestern section of the Big Sarasota Pass investigation area, several patches of seagrass were observed during the towboard survey and subsequently confirmed by diver verification. A dense patch (Patch 2) of *Syringodium filiforme* (75-100% cover) at approximately 1-2 m (4 ft) depth was observed along the edge (and continuing outside) of the investigation area and was delineated from the vessel. Two small patches (Patches 3 and 4) of *Halodule wrightii* (approximately 50-75% cover) were observed at a depth of 1.5-2 m (5-6 ft), and fixes were taken at the center of the patches. Three larger patches (Patches 5, 6, and 7) of *H. wrightii* were also observed and delineated using the diver towed buoy. The percent coverage of *H. wrightii* was greater at Patch 5 (approximately 75-100%) than at Patches 6 and 7 (both had approximately 50-75% cover), and depths ranged from 1.5-2 m (5-7 ft). A patch (Patch 8) of *S. filiforme* was observed along the seawall at the north end of Siesta Key during the towed video survey and fixes were taken from the vessel (Figure 2b). This patch was located near the start of the rocky rubble area in approximately 4 m (14 ft) depth. Due to the strong tidal currents, divers could not safely dive the site to collect *in situ* data. Representative photographs of the seagrass resources in Patches 1-8 are presented in Figures 3 through 5.

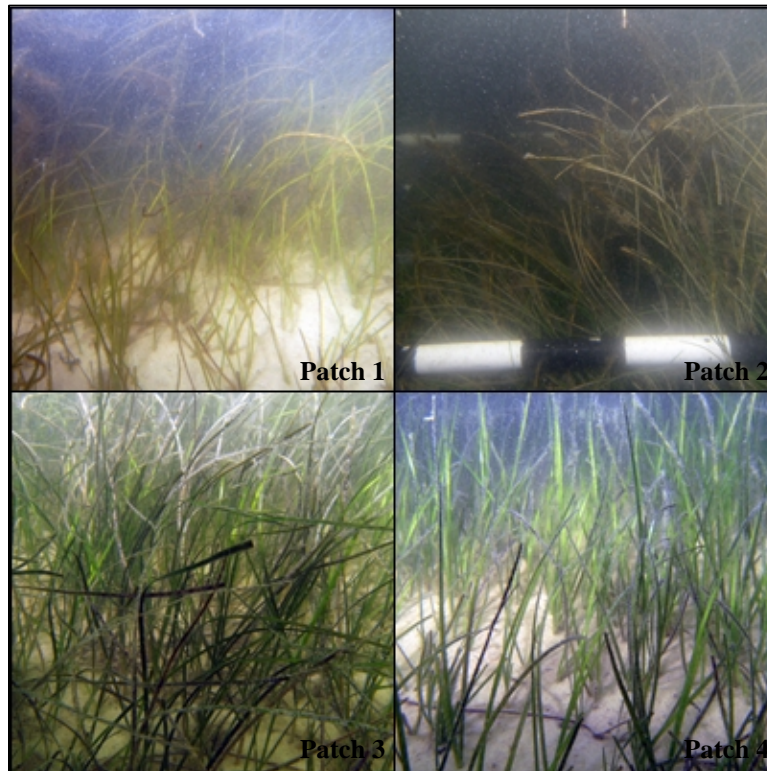
**Figure 3. Photographs of seagrass Patches 1-4 located inside of Big Sarasota Pass. Patches 1 and 2 are *S. filiforme* and Patches 3 and 4 are *H. wrightii*.**

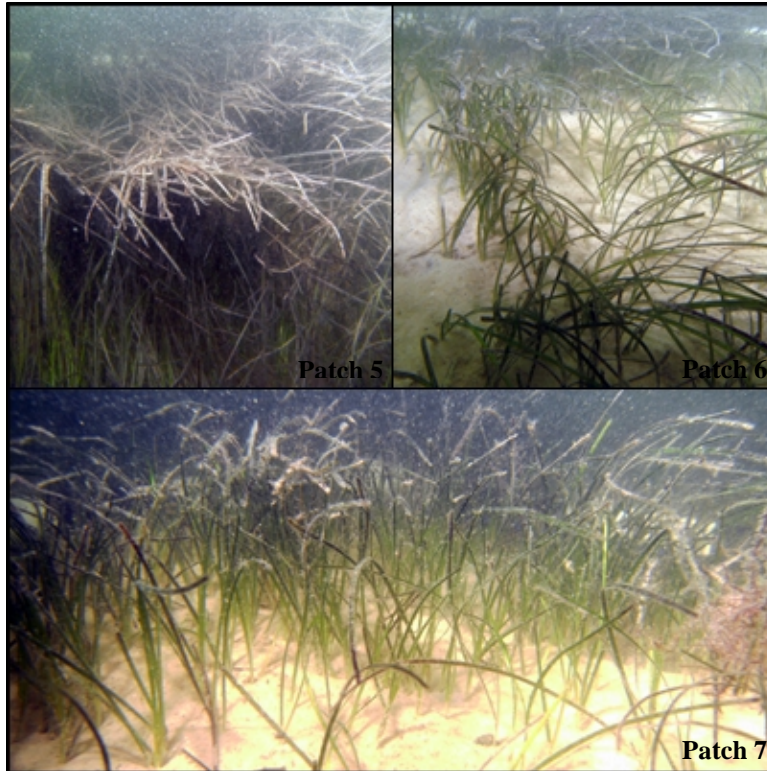
Figure 4. Photographs of seagrass Patches 5-7 located inside of Big Sarasota Pass. All patches consist of *H. wrightii*.

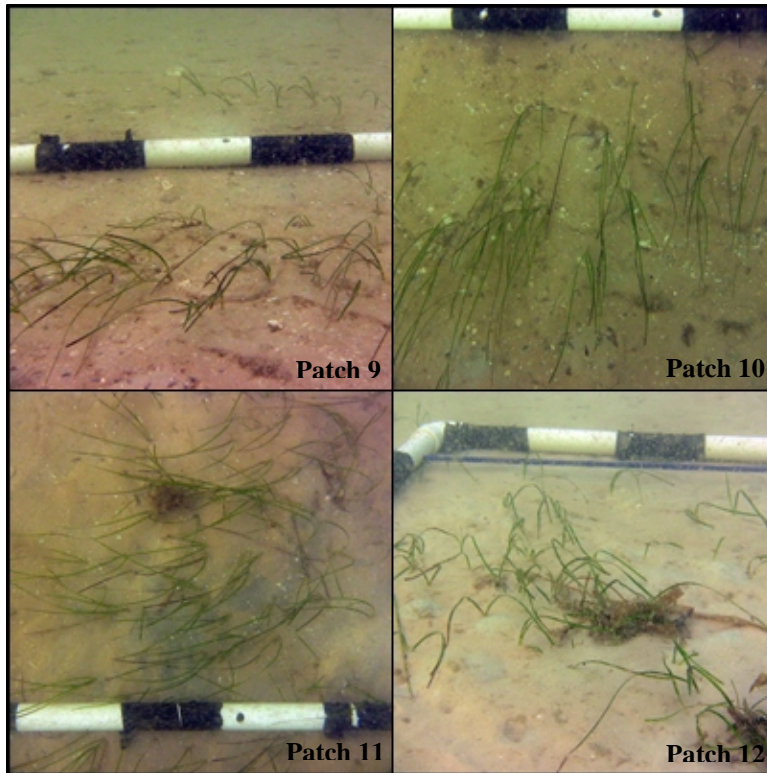
Figure 6. Photographs of seagrass Patches 9-12 located in the southwestern portion of the Big Sarasota Pass ebb shoal. All patches consisted of *H. wrightii*.

On the southwest portion of the Big Sarasota Pass ebb shoal, four large patches (Patches 9, 10, 11 and 12) of *H. wrightii* were observed during the towed video survey and confirmed by diver verification (Figures 2b and 6). Cover by *H. wrightii* was sparse, less than 5% at each of the patches, and depths ranged from 2-3 m (9-11 ft). The substrate consisted mostly of fine sand with areas of shell hash and dense aggregations of sand dollars (*Mellita tenuis*). To ensure the areas surrounding Patches 9-12 were adequately surveyed, intersecting towed video lines were conducted and fixes were taken to confirm the outer limits of each patch (see lines C1-C7 in Figure 1).

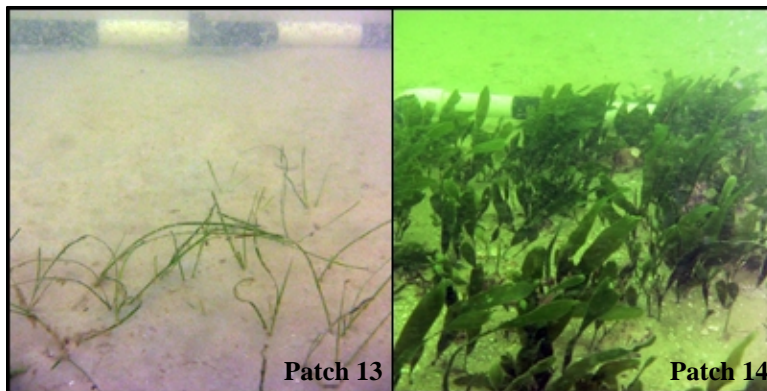
Figure 7. Photographs of seagrass Patches 13 and 14 located in the southern portion of the investigation area, offshore of Siesta Key. Patch 13 consists of *H. wrightii* and Patch 14 is *Halophila decipiens*.

In the southern portion of the investigation area, located southwest of the north end of Siesta Key, two small patches (Patches 13 and 14) were observed during the towed video survey and subsequently confirmed by diver verification (Figures 2b and 7). Fixes were taken at the center

of each patch. Patch 13 was a sparse patch (few individuals, less than 5% cover) of *H. wrightii* that covered approximately 0.5 m<sup>2</sup> at 3 m (9 ft) depth. Patch 14 was a dense patch (50-75% cover) of *Halophila decipiens* that covered approximately 0.5 m<sup>2</sup> at 5 m (17 ft) depth. The substrate consisted of fine sand and sand dollars at both sites.

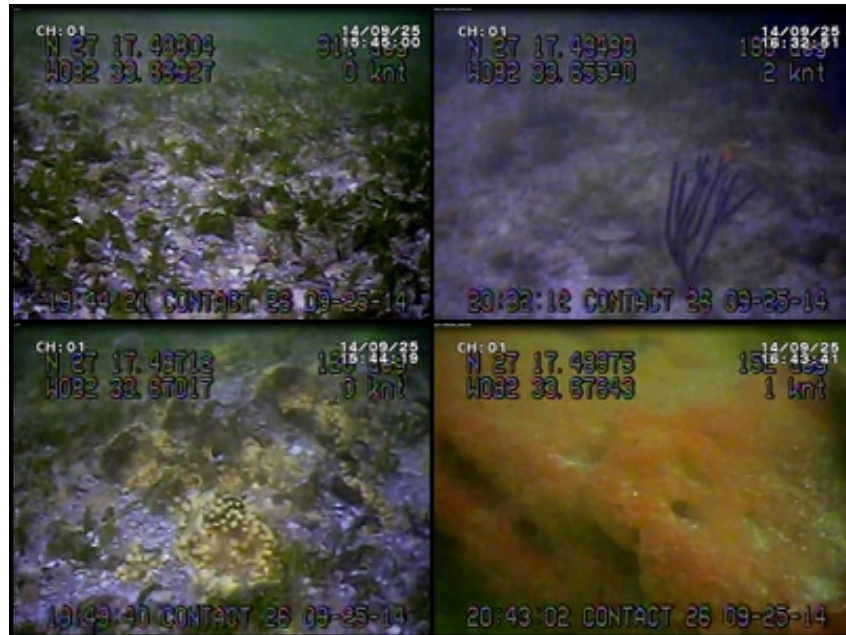
Figure 8. Hardbottom resources located within the channel in Big Sarasota Pass recorded during the towed video survey. Clockwise from the top: *Caulerpa* sp., *Leptogorgia virgulata*, *Cliona celata*, and *Pione lampa*.

(Figures 1 and 2b). Figure 8 shows representative images of the rock and rubble resources recorded during the towed video. Diver verification was attempted within the channel and a few photographs were taken, however due to the strong tidal currents the diving activities were limited for safety reasons. The benthic resources in this location consisted of large rocks, rubble, and debris that supported growth of sponges (e.g., *Cliona celata*, *Pione lampa*), macroalgae (e.g., *Caulerpa* sp.), and octocorals (e.g., *Leptogorgia virgulata*) (Figures 8 and 9). Fish species, such as sheepshead (*Archosargus probatocephalus*), were also observed utilizing this habitat (Figure 10).

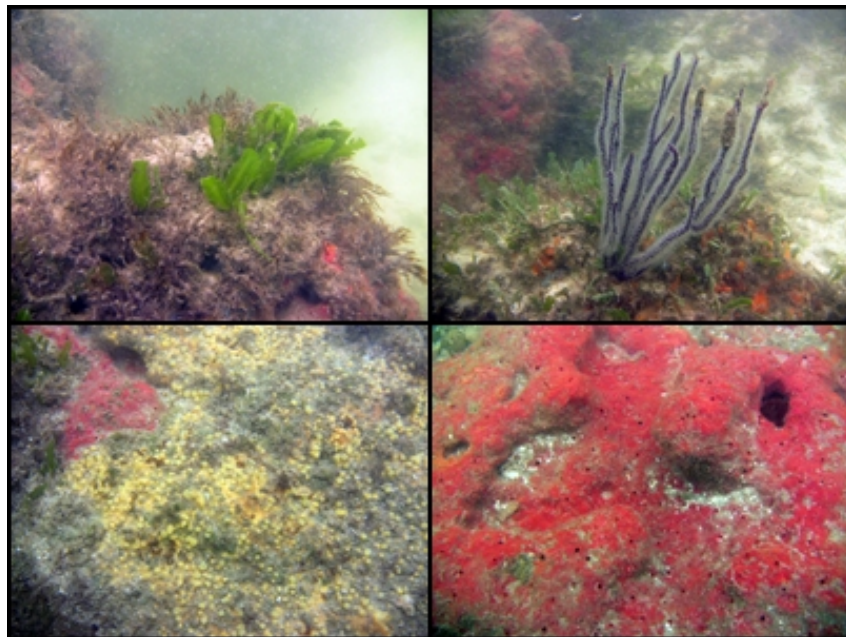
Figure 9. *In situ* photographs of the hardbottom resources located within the channel in Big Sarasota Pass. Clockwise from the top: *Caulerpa* sp., *Leptogorgia virgulata*, *Cliona celata*, and *Pione lampa*.

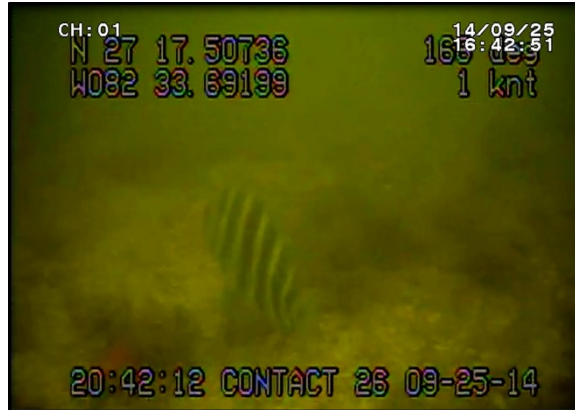
**Figure 10.** *Archosargus probatocephalus* (sheepshead) were one of the fish species recorded during the towed video survey within the channel in Big Sarasota Pass.
