# BEDS, BOATS, AND BUOYS: A STUDY IN PROTECTING SEAGRASS BEDS FROM MOTORBOAT PROPELLER DAMAGE

Ruth Folit
Julie Morris
Environmental Studies Program Publication # 39
New College of University of South Florida
with the support of the New College Foundation, Inc.
Sarasota, Florida
June, 1992

Prepared as an Early Action Demonstration Project for the Sarasota Bay Project National Estuary Program 1660 Thompson Parkway Sarasota, Florida 34236

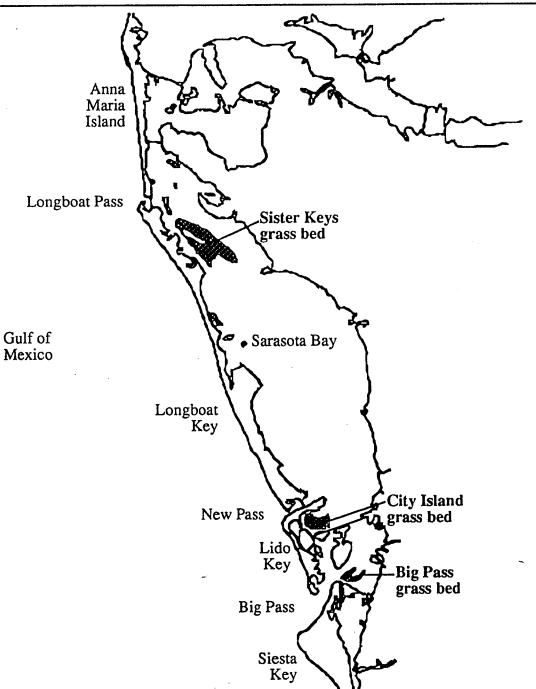
Figure 5. Sister Keys seagrass bed: buoy locations, marked channels, and water depths

Maria Island  $\parallel$ Jewfish Longboat Pass Key 10 13 3 17 Tidy Island grass Gulf of Mexico 5 Longboat Key Sarasota Bay Sister Keys grass bed Seagrass informational buoy Channel marker buoys Intracoastal Existing channel markers \\ Waterway Polygons for mapping analysis scale 2 Water depth in feet 3/8 mi.

The predominant grass is *Thalassia*, with areas of *Halodule* and *Syringodium*. During the course of the study, large bare areas in the northwestern and central portion of the bed were found to be enlarging. *Thalassia* rhizomes are present in these bare areas, but no blades are growing. There is no apparent explanation for the loss of such a large portion of the grass bed. Water depths throughout the bed range from about 1/2 foot to three feet of water at low tide. There are a string of deeper holes in the western area of the bed.

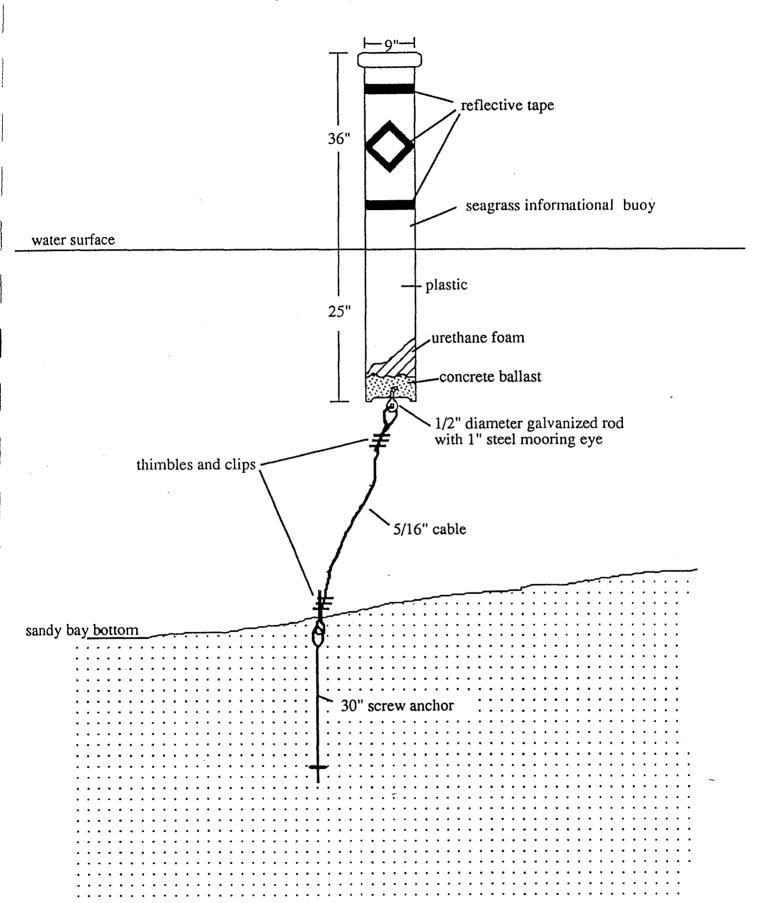
Figure 8. Buoy and anchoring system

It was important to design an anchoring system that would be secure during storms, resist vandalism, and not damage the grass meadows. A system that appears to have accomplished all three is one in which a 30" screw anchor is screwed into the sandy bay bottom at least five feet from the edge of the grass bed. A polypropylene coated 5/16" cable is attached with thimble and two clips at the anchor and buoy ends. The anchoring system has failed only once during the almost two years since the first buoys were installed. (See figure 8.) A seagrass informational buoy which was located along the eastern end of the Big Pass flood tidal shoal channel disappeared. The buoy marked the narrowest point of the channel, and it is possible that a very large boat accidentally pulled it out.

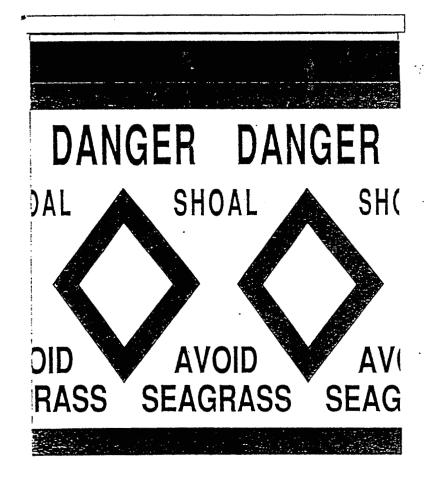
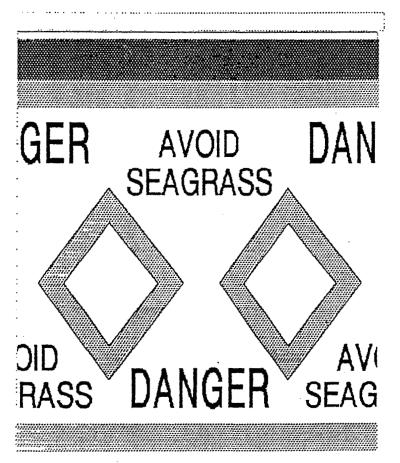
Figure 9. Buoy messages

The set of buoys at the pilot bed had the words, "DANGER" across the top of the buoy, "AVOID SEAGRASS" right above the water line, and "SHOAL" running vertically next to the Coast Guard hazard symbol of an orange diamond. The results of the boater interviews (see appendix 1) indicated that boaters felt that the most persuasive argument for keeping boats away from grass beds was environmental information, rather than information relating to the safety of their craft. The second set of buoys reflected this information, and these buoys had "AVOID SEAGRASS" and "DANGER", each imprinted across the top and above the water line of the buoy. (See figure 9.)

City Island grass bed

Sister Keys and Big Pass grass bed

Terns, gulls, cormorants, and other birds quickly discovered the buoys near the pilot bed were desirable perches between fishing forays over the grass bed. White stains began to obscure the message on several buoys and cleaning attempts eroded the vinyl lettering. To solve this problem, an inverted funnel was secured to the top of each new buoy to discourage birds from perching. The first set of buoys were retrofitted with the funnels.

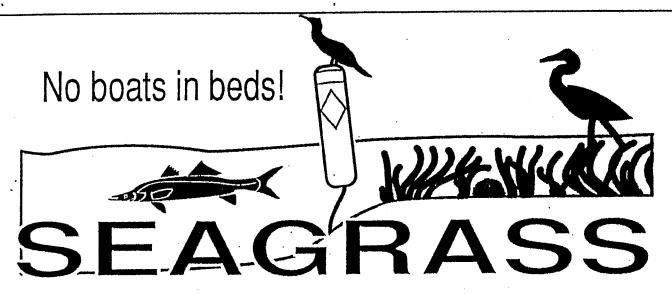
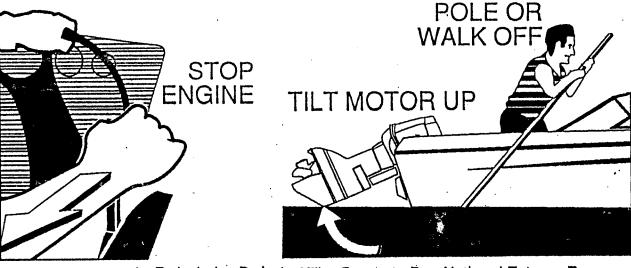
Figure 14. Boat ramp sign

Running aground in seagrass beds can ruin your motor, propeller, and reputation. It's also rough on the sealife that lives in grassbeds. Wounds from propellers heal slowly, if at all.

Learn to avoid grassbeds. Some beds are marked with buoys -most aren't. Reading charts can help, so can reading the water for dark patterns.

If you do run aground, what you do next counts.
