# FLOOD PLAIN MANAGEMENT STUDY

## COW PEN SLOUGH WATERSHED SARASOTA COUNTY, FLORIDA

U.S. DEPARTMENT OF AGRICULTURE  
SOIL CONSERVATION SERVICE

1985

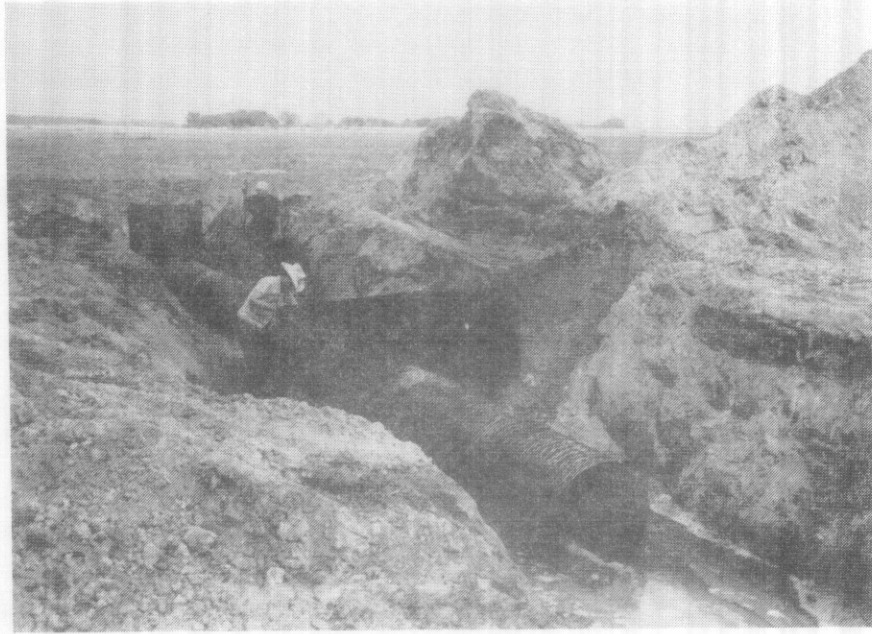
Figure 3. Installation of this gravity drain took place May 16, 1967.

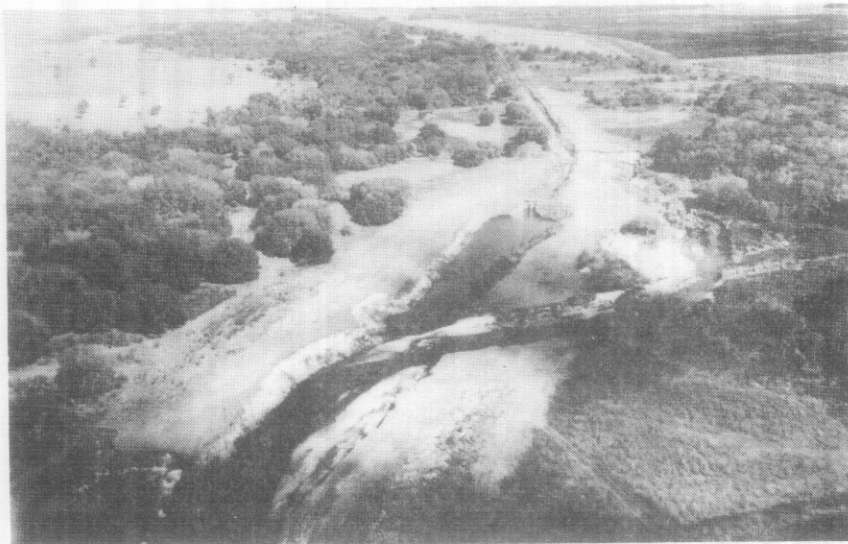
Figure 4. Cow Pen Slough looks similar today to this December 1967 photo showing the washout of Structure 3 (looking upstream)

Although the original plans called for five flood control structures, only three were built. These structures are for grade stabilization and water conservation. They are reinforced concrete drop spillways with 20 foot weirs and 3 foot high radial gates (see figures 12 & 14). They were designed to be "island" type structures with dikes constructed to divert part of the flow around the structure to prevent overtopping. Structure 1 is located just north of Laurel Road. Structure 2 is located slightly more than a mile south of Highway 72, and Structure 3 is located approximately midway between Highway 72 and Highway 780 (see figure 1). Structure 3 failed in August 1967 after 5.17 inches of rain fell over a 3-day period. The flood flows carried a heavy concentration of water hyacinths to Structure 3, significantly restricting its discharge capacity. Flood waters then overflowed around Structure 3. A 54-inch pipe side inlet, located 500 feet downstream of the structure on the east bank, washed out. This washout started the formation of a gully that cut upstream around Structure 3, following the original channel of Cow Pen Slough which had been filled in during channel improvement and realignment. The formation of this large bypass gully caused severe erosion and downstream sedimentation. Figure 4 depicts the present situation.

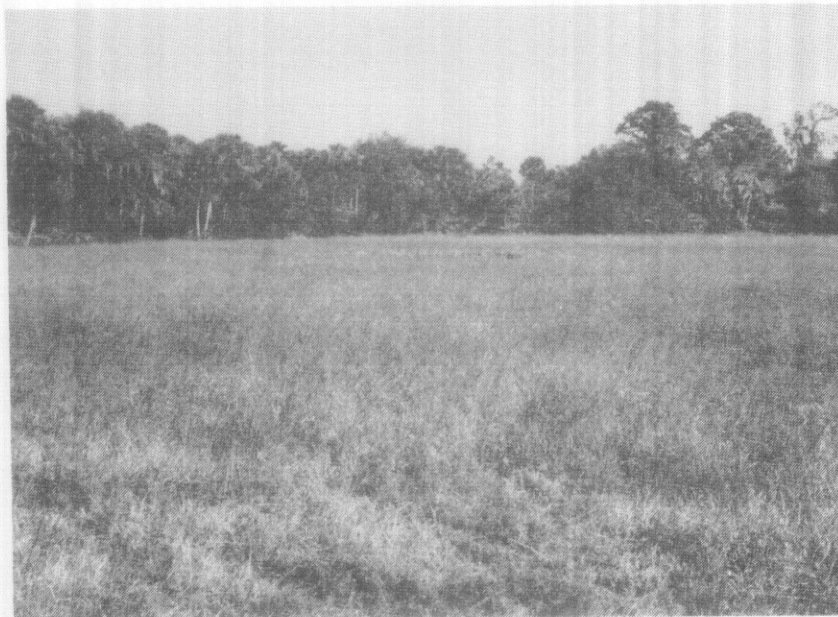
Figure 7. The background is a cabbage palm hammock with Bradenton and the foreground is the Holopaw Series of association 6.

Association 6 consists of soils of the Holopaw, Malabar, and Floridana series (see figures 7 and 8). Other soils of minor extent throughout this association are of the Felda and Delray series. All of these soils are sandy in the surface and subsurface layers and loamy in the subsoil. They occur in sloughs and depressions. The dominant vegetation in the sloughs is blue maidencane and wiregrass. The depressions are vegetated with St. Johnswort, pickerelweed, maidencane or sawgrass. The depressions have water above the surface for several months each year.

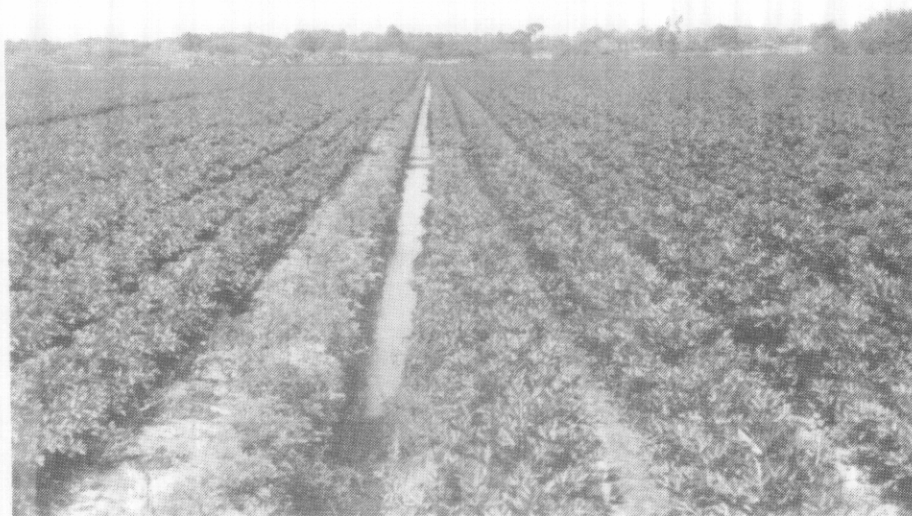
Figure 8. Celery growing in Floridana mucky fine sand.

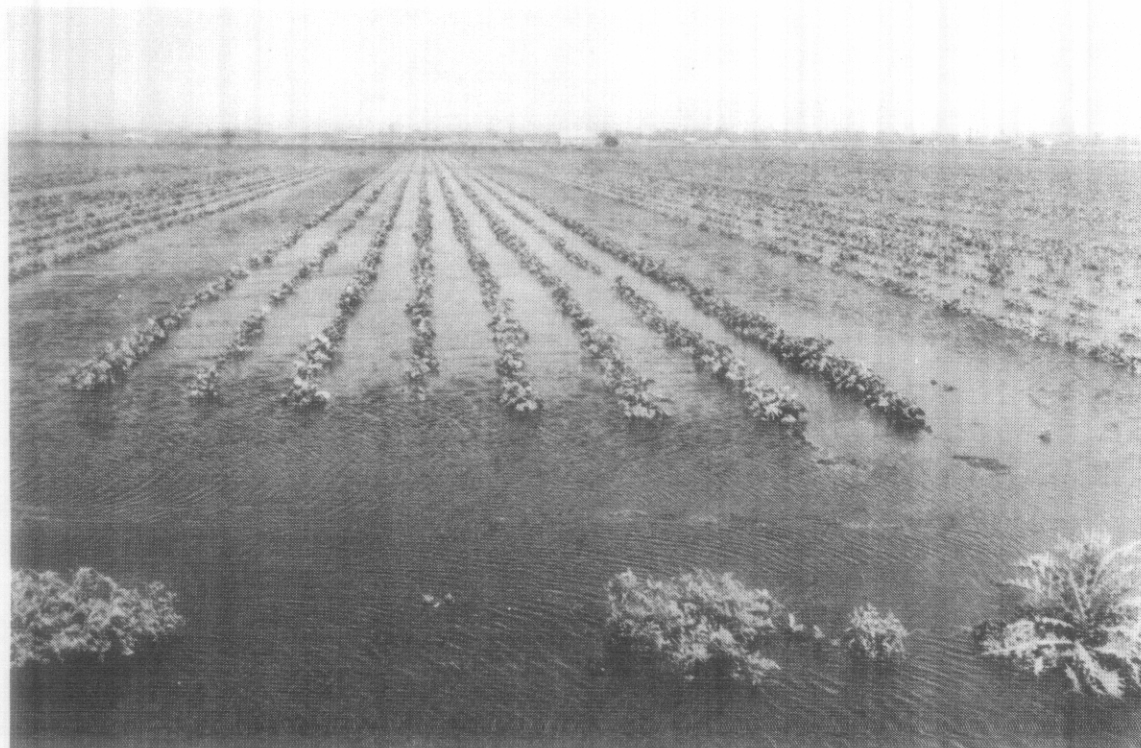
Figure 9. Vegetables under 12 inches of flood water. The photo was taken March 12, 1958 after 4.98 inches of rain (less than a 2-year storm) that day. This storm occurred prior to the flood control work installation.

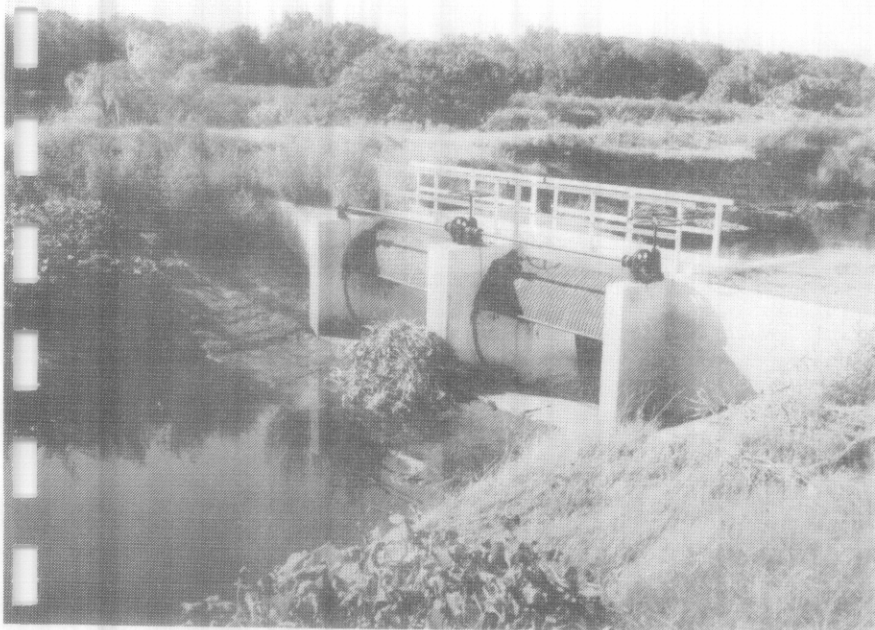
Figure 14. Debris blocking flow through Structure No. 3 (looking downstream)  
Date: 8/17/67
