## Deer Prairie Slough Restoration Project: Phase II Monitoring Report

Warren Reuschel, Project Scientist  
Ron Van Fleet, Project Manager  
Sarasota County Public Works  
Permitting, Mitigation, and Restoration  
1001 Sarasota Center Boulevard  
Sarasota, Florida 34240

April 10, 2004

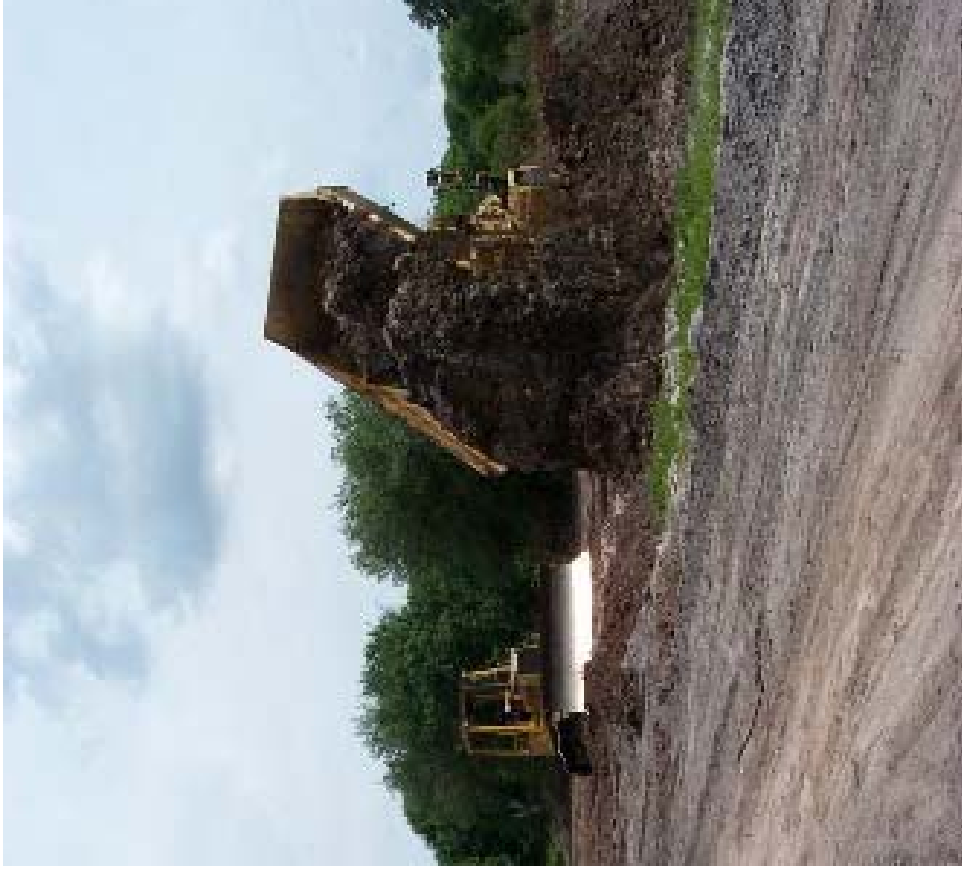
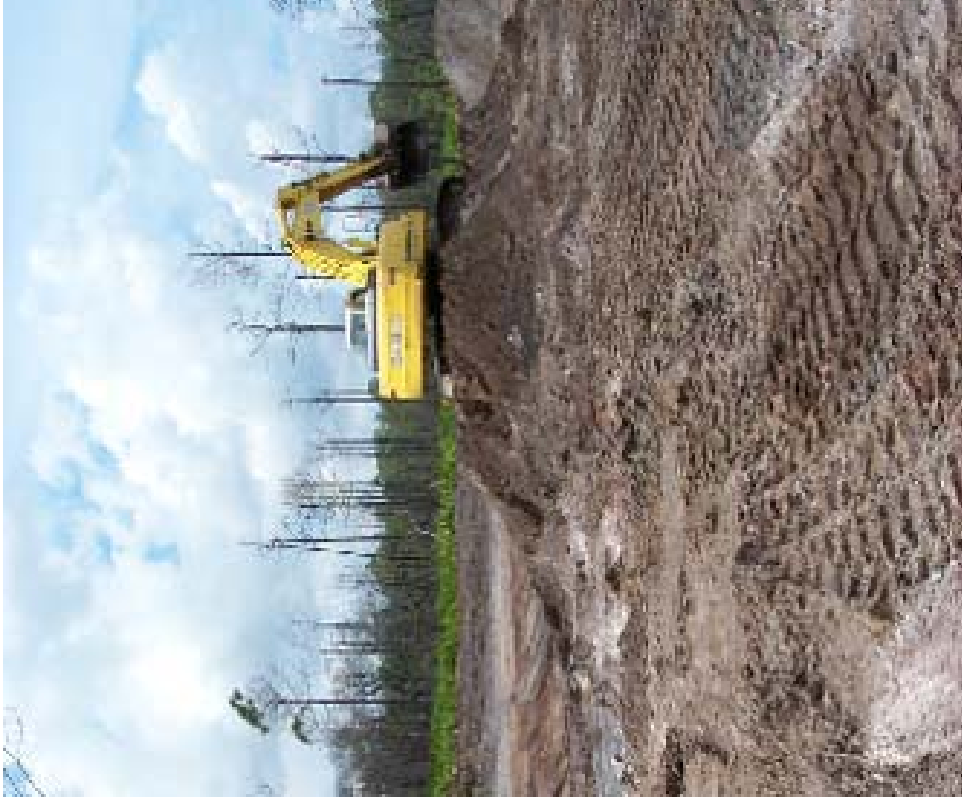
**Figure 3.** Deer Prairie Slough Restoration Earthwork:      a. Long-reach excavator extracting fill material from borrow pit area.  
b. Placement and distribution of fill with off-road truck and bulldozer

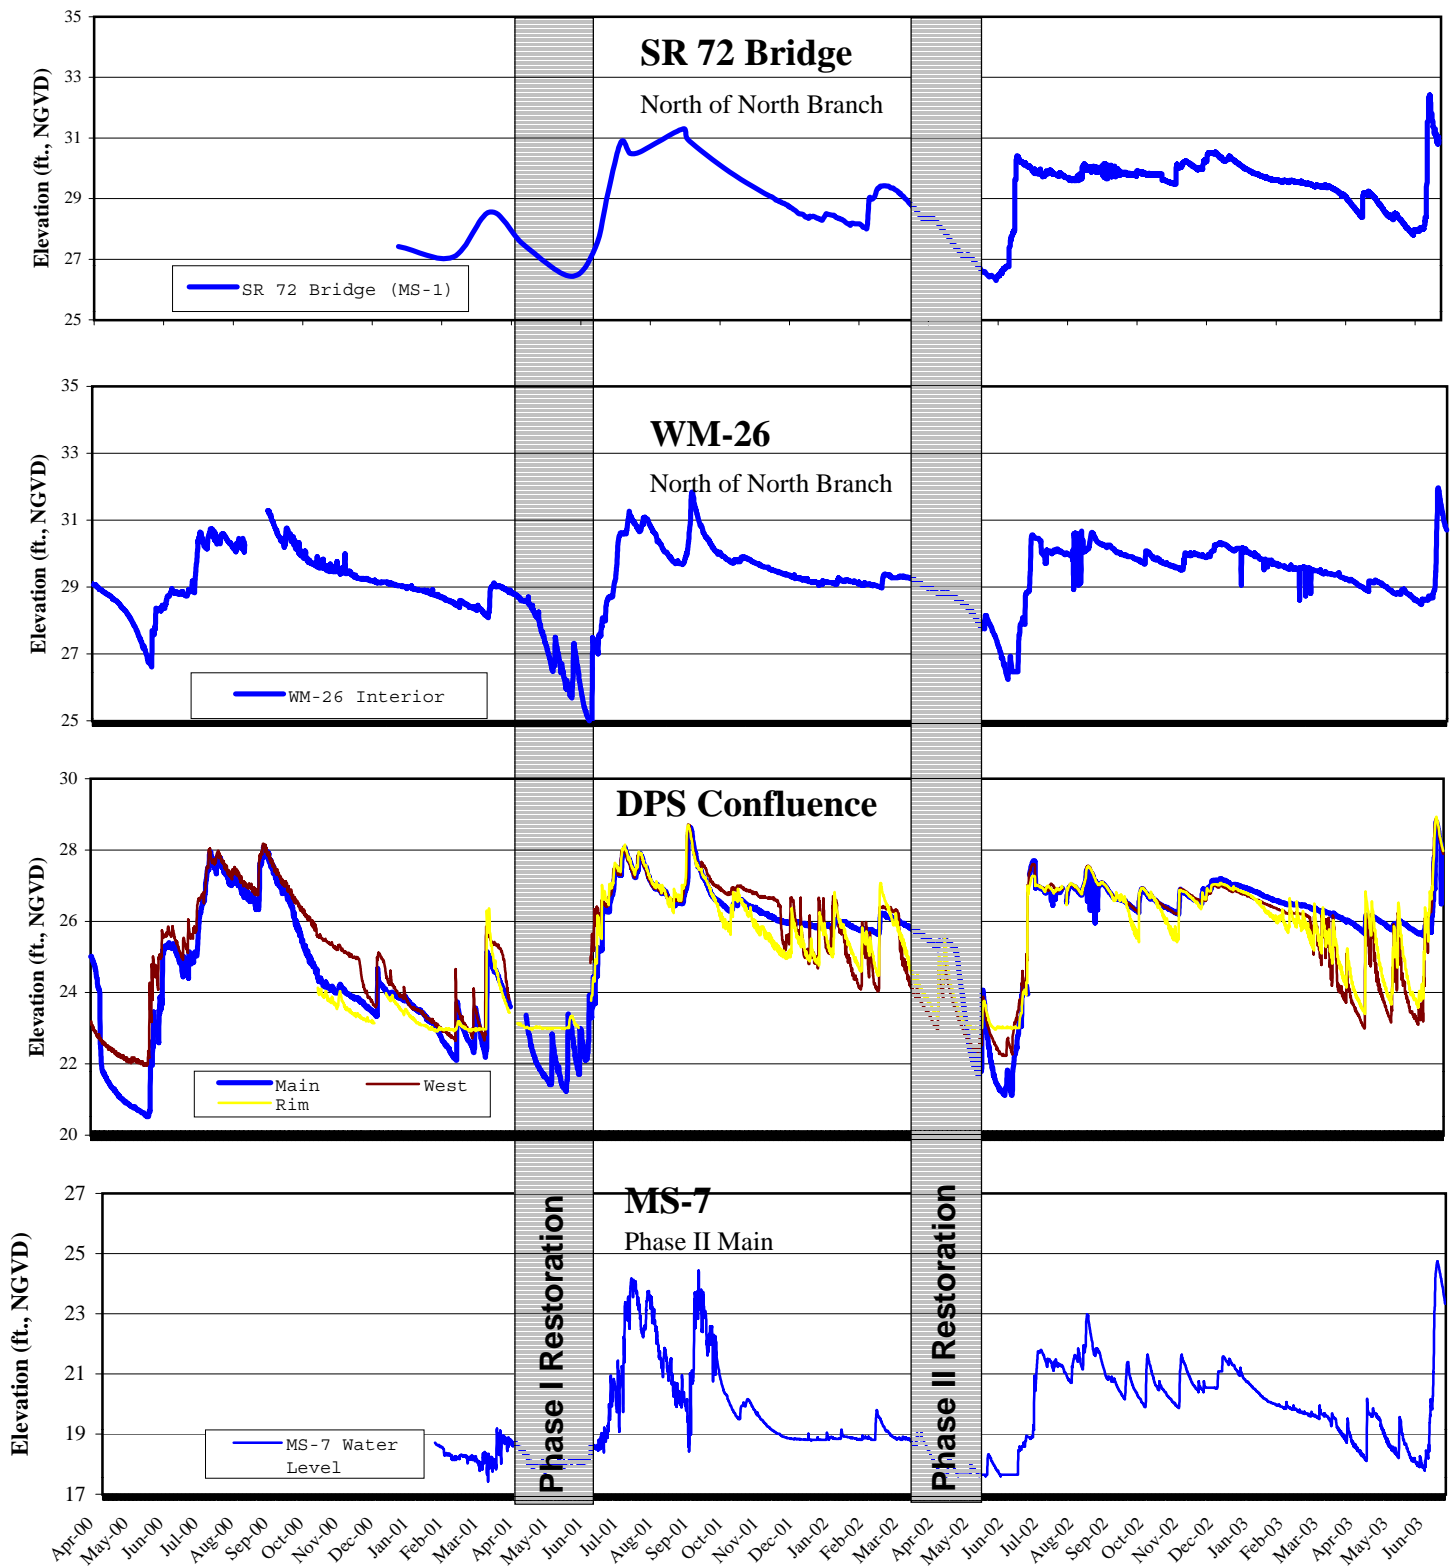
**Figure 7.** Deer Prairie Slough telemetry hydrographs, North to South.

Telemetered stage data for the slough corridor, measured at sites SR72, WM-26, DPS confluence, and MS-7 further resolve the more gradual drawdown following restoration, particularly following Phase II (Figure 7). Because this telemetered data was recorded at six hour intervals, the longer periods of inundation indicated on this figure are more significant than those implied by the manual monthly measurements. It should be noted that the hydroperiod improvements are more pronounced in the northern (upstream) telemetered sites, indicating that the downstream restoration performed during Phase II further improved the hydroperiod in Phase I wetlands.

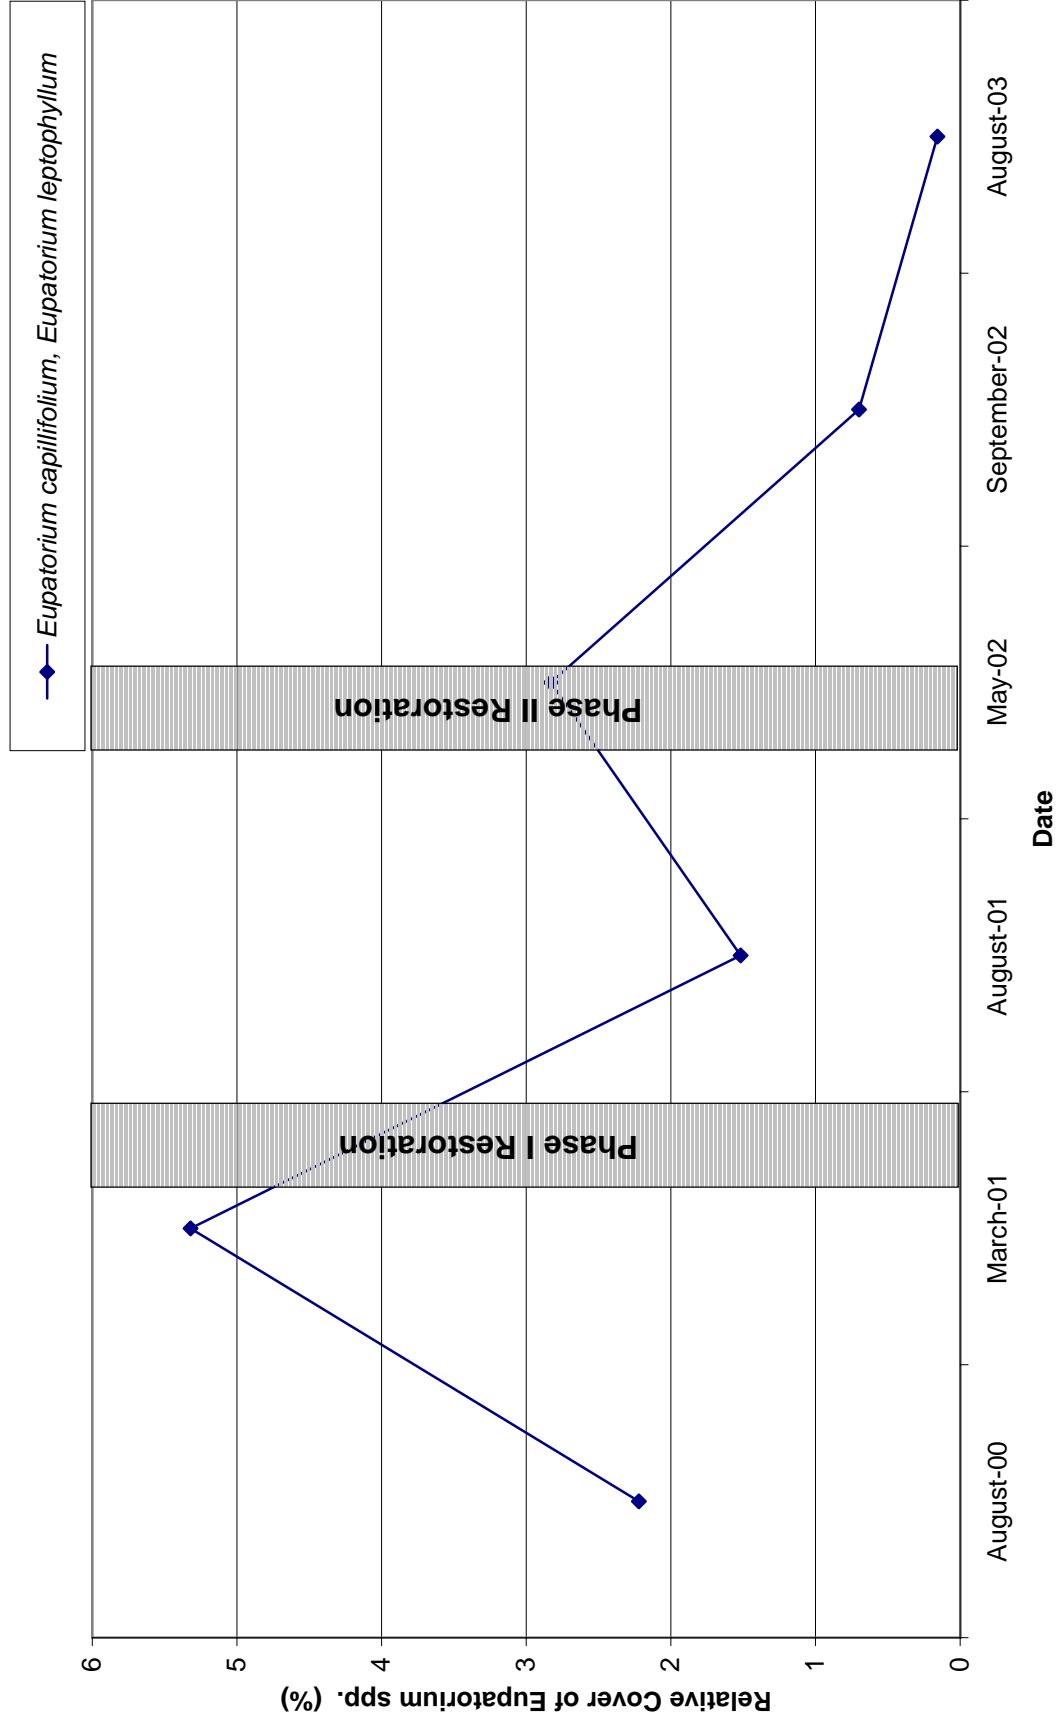
**Figure 13.** Change in relative cover of dog-fennel (*Eupatorium capillifolium, Eupatorium leptophyllum*) in Deer Prairie Slough vegetation monitoring transects.

natural hydroperiod and reflects significant progress toward the stated goal of reduced seasonal coverage of upland or disturbance species.

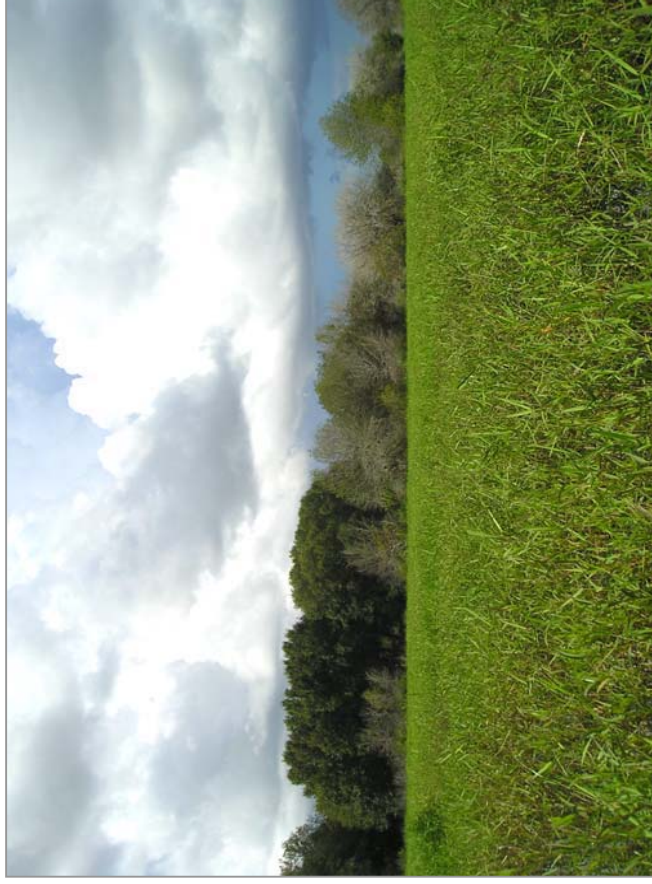
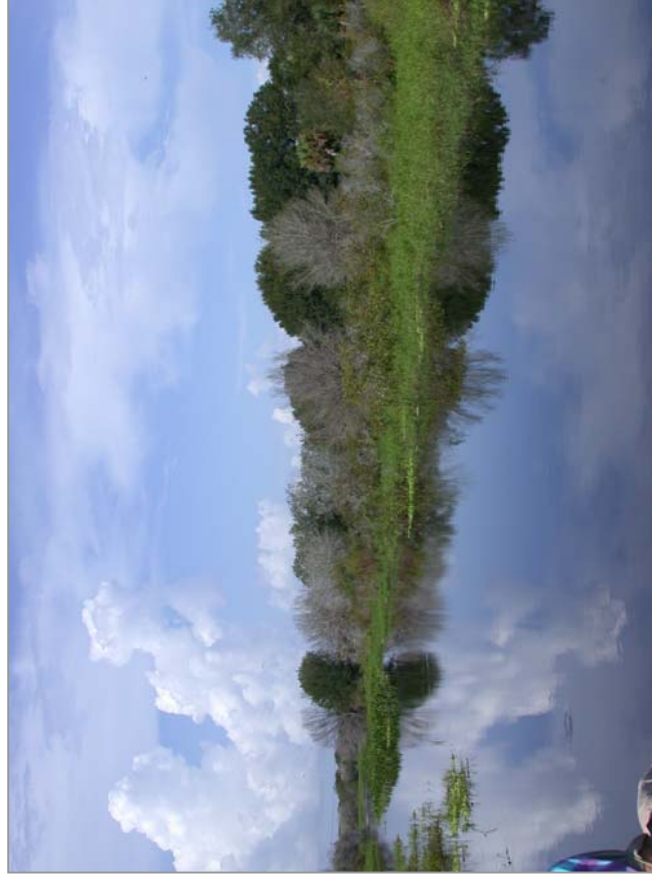
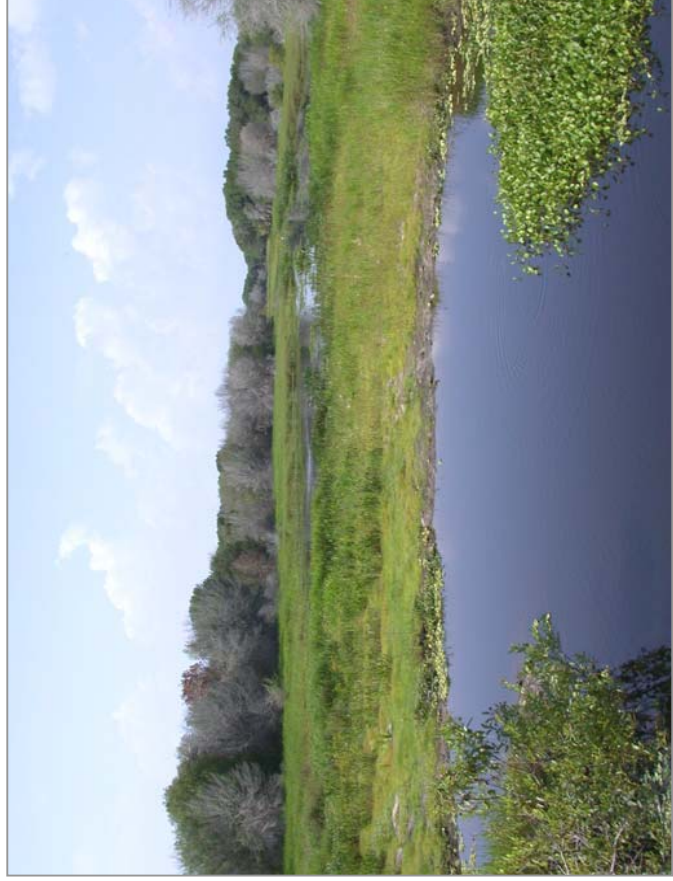
**Figure 15.** Dying laurel-oak (*Quercus laurifolia*) fringe at Deer Prairie Slough following restoration. **A)** View west from Phase I Main. **B)** View northeast from Phase I Main. **C)** View northeast from South Powerline Bridge. **D)** View south from South Powerline Bridge

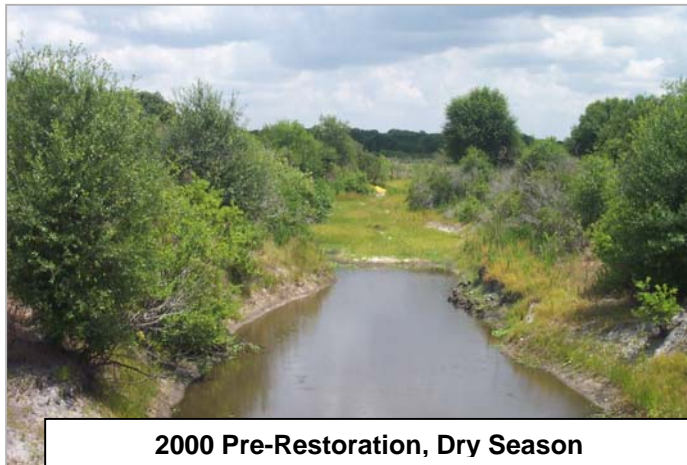
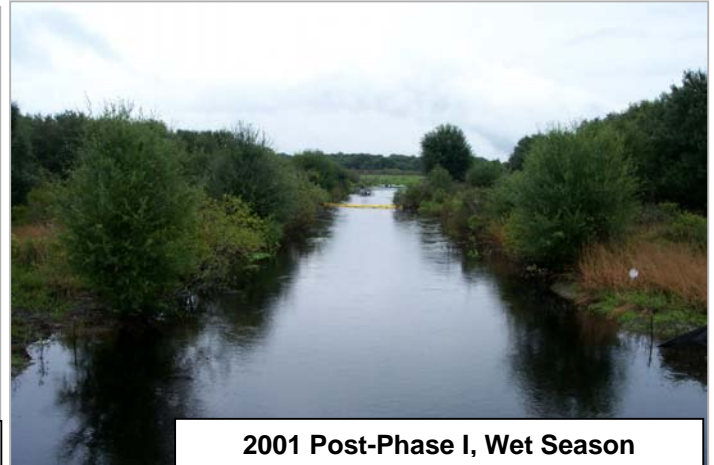
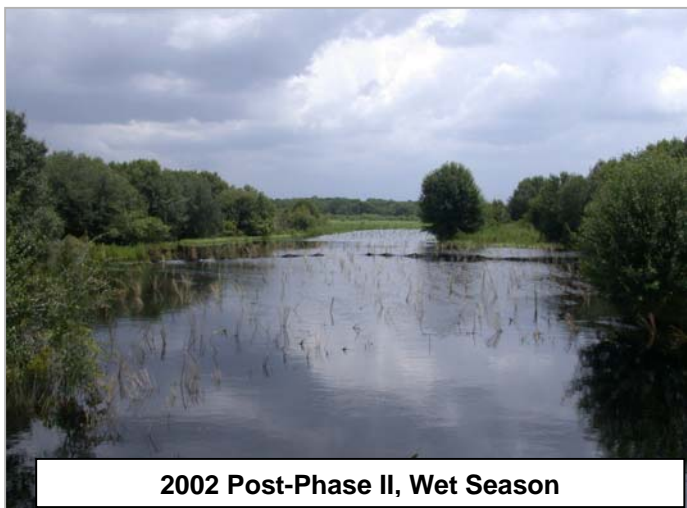
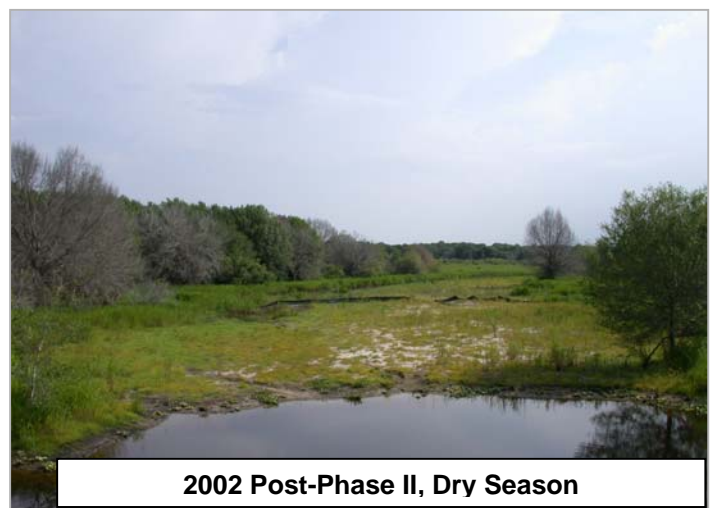
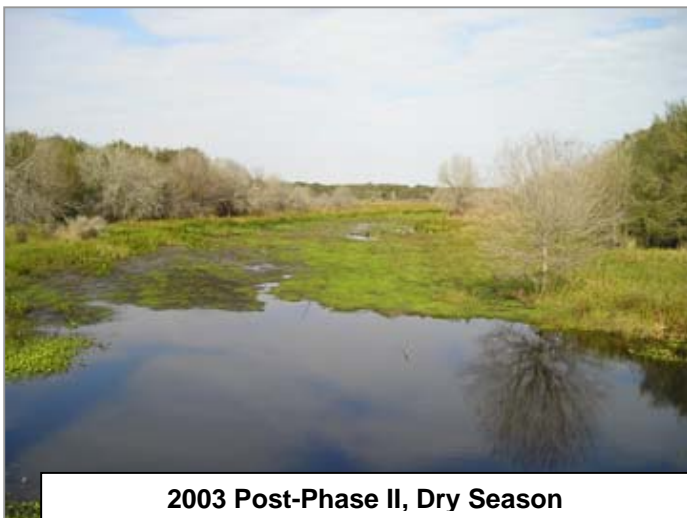
**Figure 17.** Photographic series of channel morphology, water levels, and tree canopy changes through Phases I and II of the Deer Prairie Slough Restoration Project, north from South Powerline Bridge.

Finally, Figure 17 provides a photographic series of typical restoration effects looking north into Phase I Main from the South Powerline Bridge. Standing water, removal of vegetated spoil, laurel oak mortality, and corridor revegetation are all apparent. This

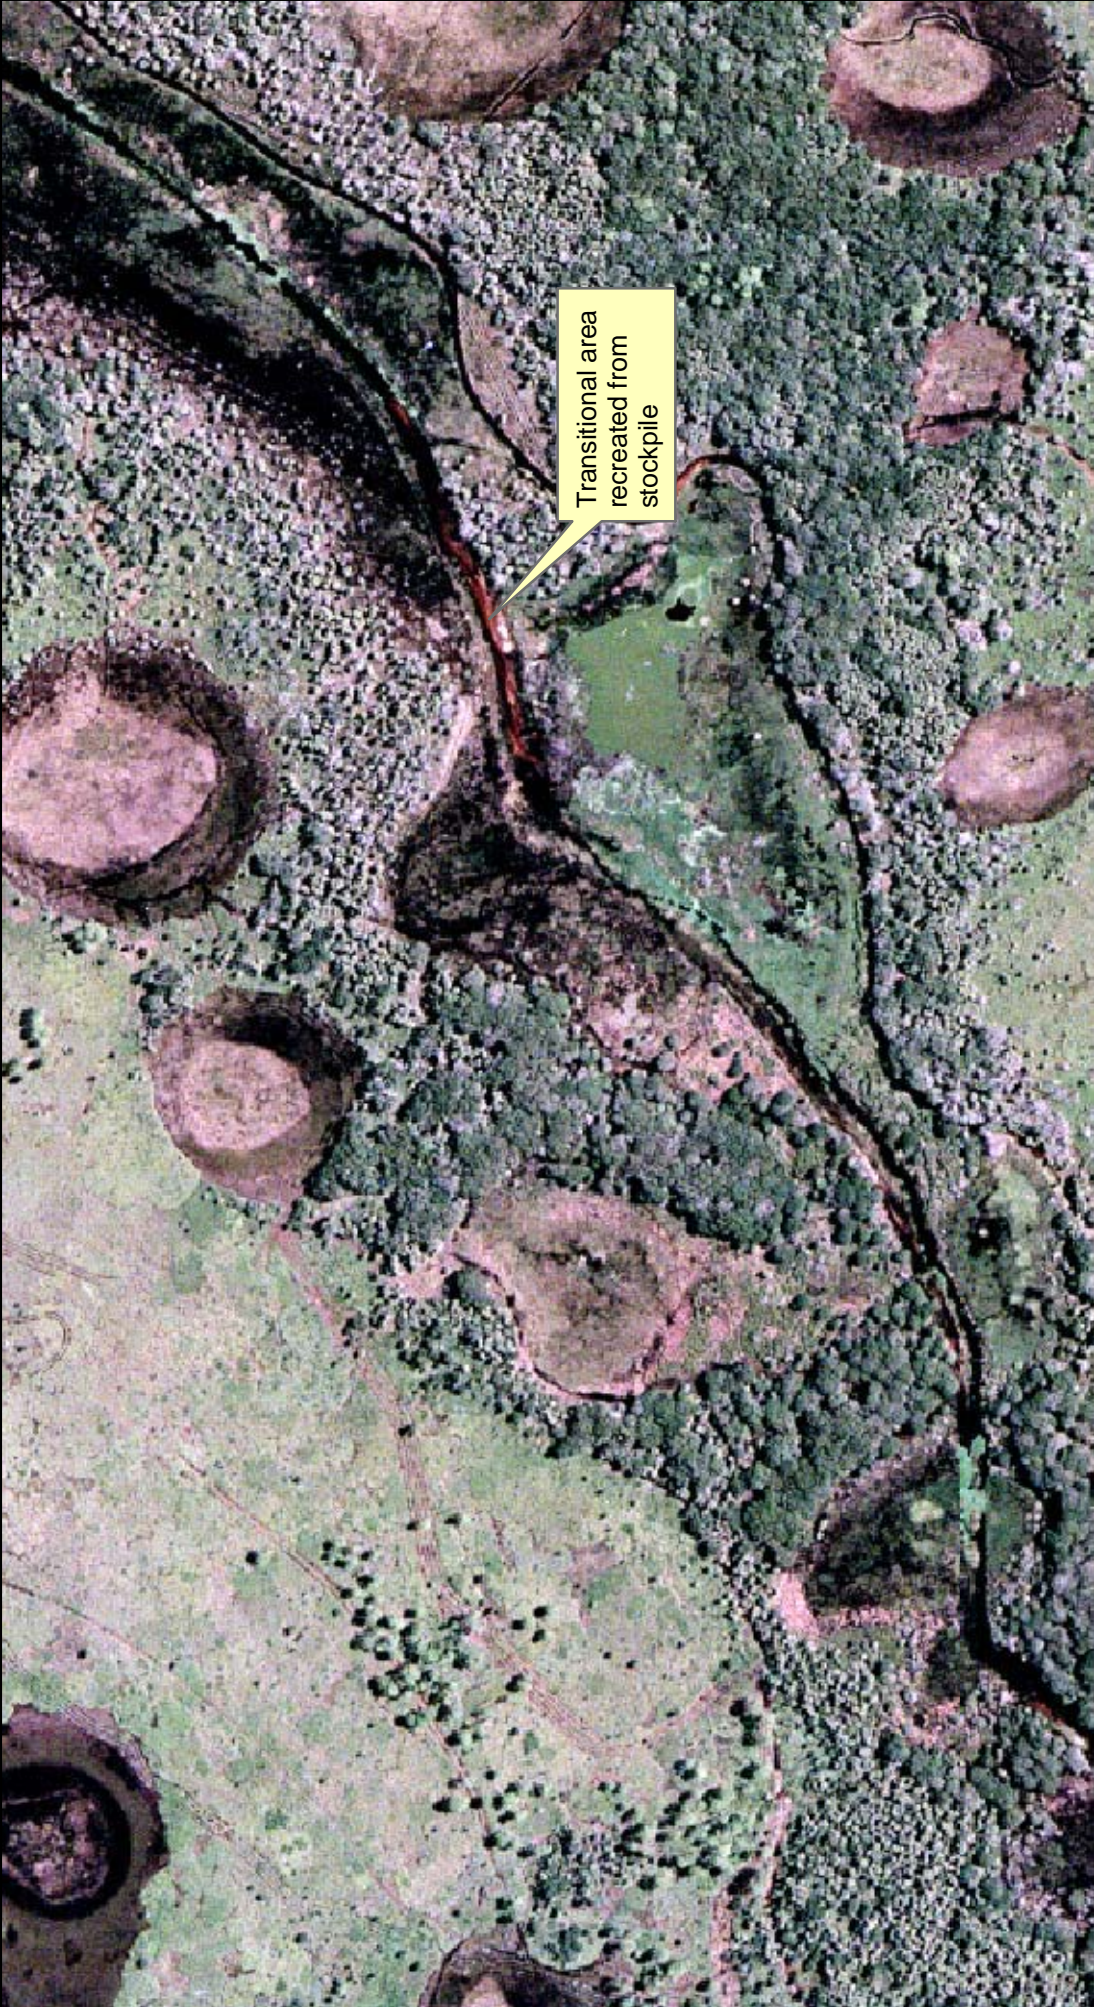
Transitional area  
recreated from  
stockpile

**Appendix B Sheet 2a**  
Phase I Main - Post Restoration  
Maximum corridor width: 120 ft  
Random spot corridor width average (n=7): 66 ft.

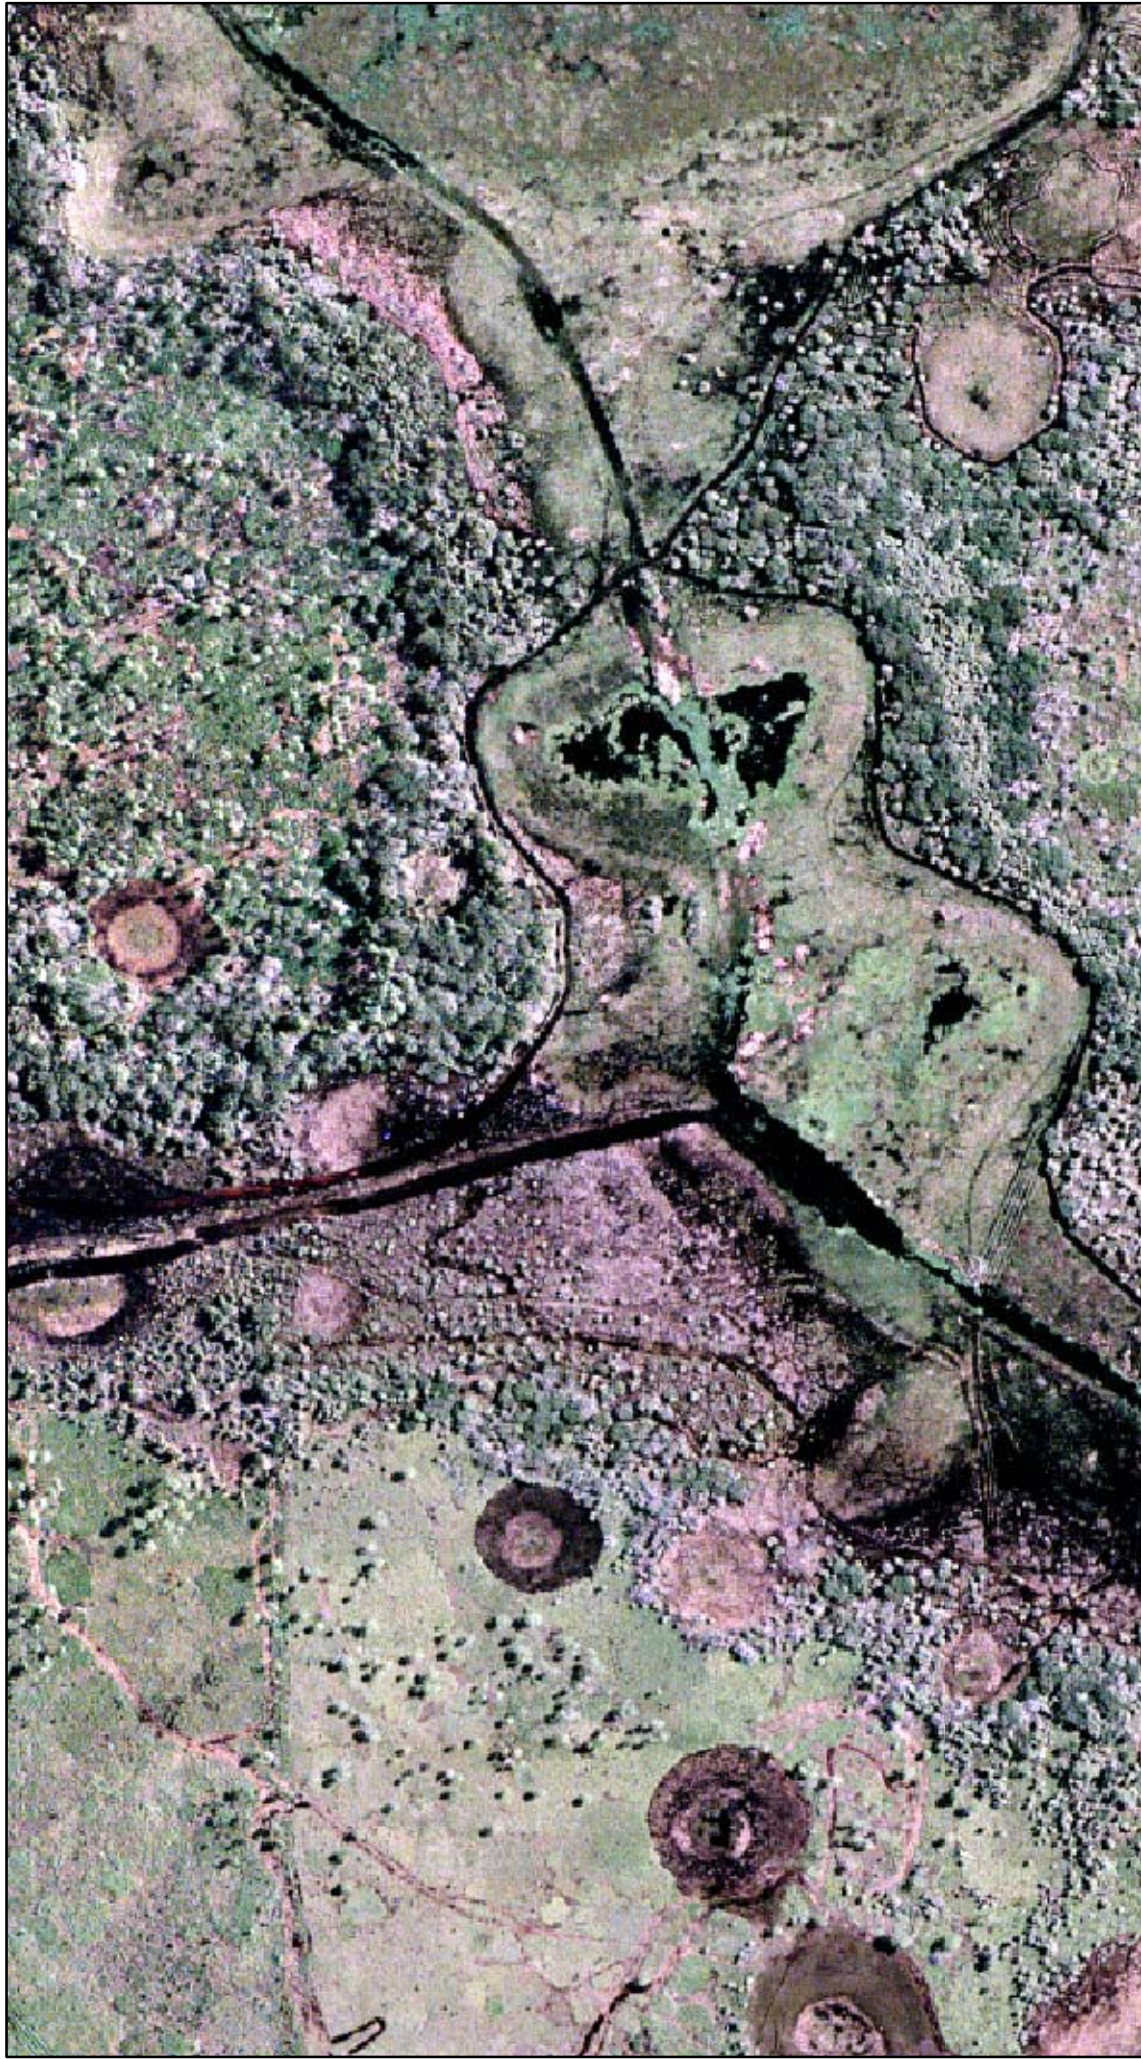
**Appendix B Sheet 3a**  
DPS Confluence - Post Restoration

Maximum corridor width: 130ft.  
Random spot corridor width average (n=6): 61 ft.

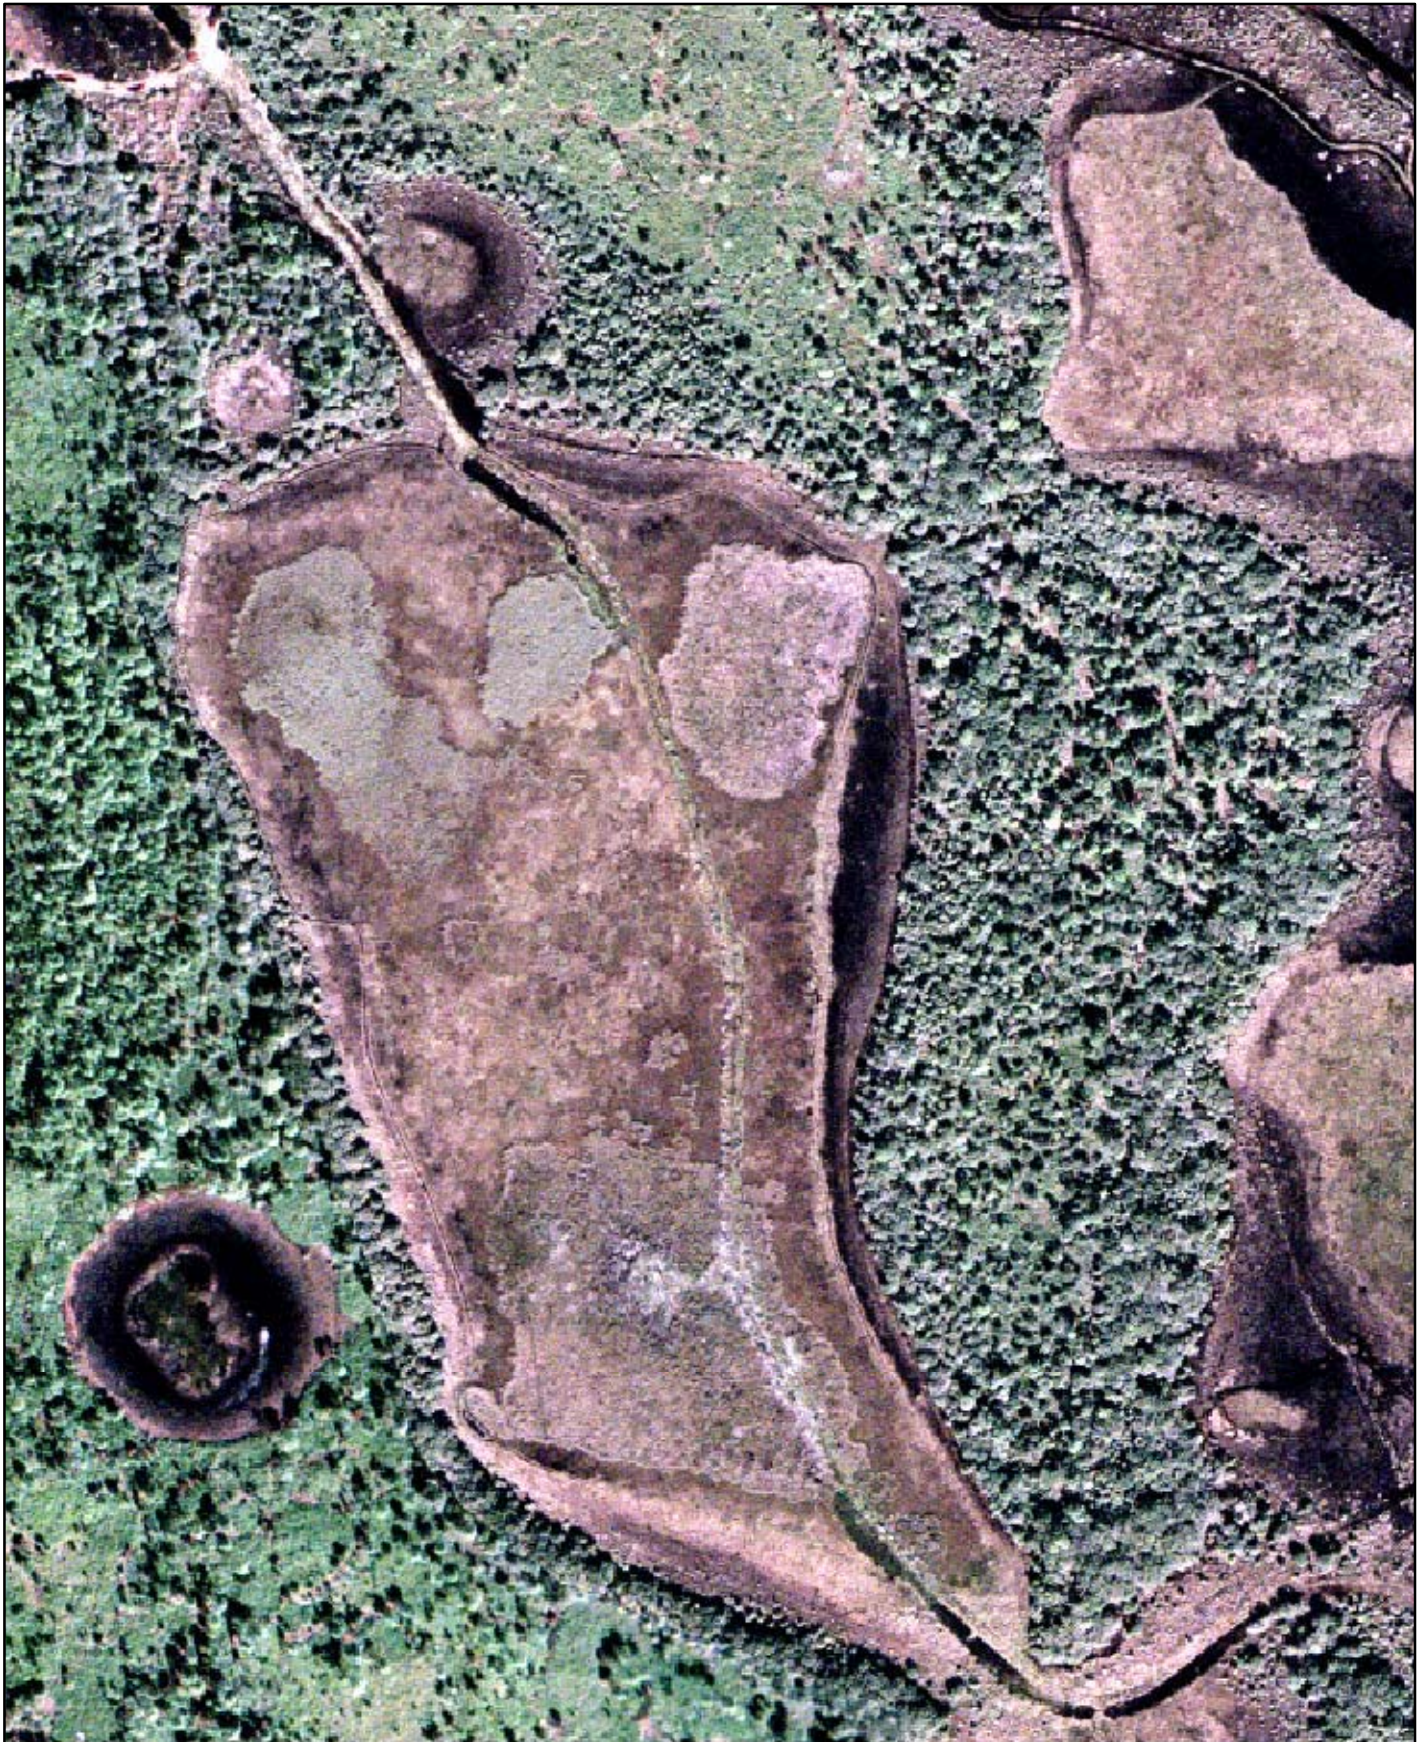
**Appendix B Sheet 4a**  
West Branch

Random spot corridor width average (n=4): 59 ft.

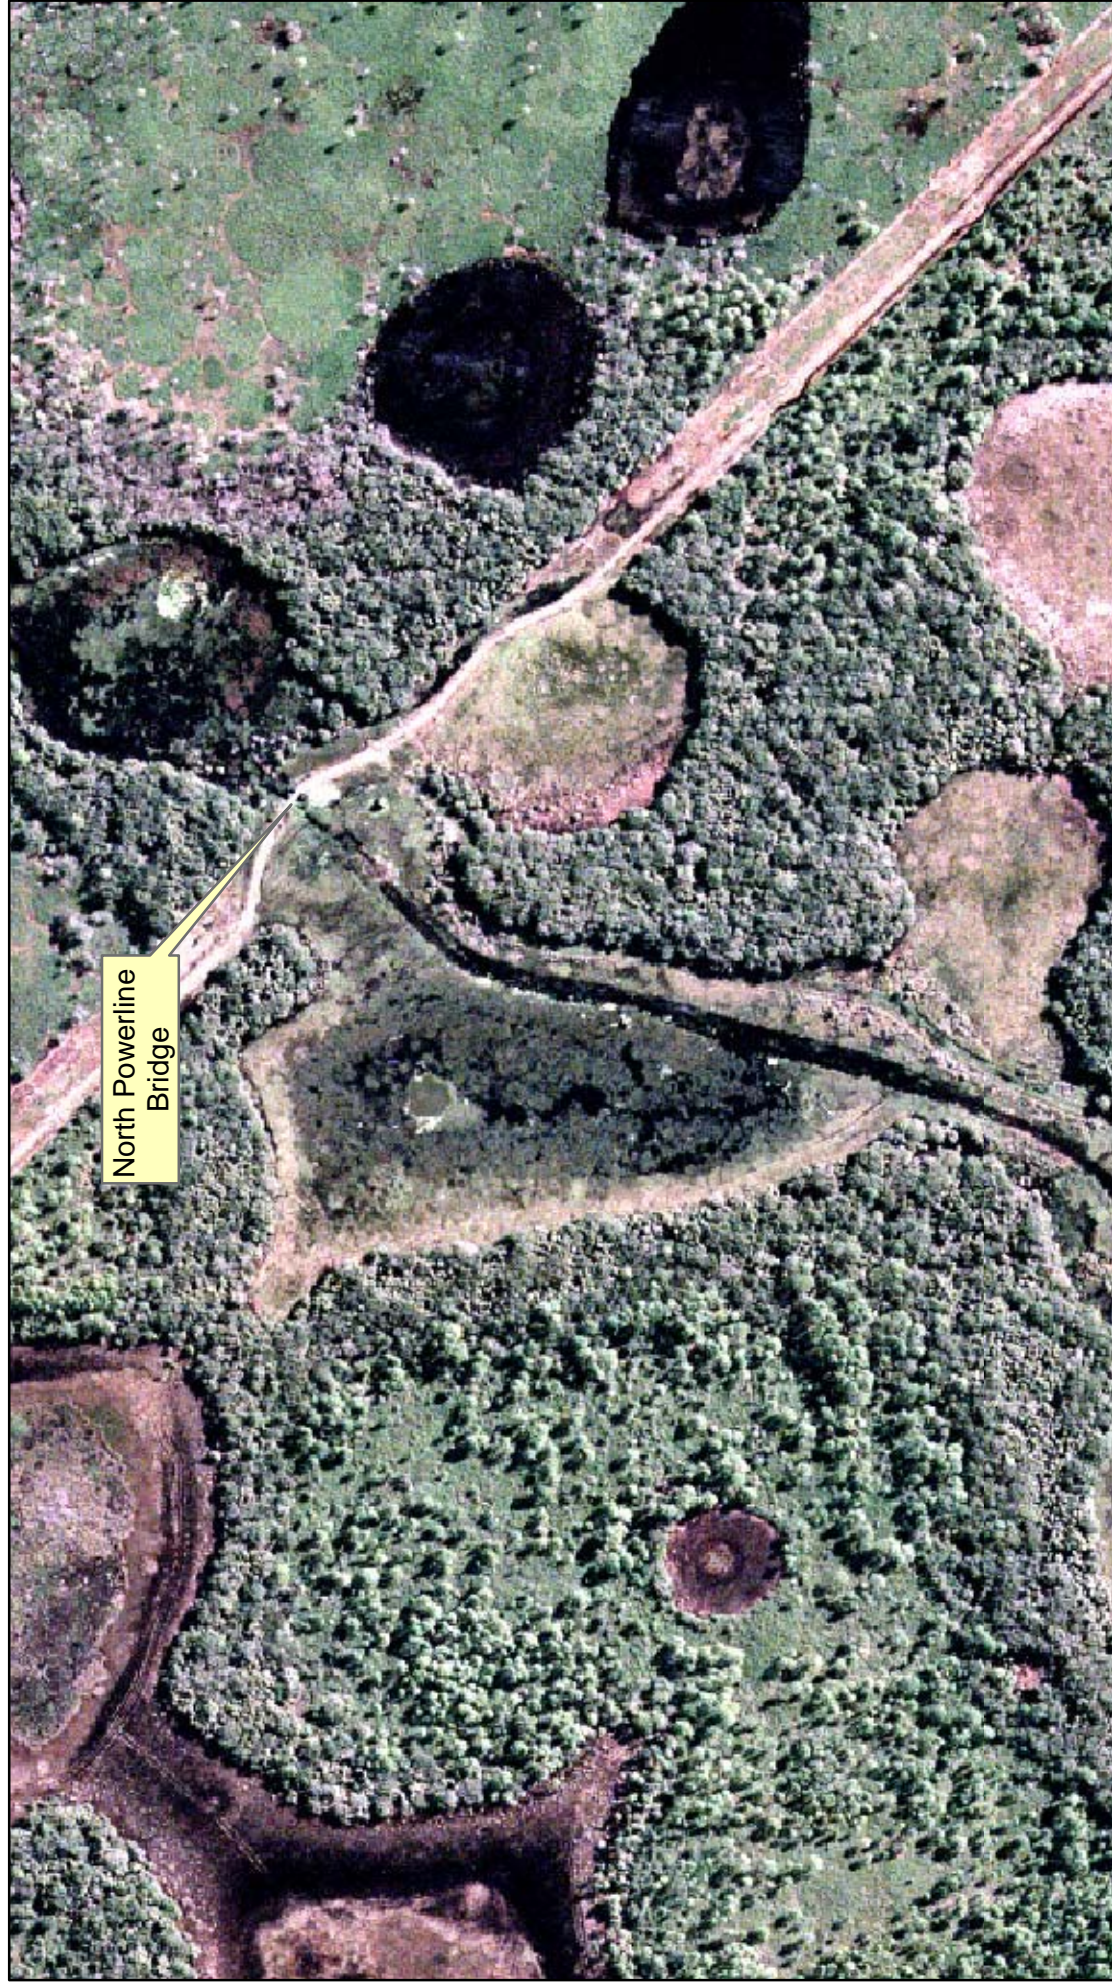
**Appendix B Sheet 6a**  
 North Branch Terminus - Post Restoration

Random spot corridor width average (n=8): 58 ft.
