# GOTTFRIED CREEK BASIN MASTER PLAN

March 1996

**PARSONS ENGINEERING SCIENCE, INC.**

**SARASOTA COUNTY, FL**

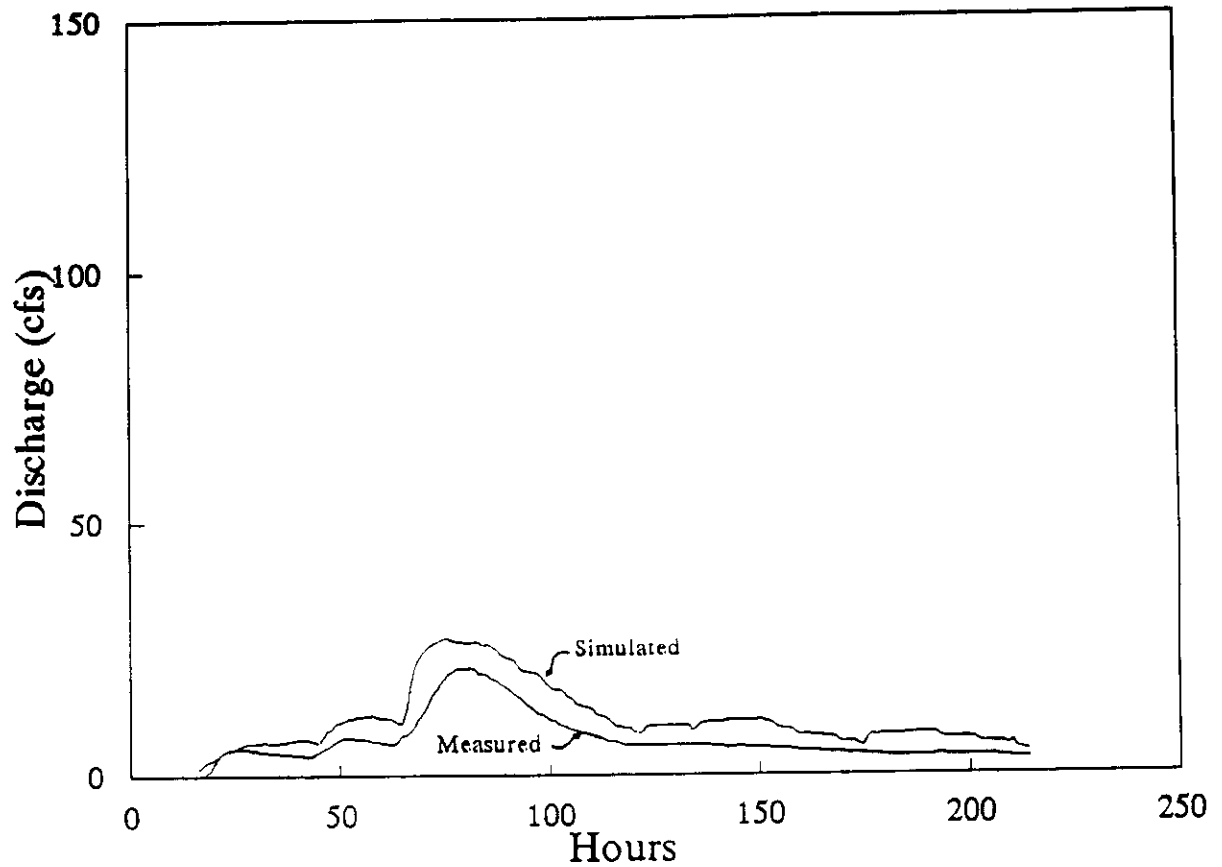
FIGURE 5.6

# GOTTFRIED CREEK MODEL VERIFICATION

Hydrograph	Peak (cfs)	Volume (million cf)
Measured	21	5.1
Simulated	27	8

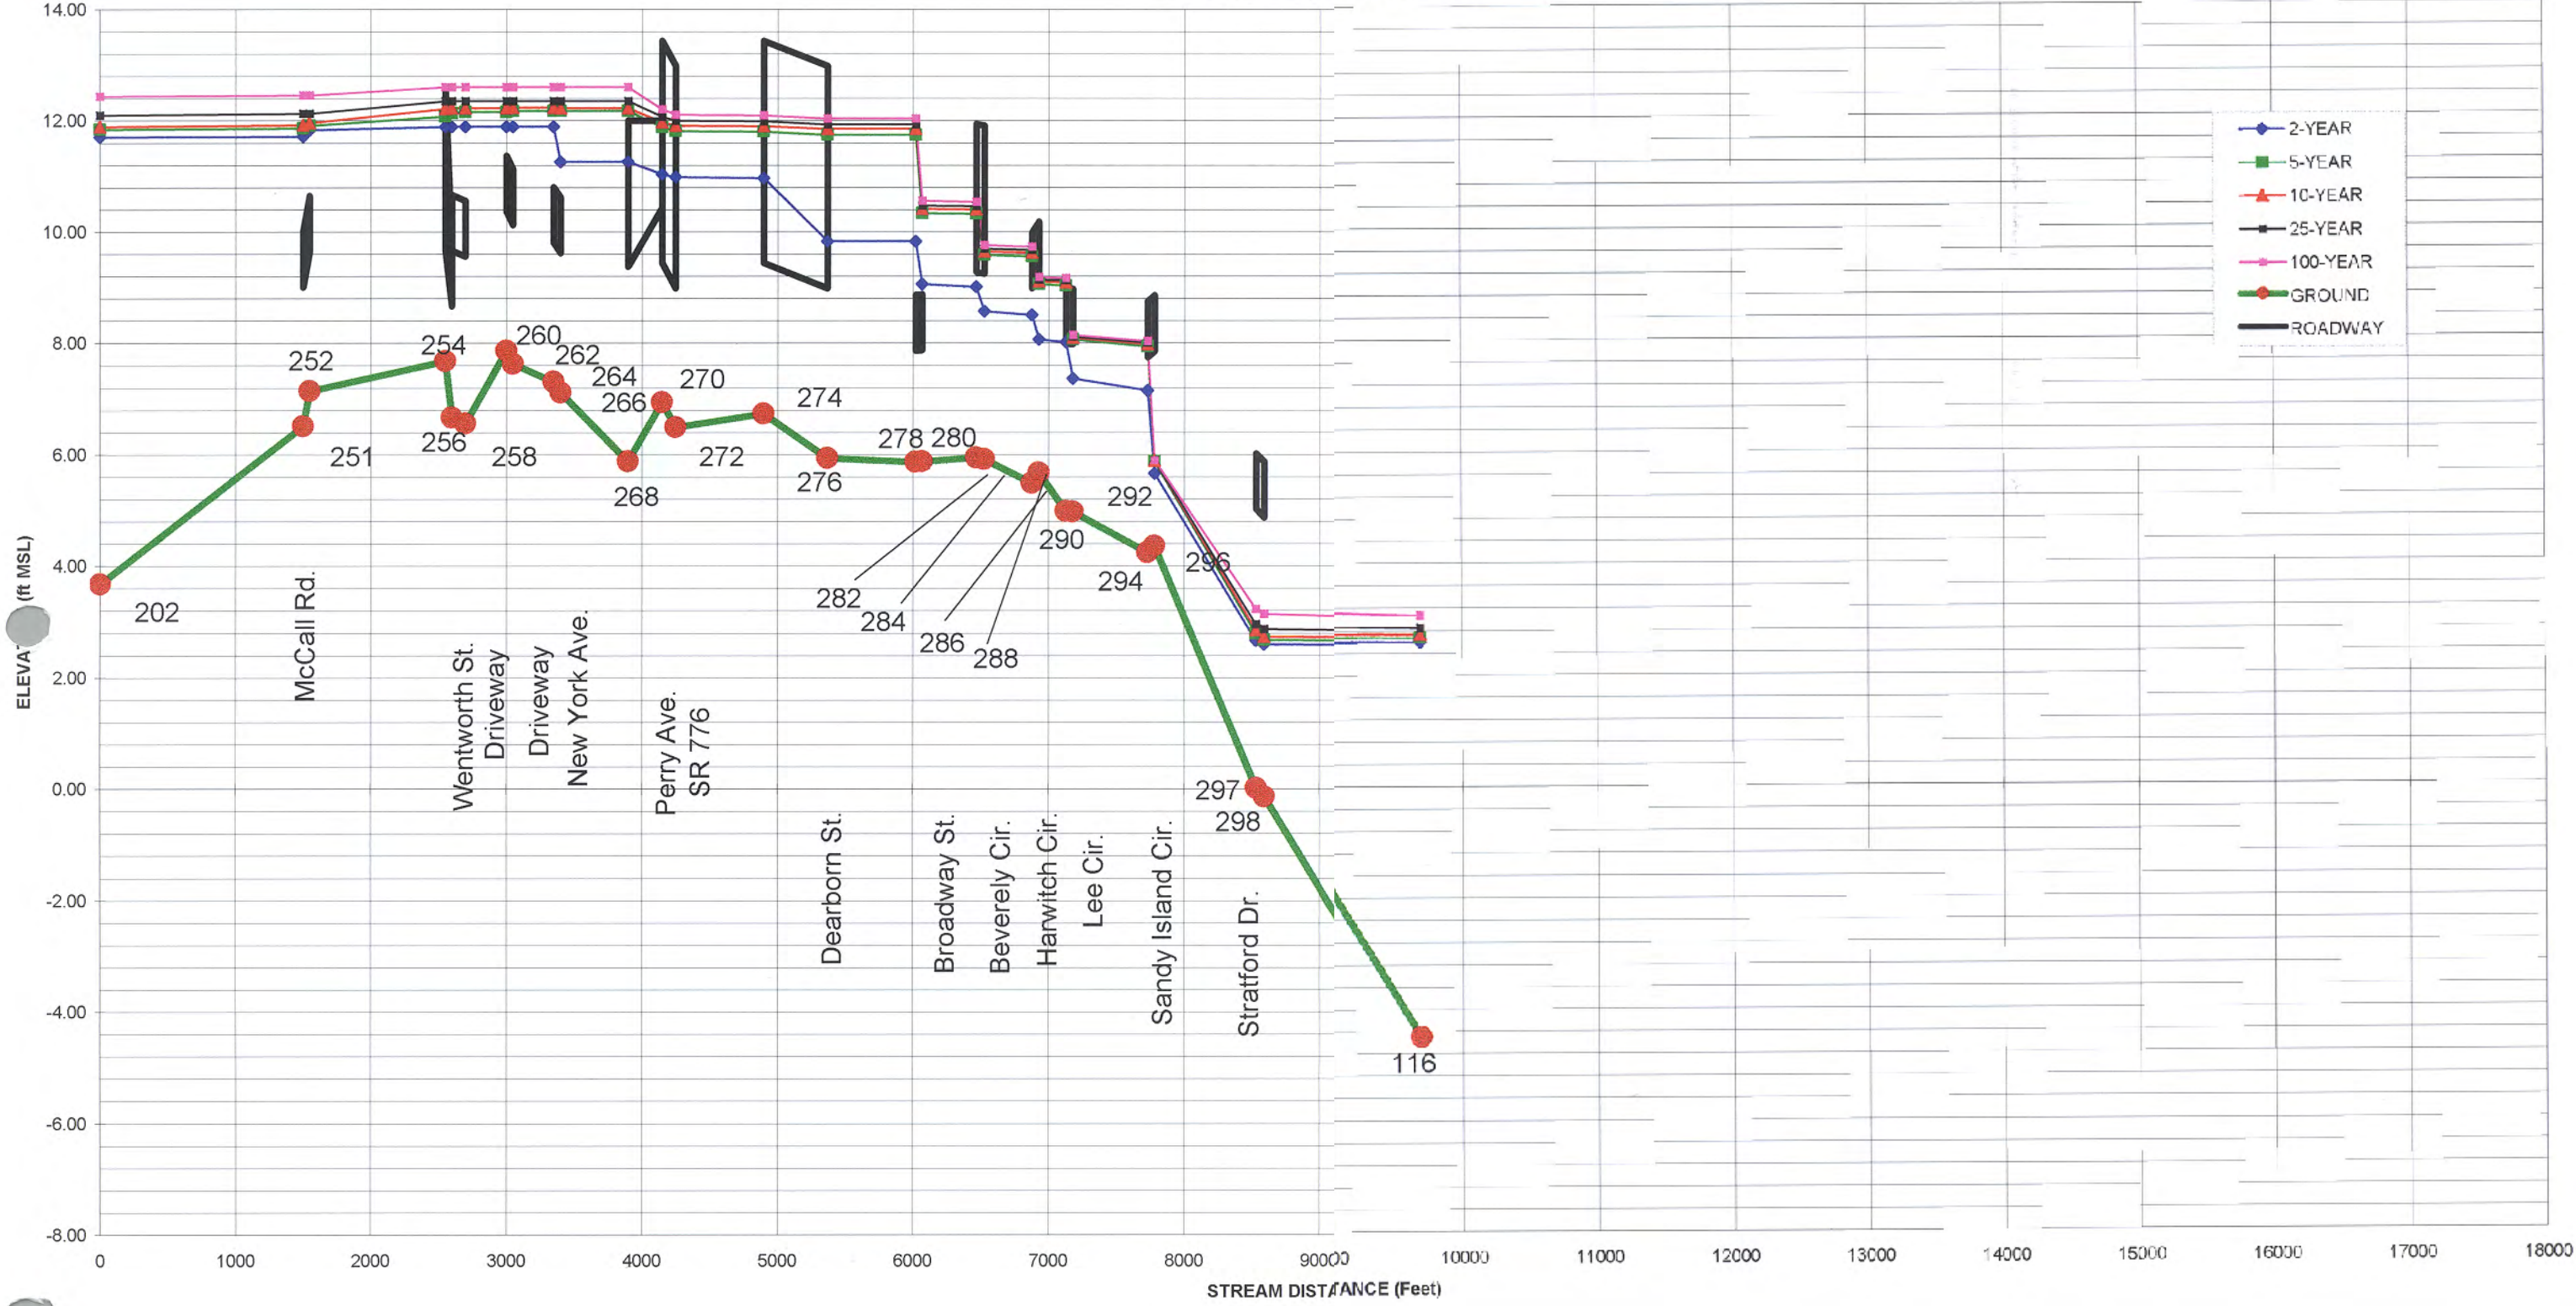
FIG. 5.7b  
EXISTING CONDITIONS: HYDRAULIC GRADE LINE PLOTS  
GOTTFRIED CREEK

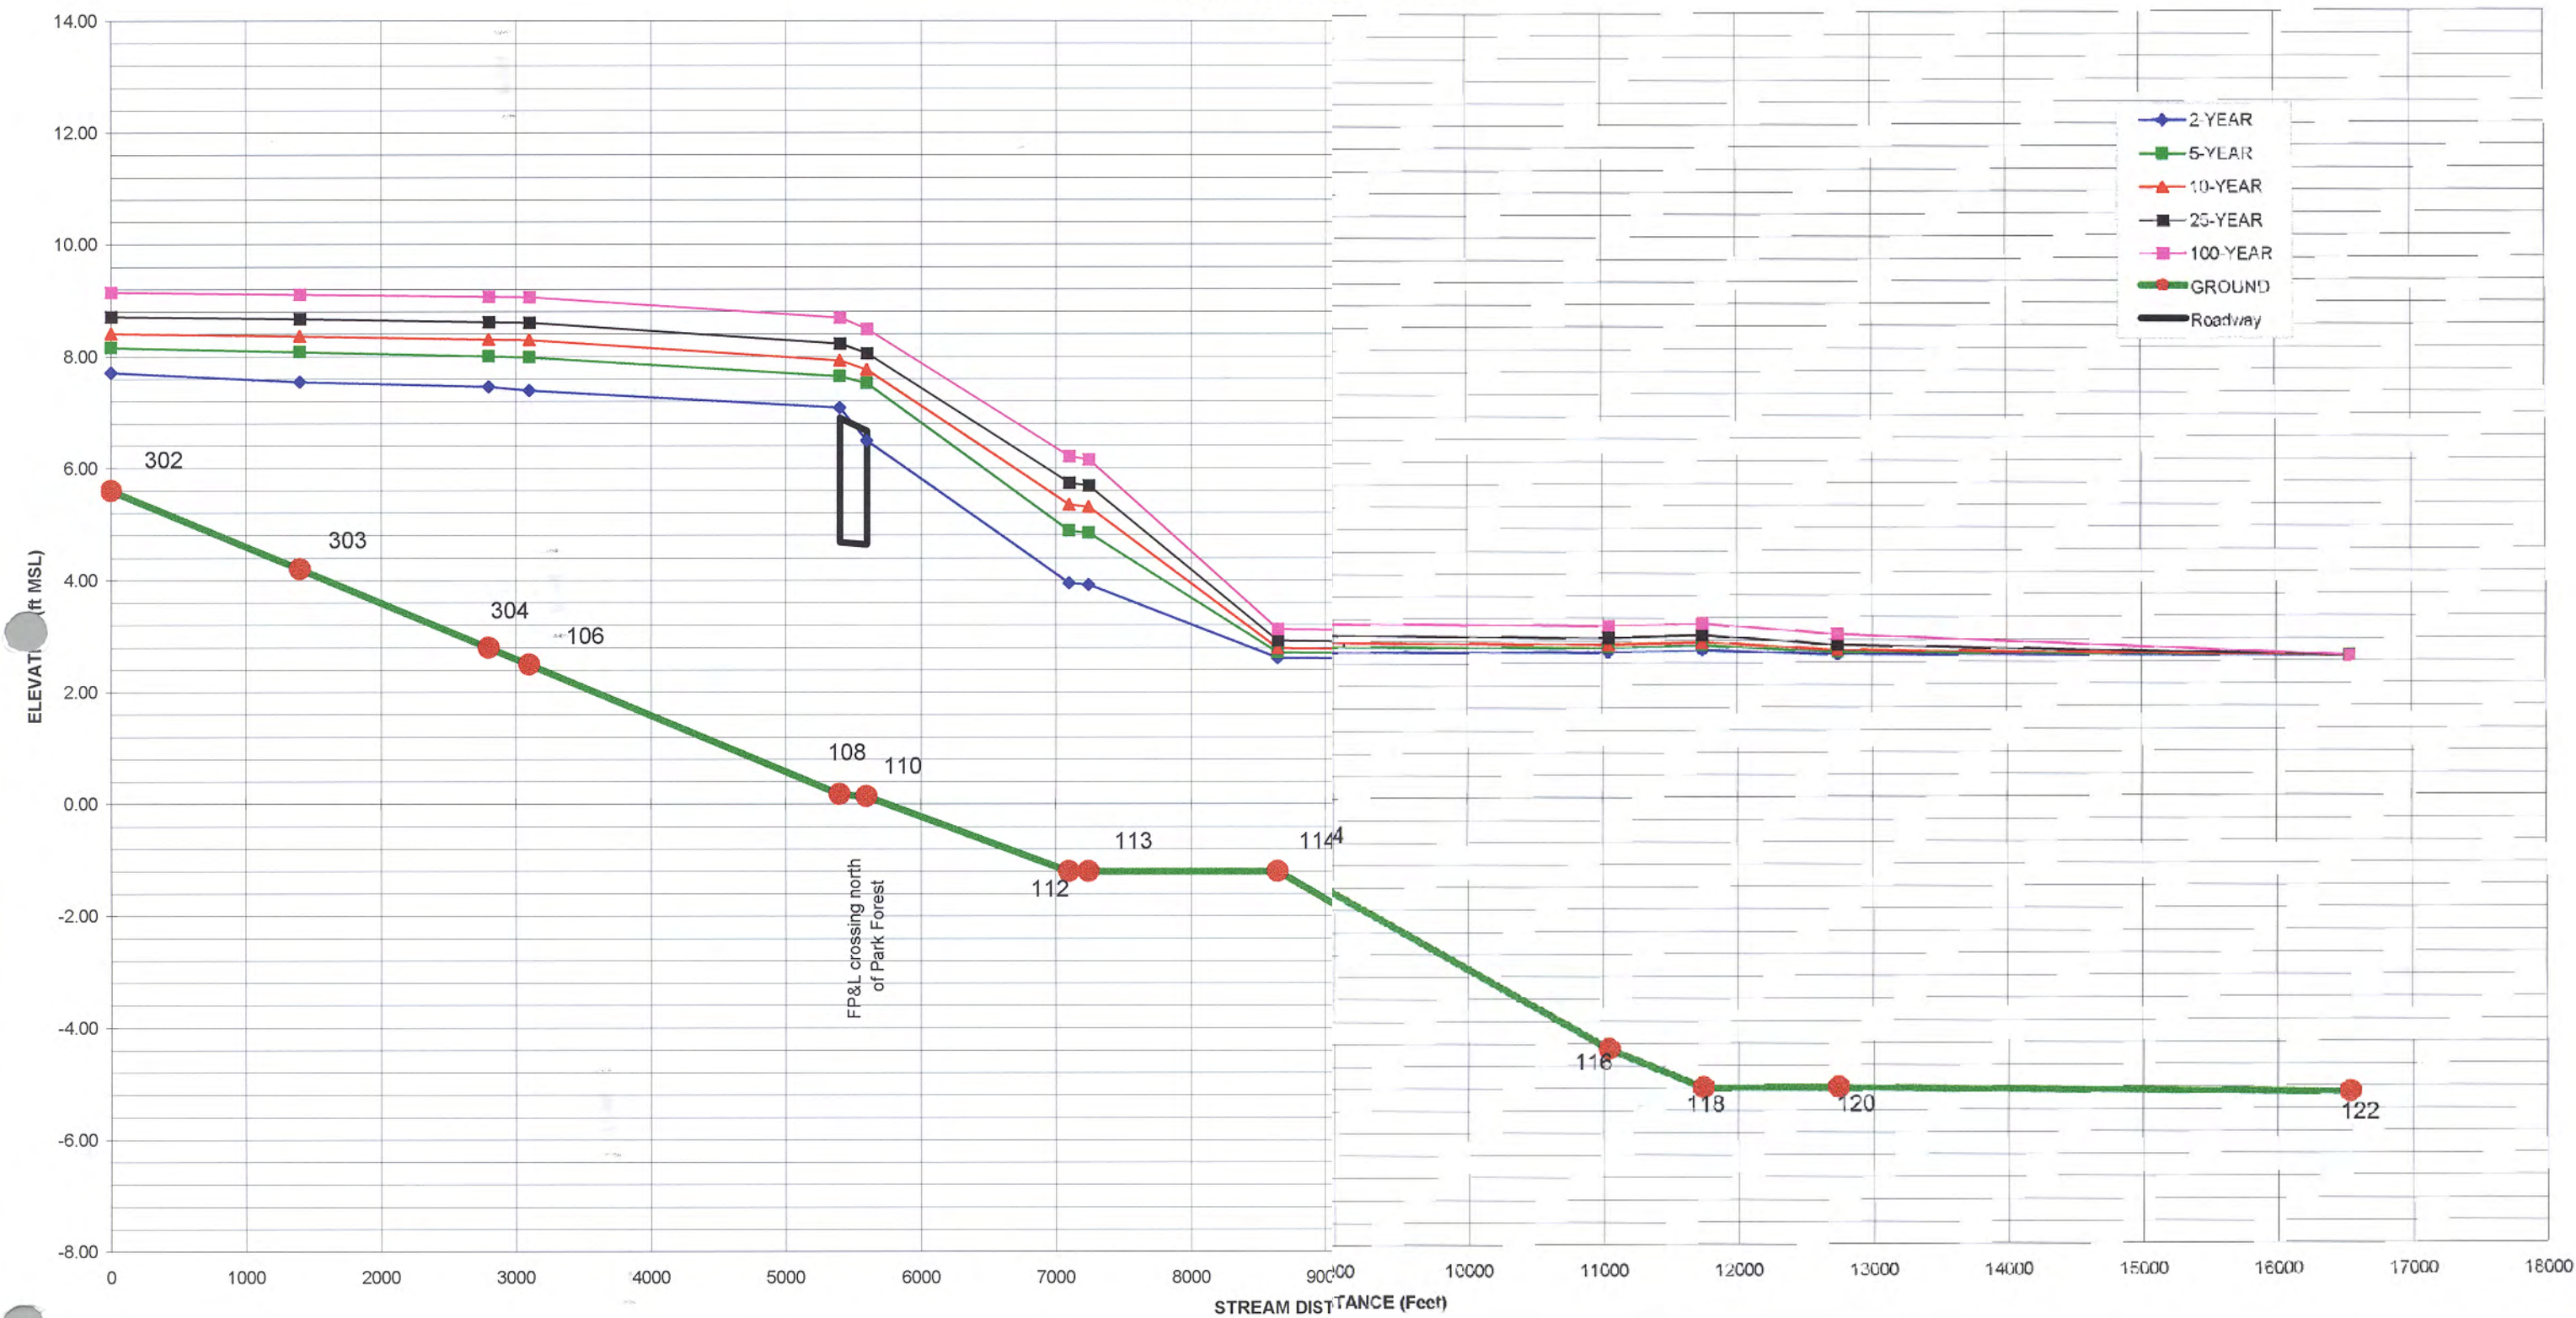
FIGURE 5.7c  
EXISTING CONDITIONS: HYDRAULIC GRADE LINE PLOTS  
GOTTFRIED CREEK

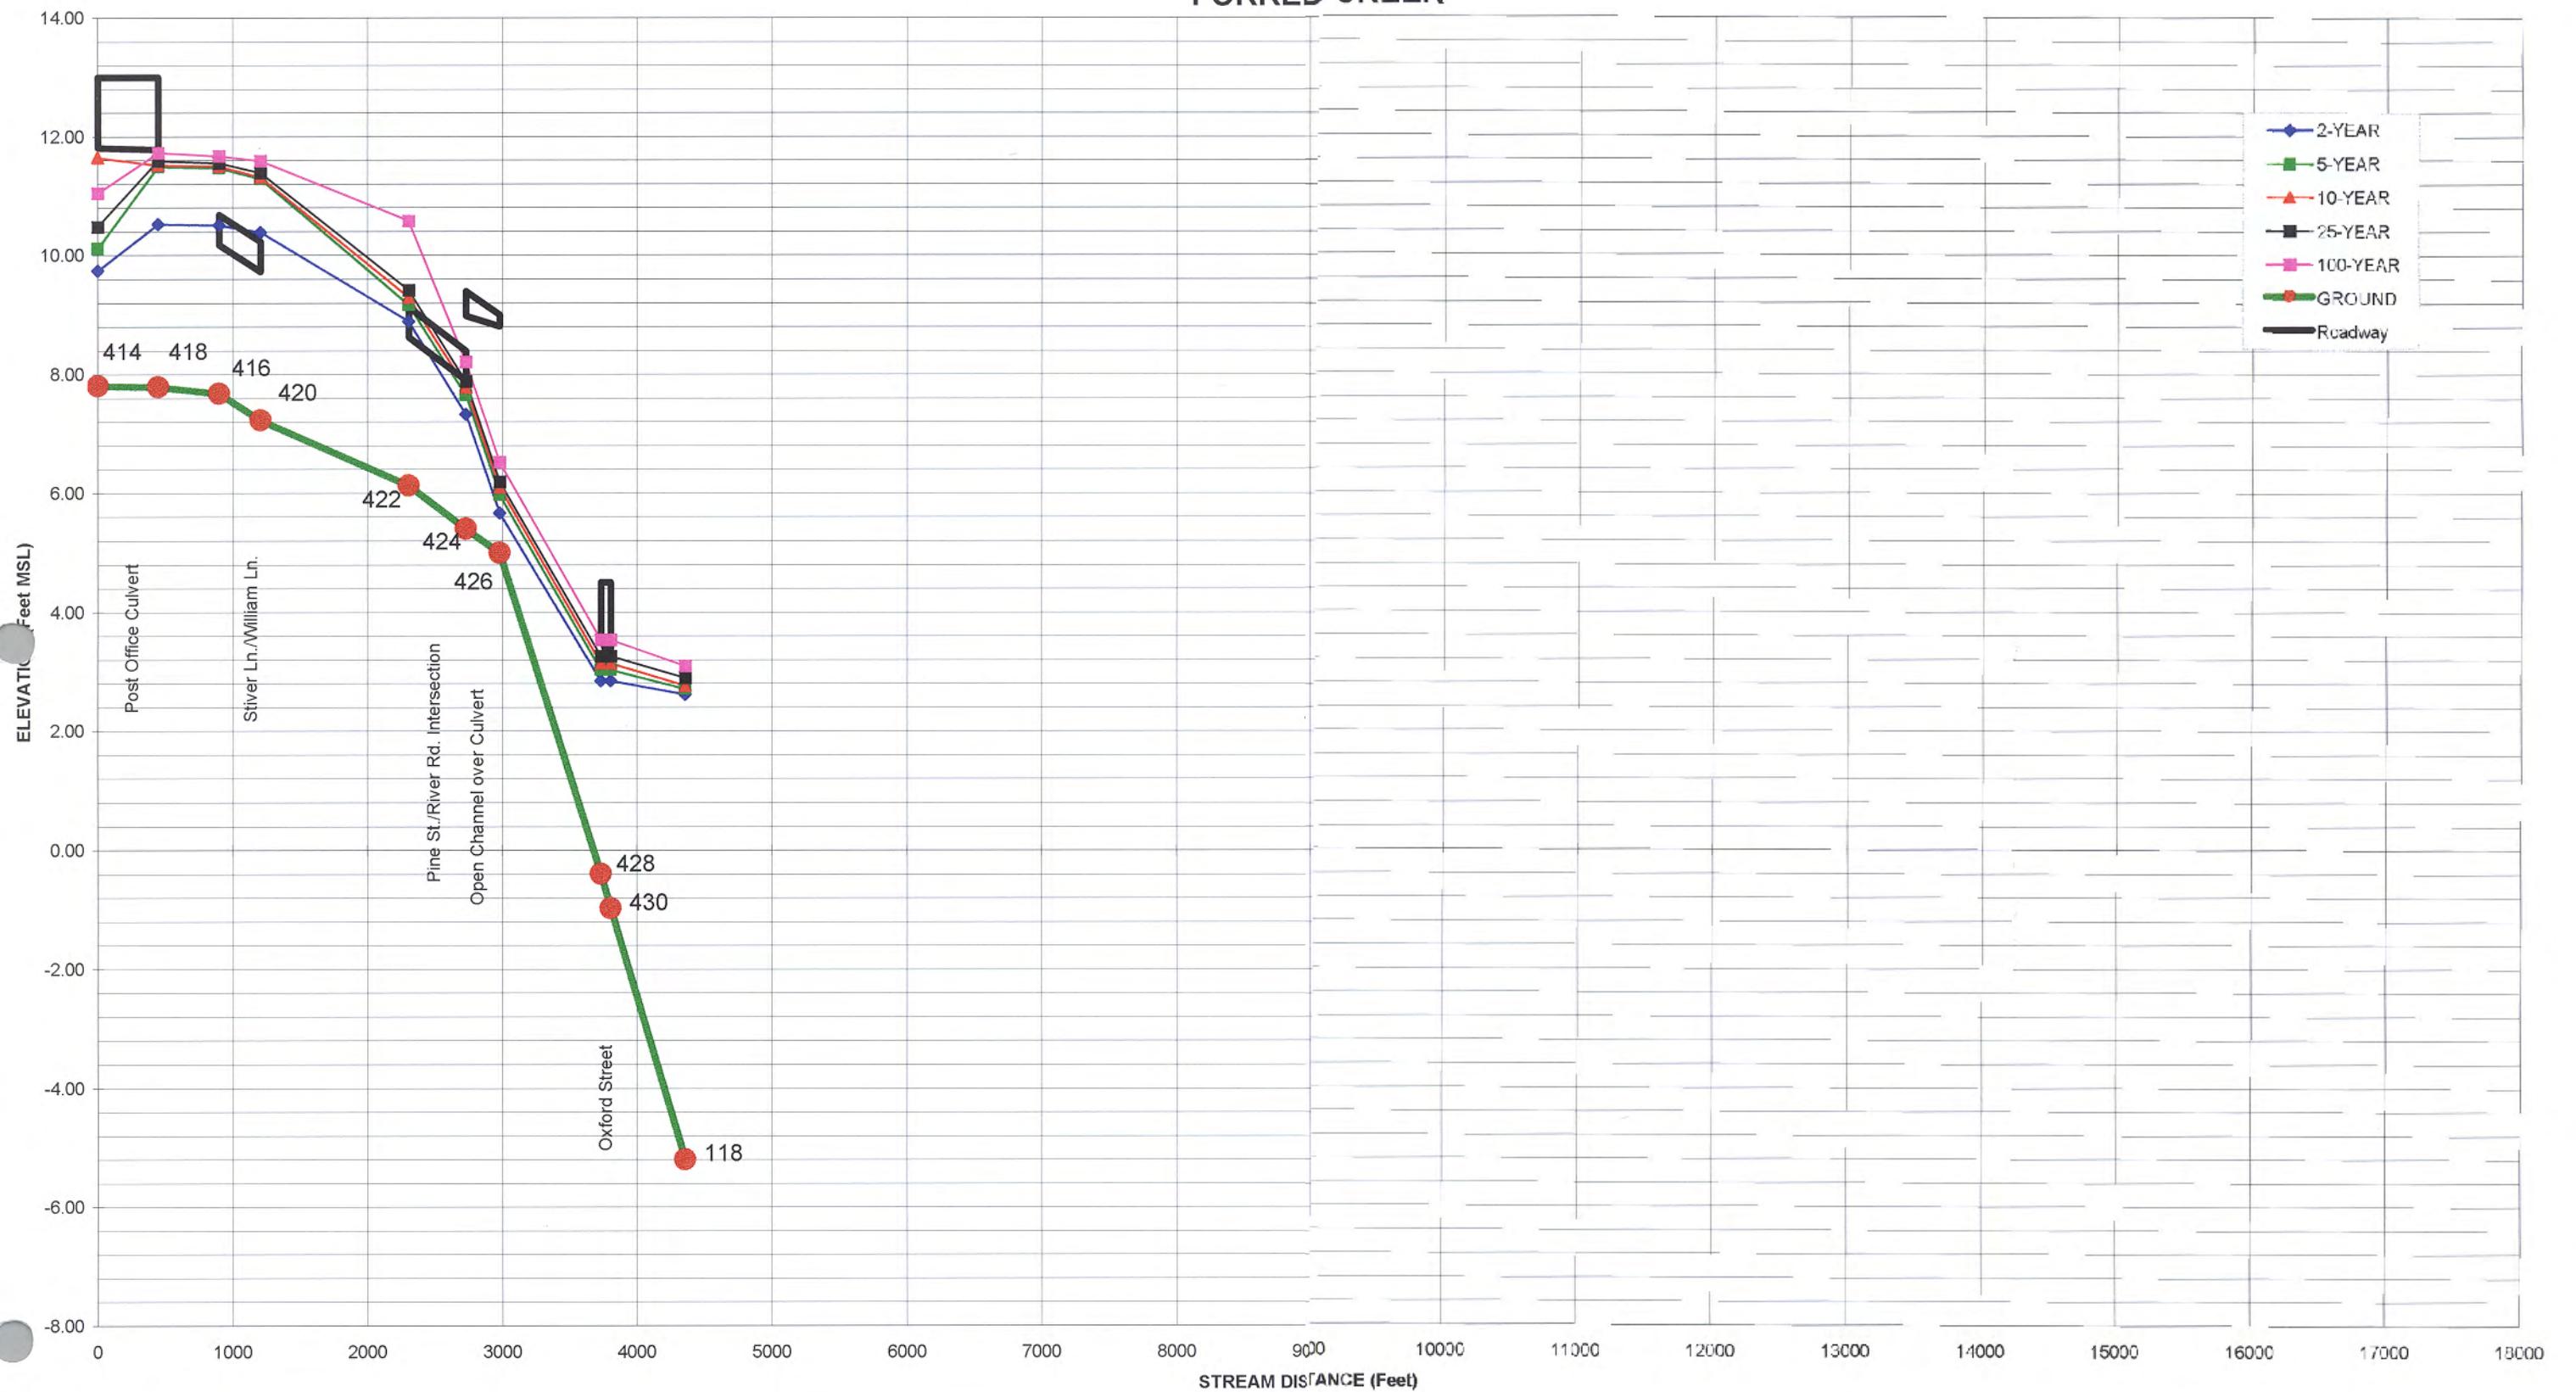
FIGURE 5.7d  
EXISTING CONDITIONS: HYDRAULIC GRADE LINE PLOTS  
FORKED CREEK

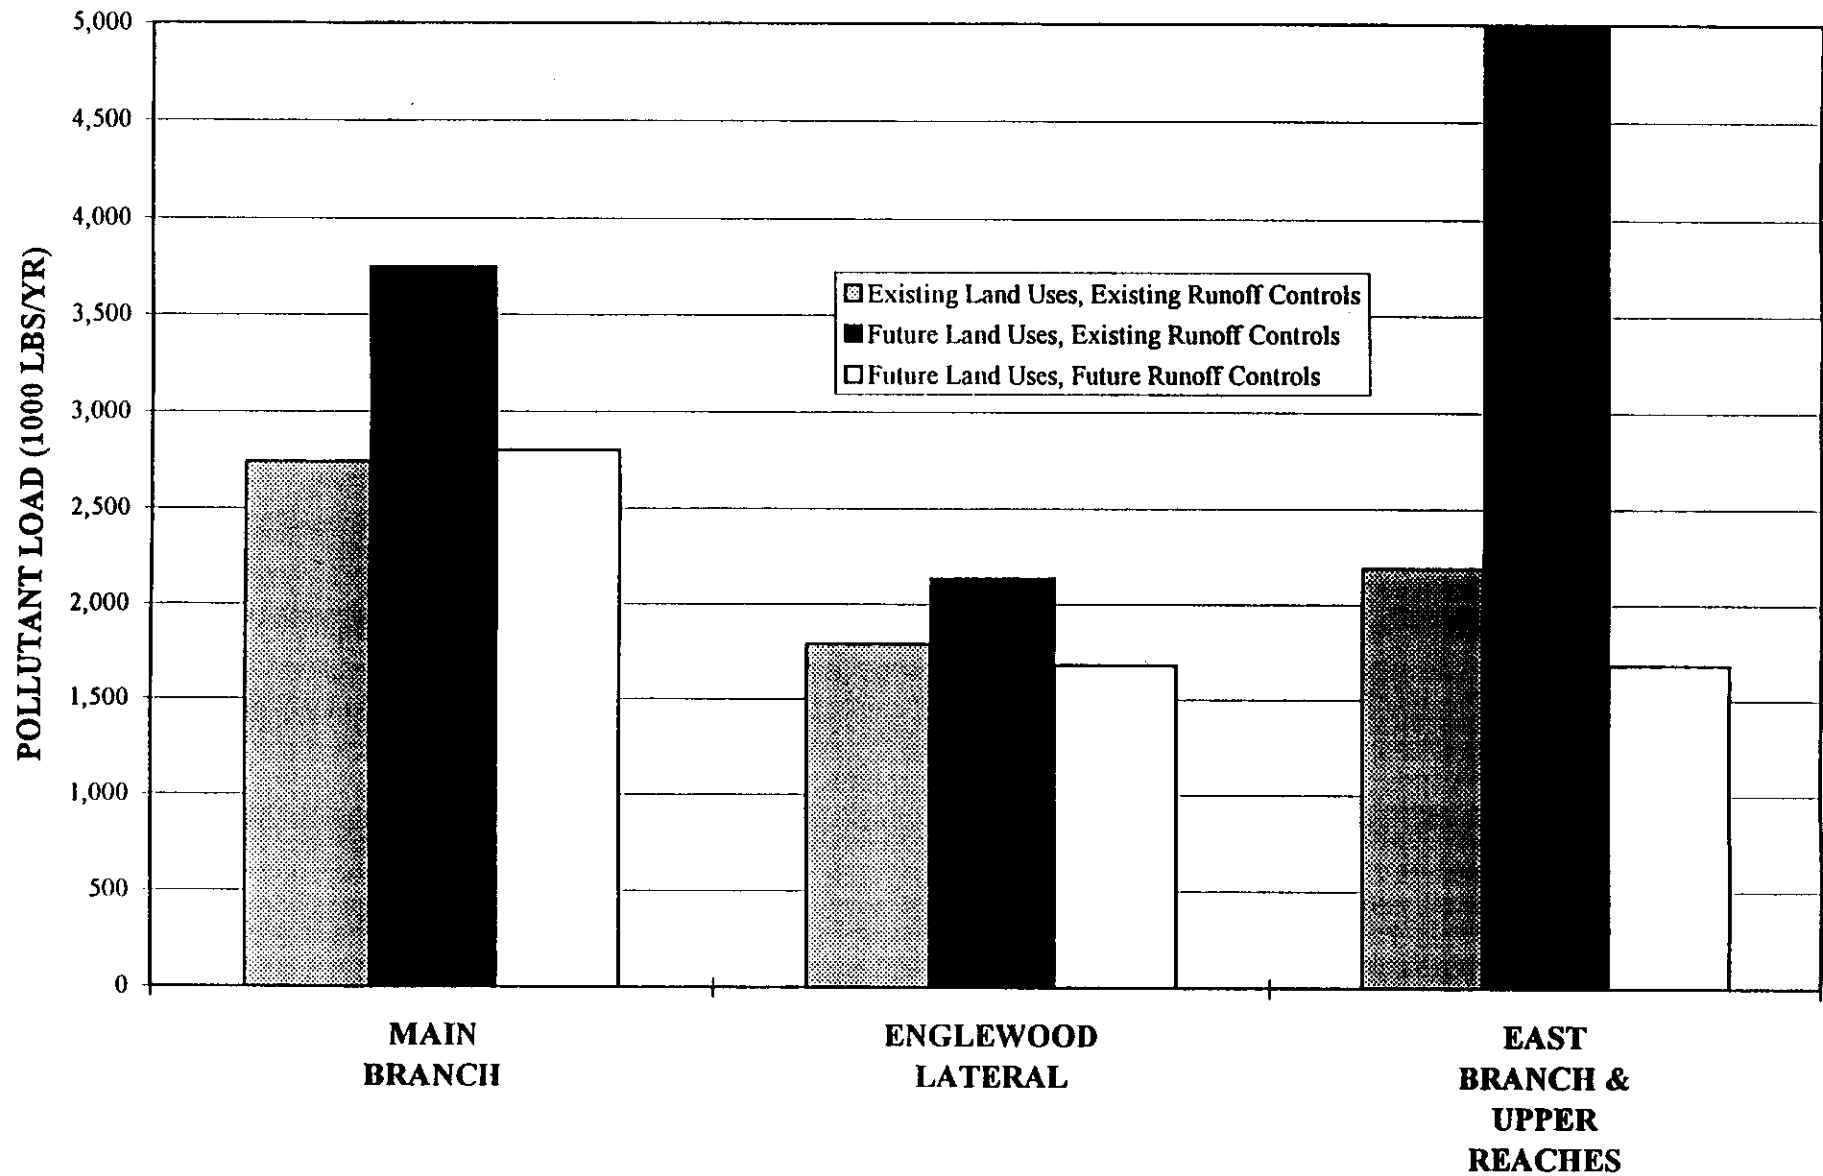
**FIGURE 6.1**  
**POLLUTANT LOAD COMPARISON**

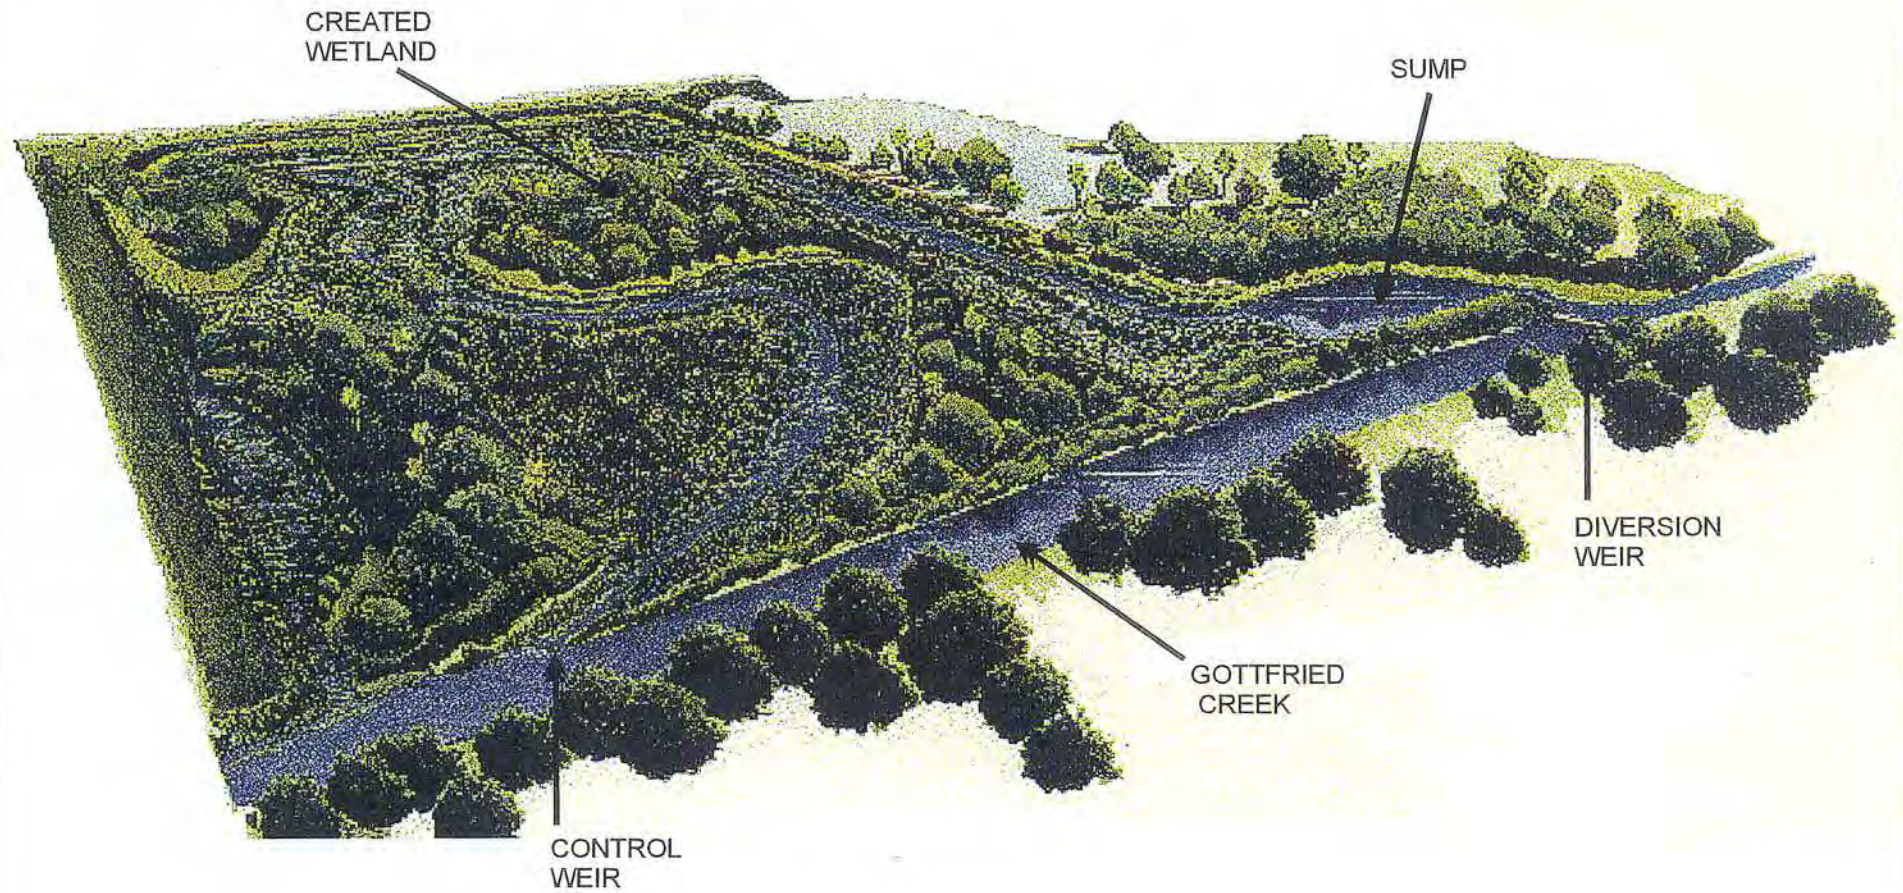
## CONCEPTUAL STORMWATER WETLAND

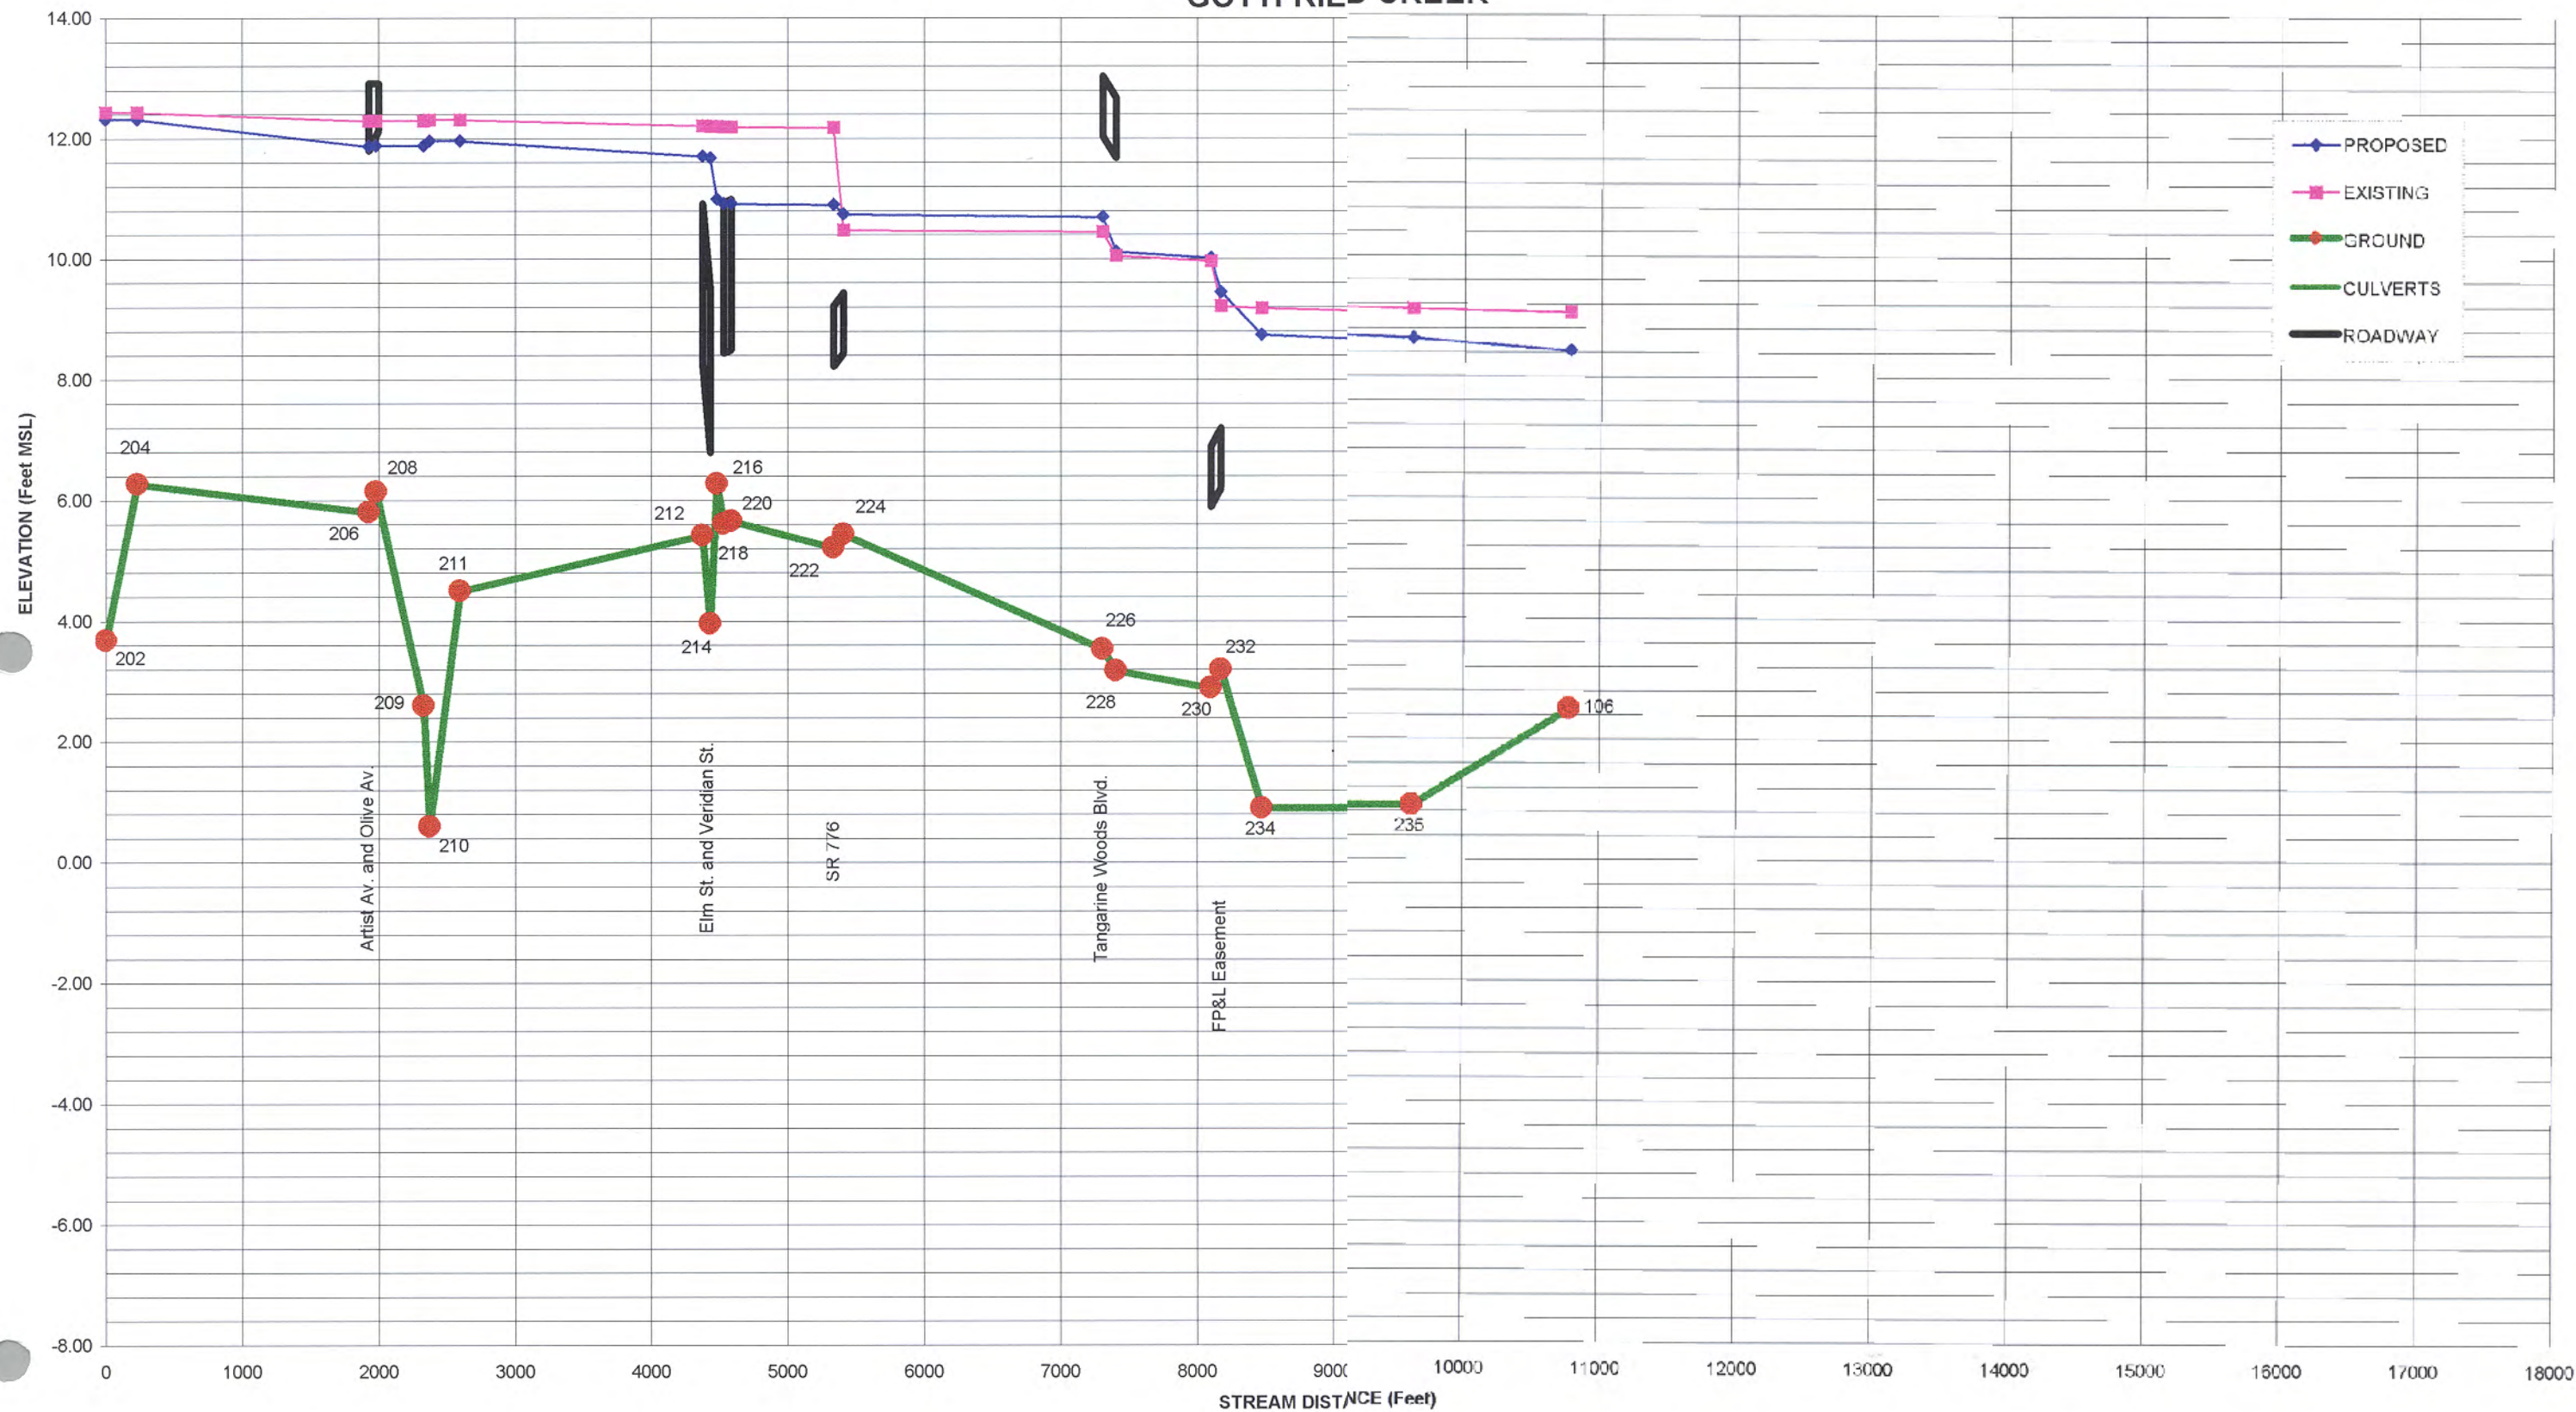
FIGURE 7.3a  
EXISTING AND PROPOSED 100-YEAR STORM: HYDRAULIC GRADE LINE PLOTS  
GOTTFRIED CREEK

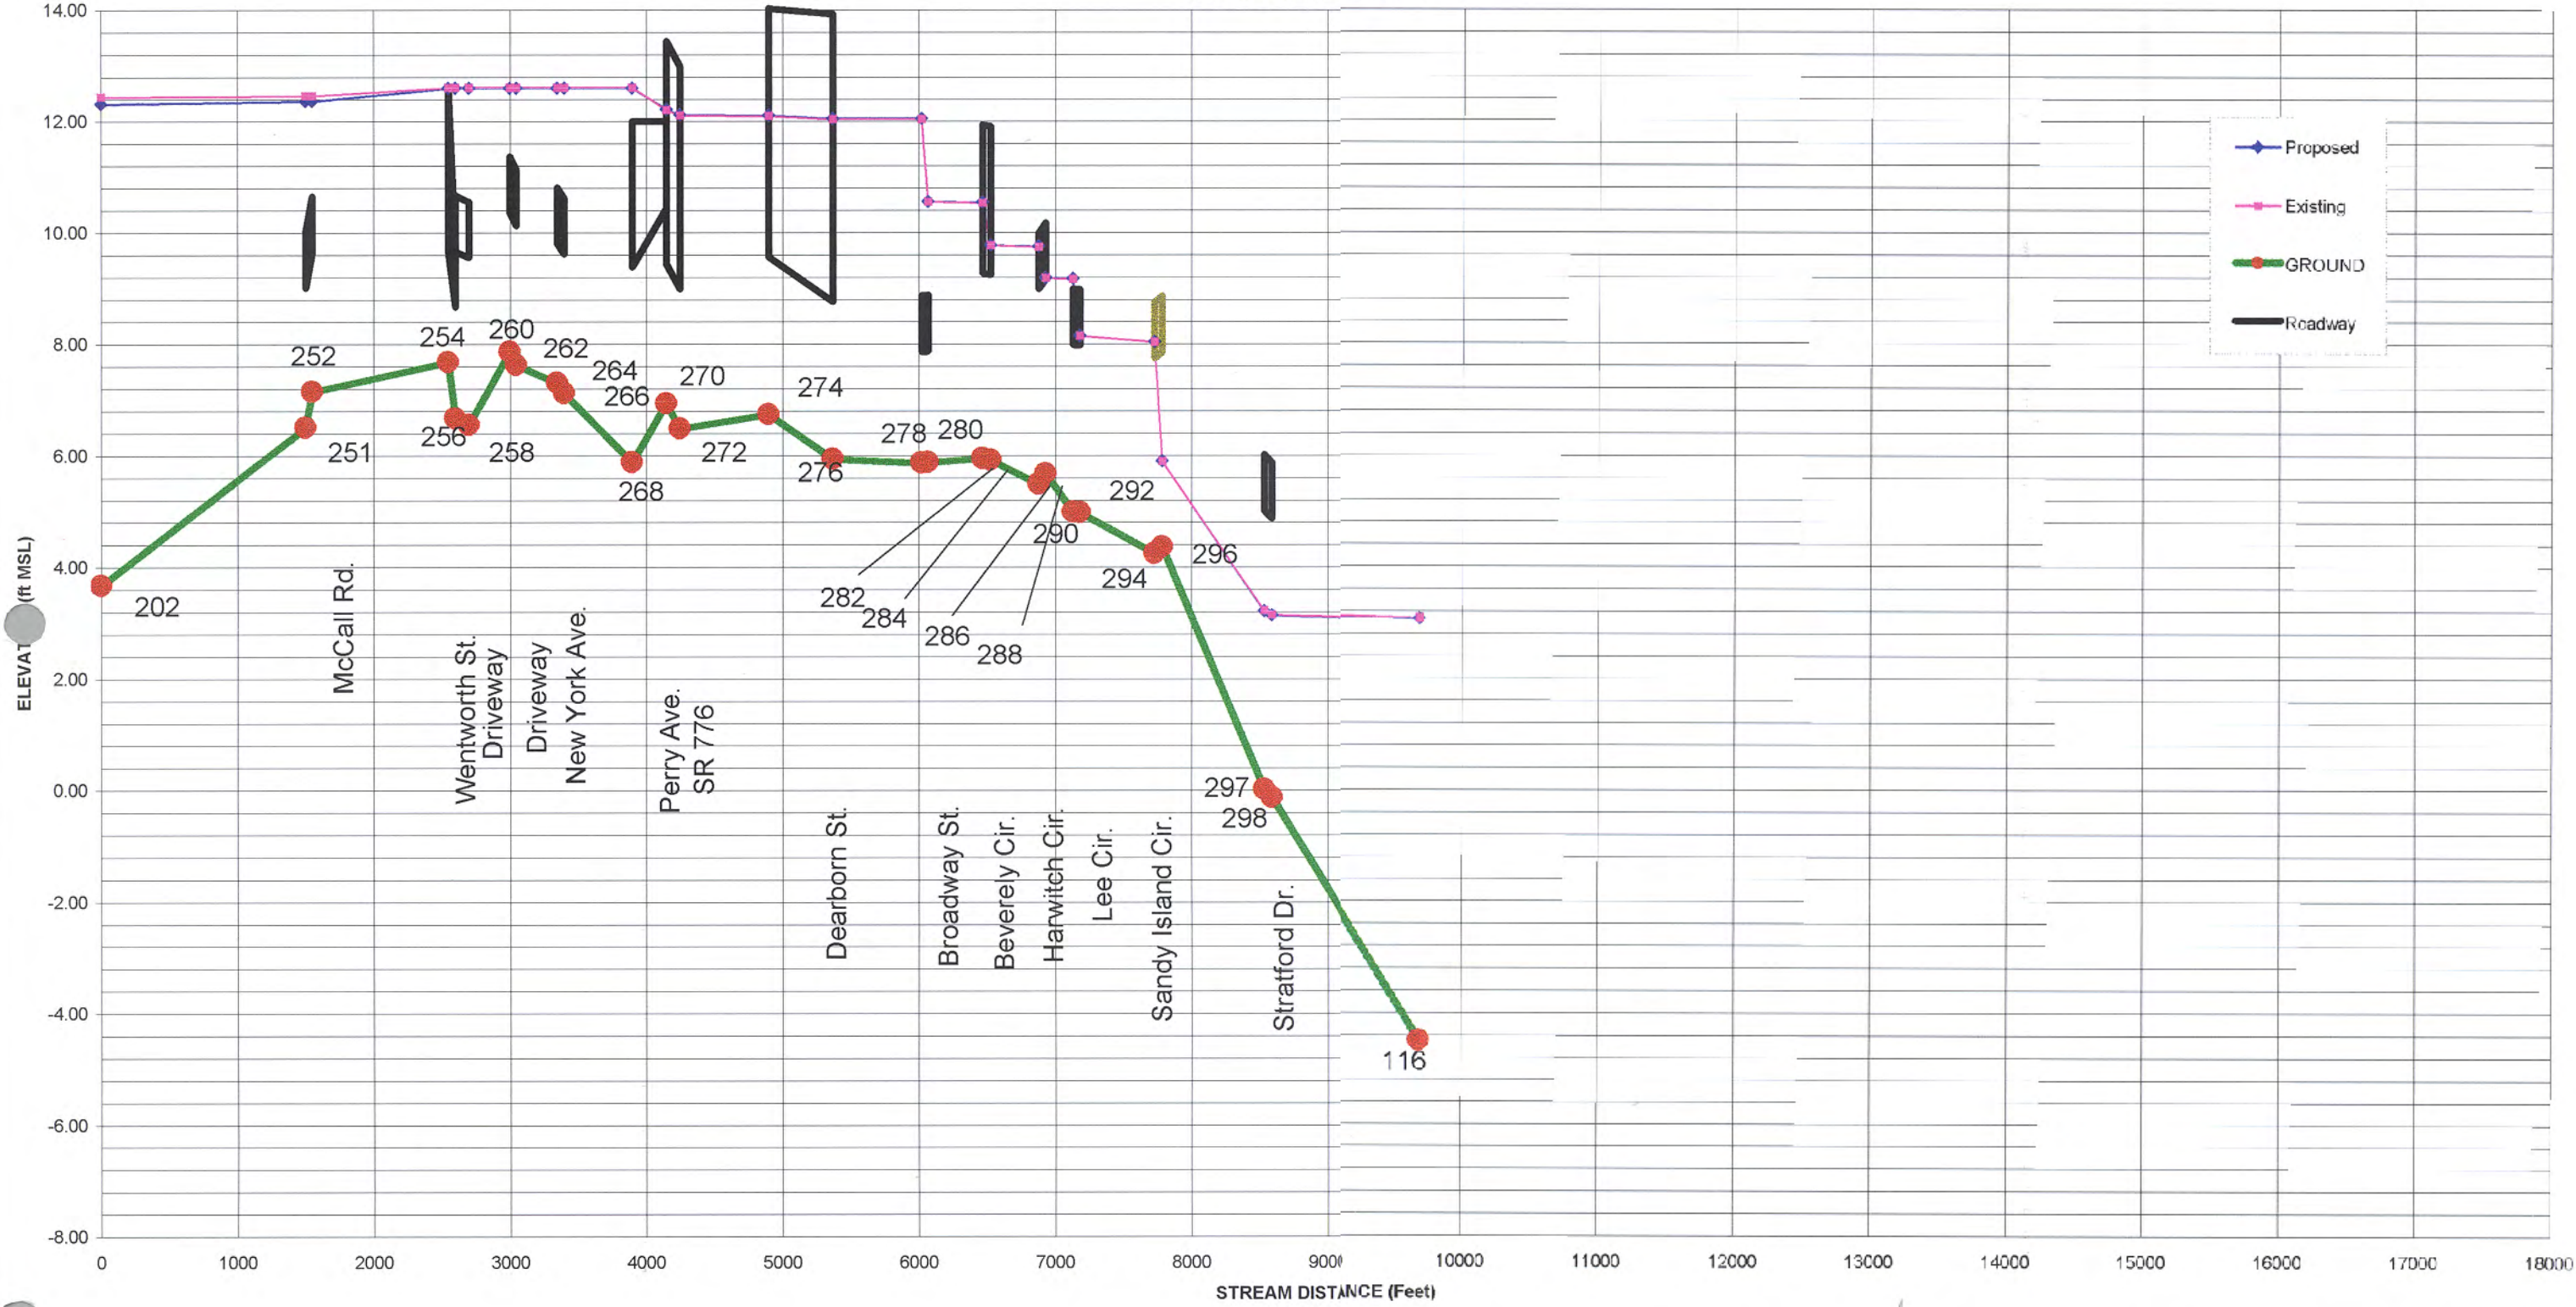
FIG. 7.3b  
EXISTING AND PROPOSED 100-YEAR STORM: HYDRAULIC GRADE LINE PLOTS  
GOTTFRIED CREEK
