# GOTTFRIED CREEK BASIN MASTER PLAN

March 1996

**PARSONS ENGINEERING SCIENCE, INC.**

**SARASOTA COUNTY, FL**

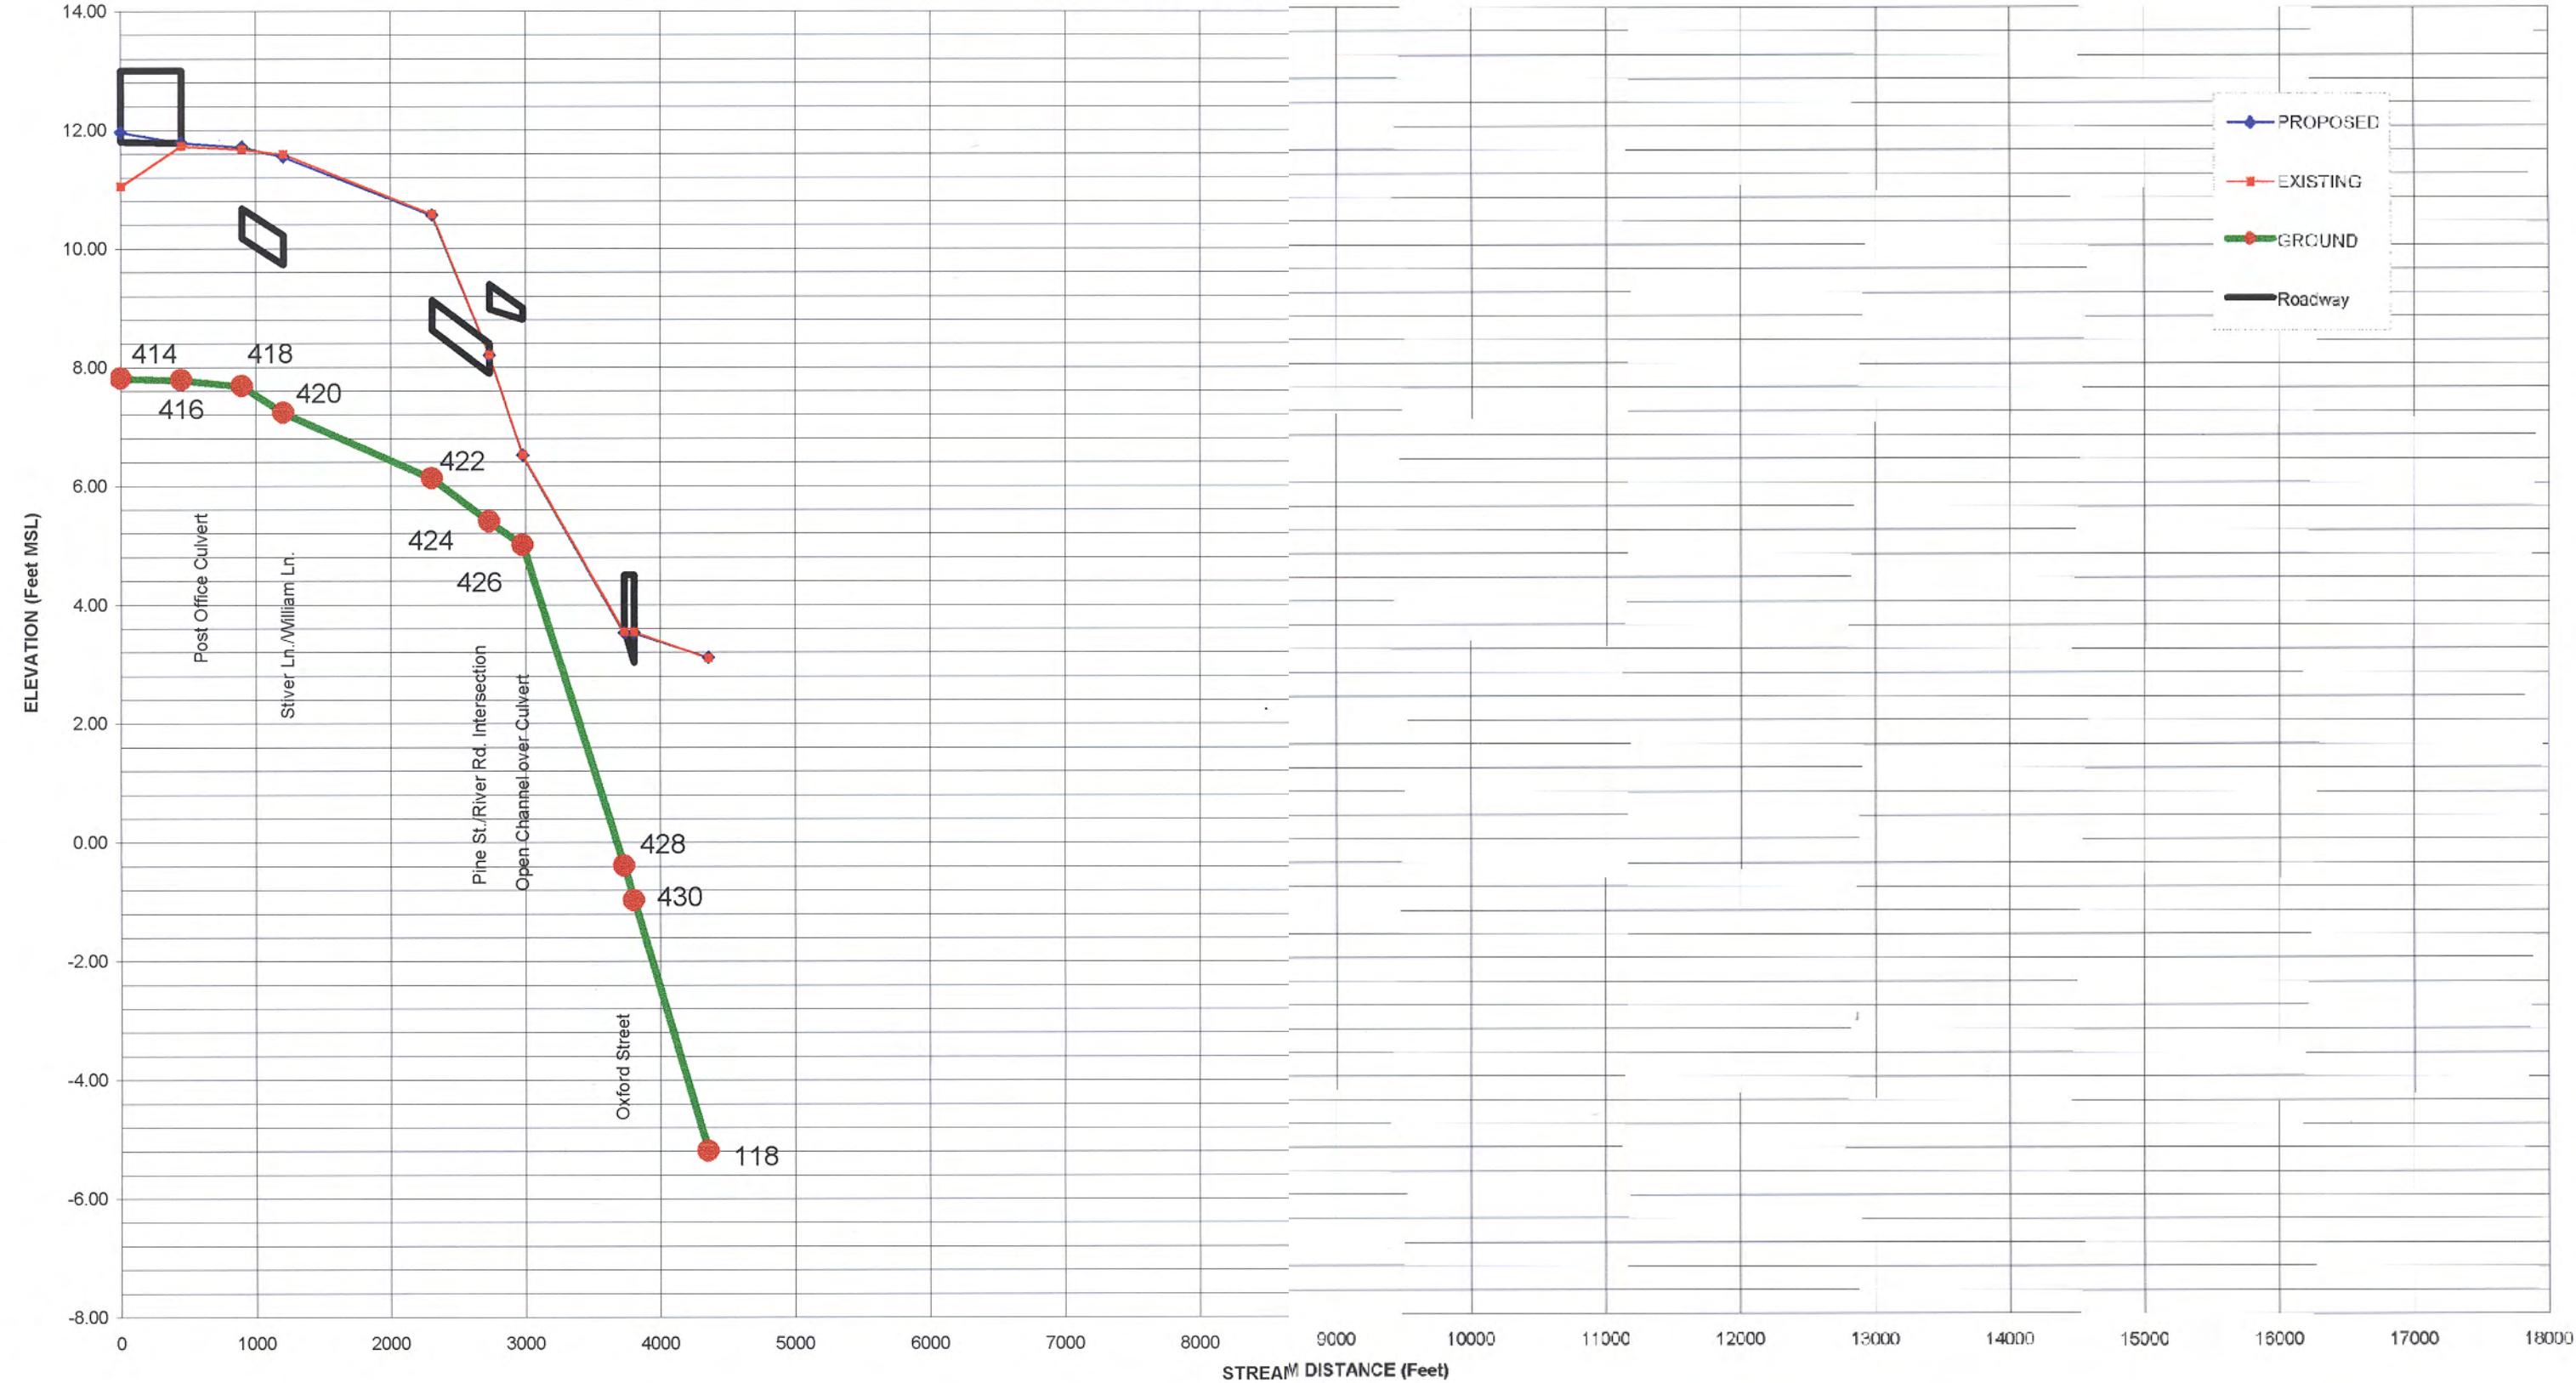
FIGURE 7.3d  
EXISTING AND PROPOSED 100-YEAR STORM: HYDRAULIC GRADE LINE PLOTS  
GOTTFRIED CREEK
