# LIVING SHORELINES: Guidance for Sarasota Bay Watershed

Prepared for  
Sarasota Bay Estuary Program

June 2018

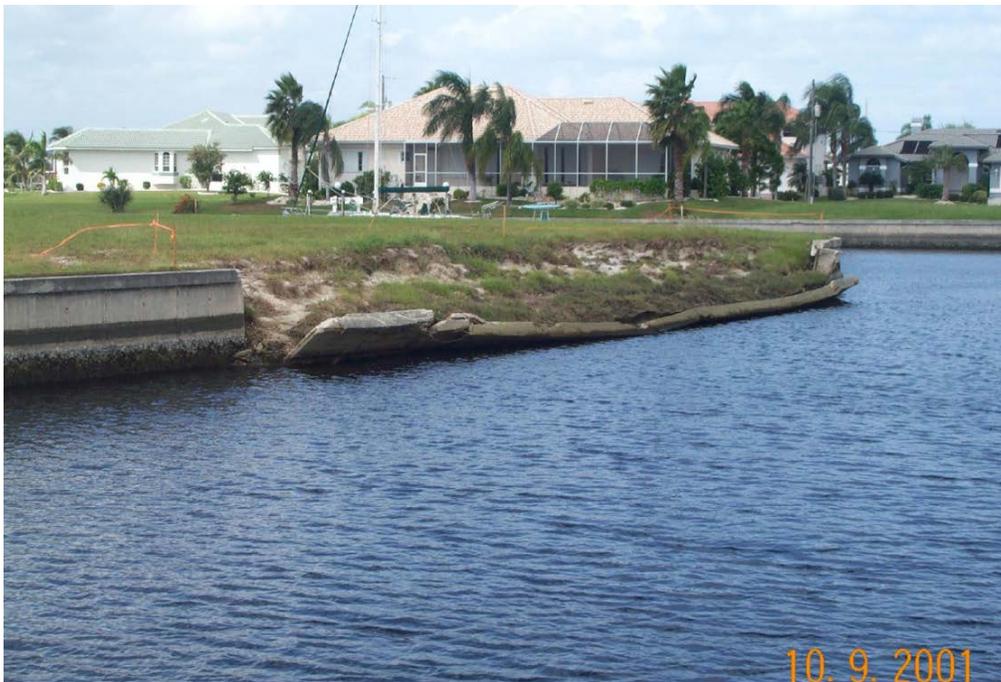
**Failed Seawall**

Vertical structures such as bulkheads and seawalls have been the most commonly used technique for shoreline protection and in some areas where there is high wave energy, they may be the most effective alternative. However, in many situations hardened structures are not always the best solution. Some of the detrimental effects of armoring include:

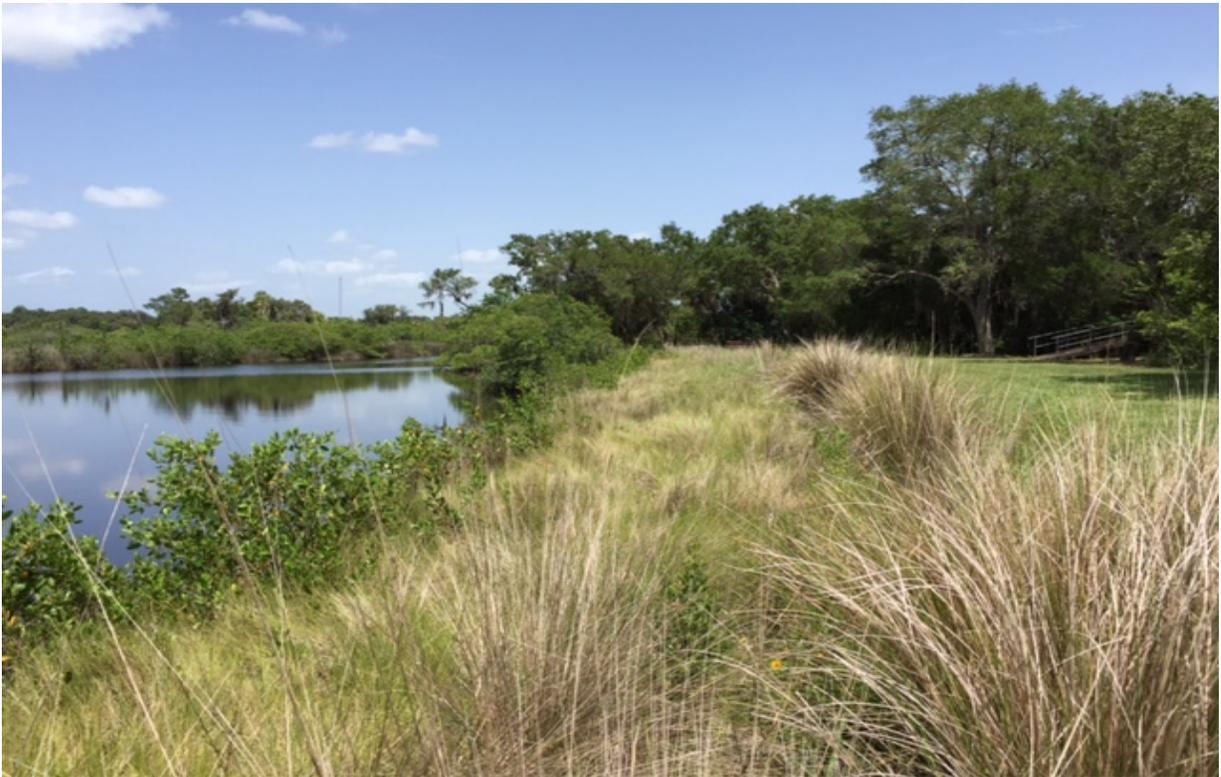
**Living Shoreline Solution after Removal of a Seawall at the Honi Hanta Girl Scout Camp in Bradenton, Florida**

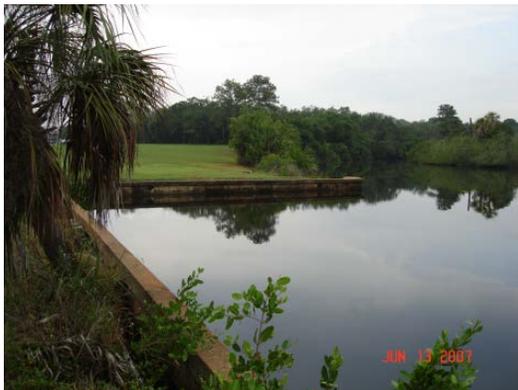
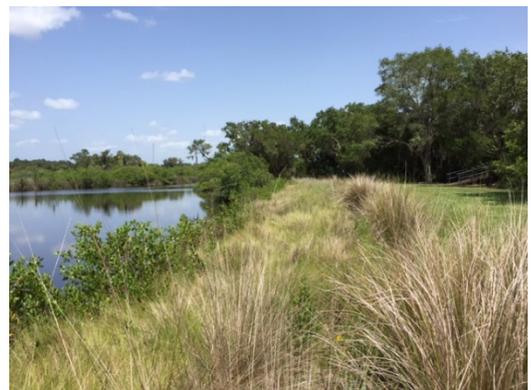
Before

After

The SBEP, in cooperation with the Girl Scouts of Gulfcoast Florida, Inc. (Girl Scouts), collaborated on a restoration project at Camp Honi Hanta, located on the Braden River. The selected habitat restoration project was accomplished through the removal of approximately 250 feet of seawall as well as the adjacent nuisance exotic vegetation, regarding of the slopes to reestablish a more natural bank slope, and the planting of native vegetation. Re-vegetation with native plants increased the water quality and wildlife habitat for this area. In this case, the restored banks were planted with native marsh grasses, with the help of the girl scouts, and within two years, mangroves trees naturally recruited the site, as anticipated. Approximately ½ acre of earthwork and 2 acres of exotic removal and re-vegetation were performed at this site. This restoration effort greatly improved juvenile fish habitat and help to increase fish production within Sarasota Bay. The overall benefits of this living shoreline project included the elimination

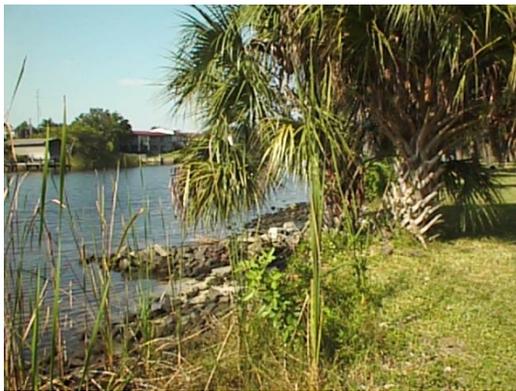
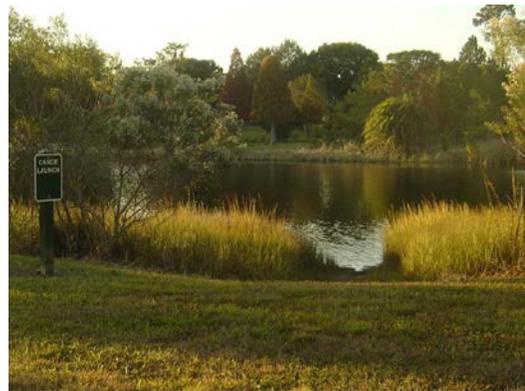
Before

After (2 years post-installation)

For this City of Tampa project, the banks were re-contoured to a gentle slope and Fibre™ Logs were placed water ward of the newly installed native wetland plants. The Fibre™ logs naturally breakdown over time (~18 months). By then the native vegetation is well established and protecting the shoreline.

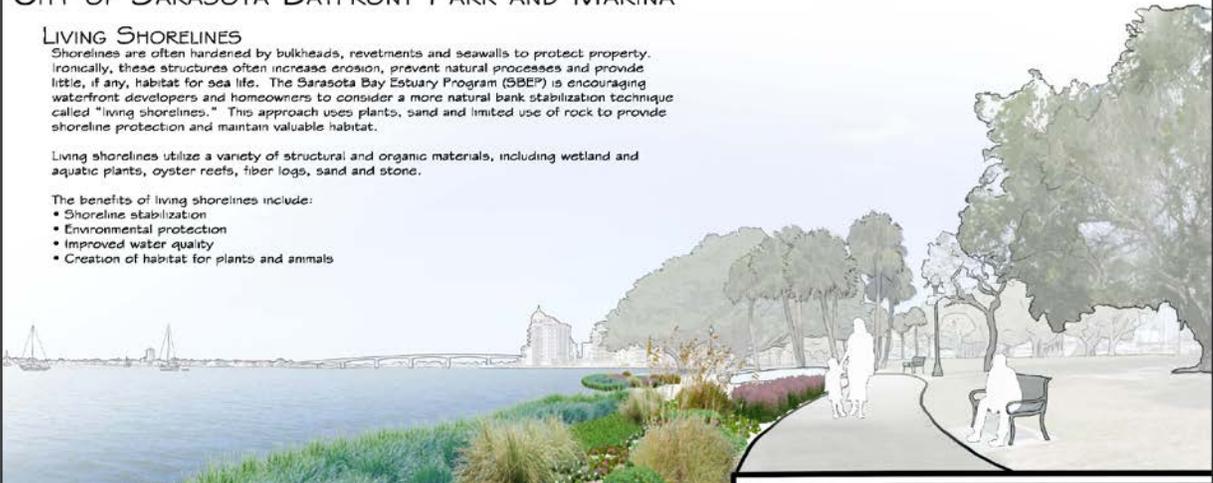
**UPPER EDGE**  
Sea Oats - *Uniola paniculata*  
Mudly Grass - *Muhlenbergia capillaris*

**TRANSITIONAL ZONE**  
Railroad Vine - *Ipomoea pes-caprae*  
Beach Morning Glory - *Ipomoea stolonifera*  
Dune Sunflower - *Helianthus debilis*  
Sand Cordgrass - *Spartina bakeri*

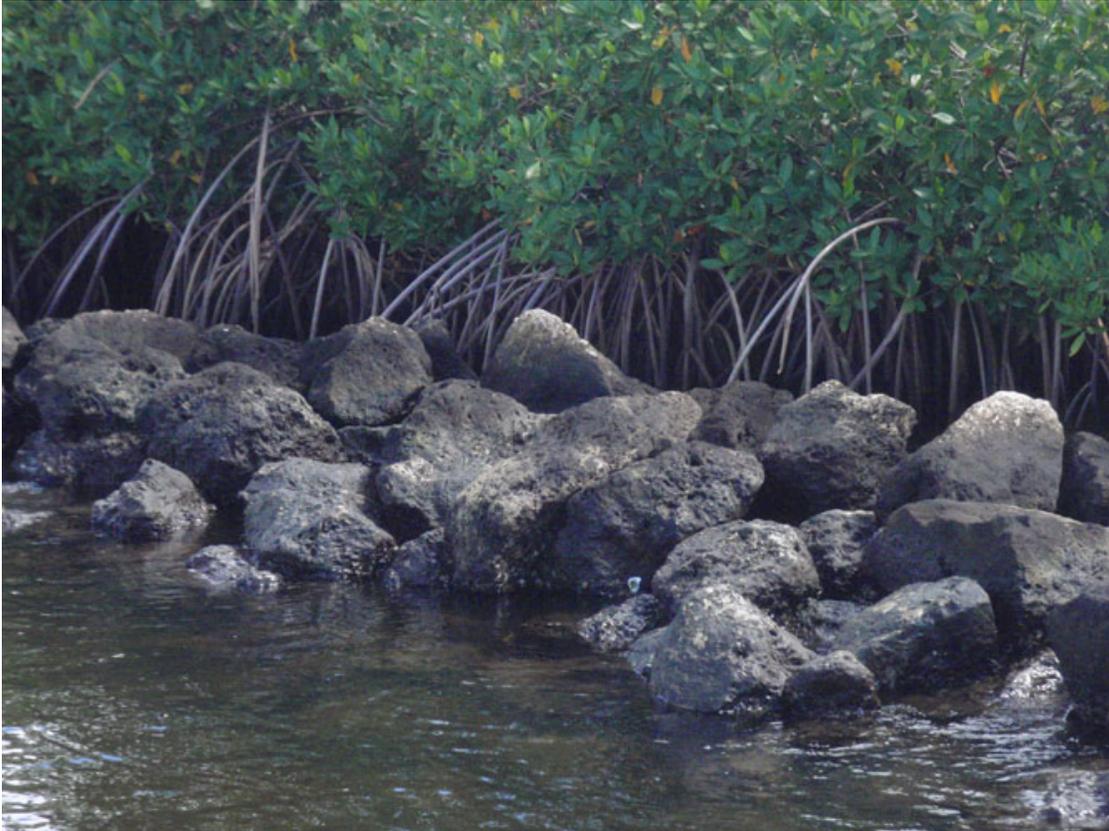
A 2,000 ft. long rock revetment was installed 8 ft. waterward of the existing seawall in the Lake Worth Lagoon. A filter fabric was placed under the rock and red mangroves were planted between the rock and seawall.

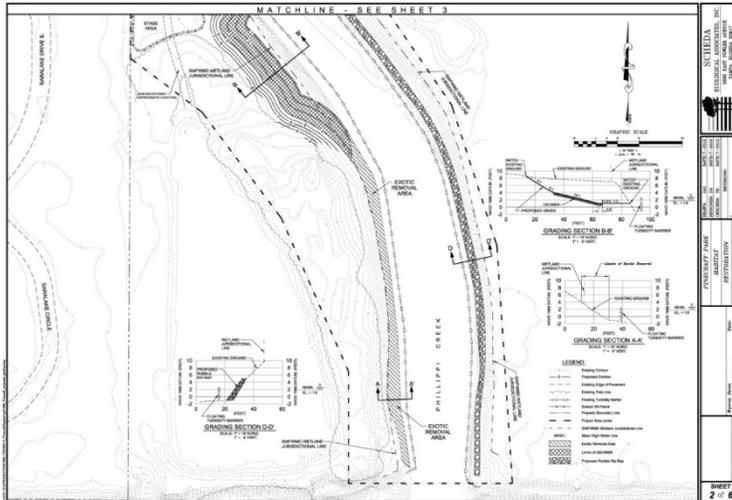
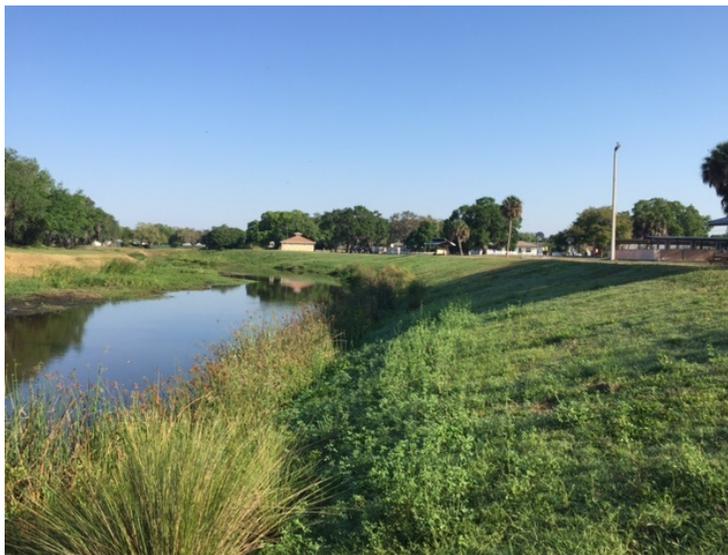
This project was designed with Geoweb™ material to stabilize the banks and allow for the installation of native freshwater wetland species. One year later, the resultant living shoreline slope is pictured below.

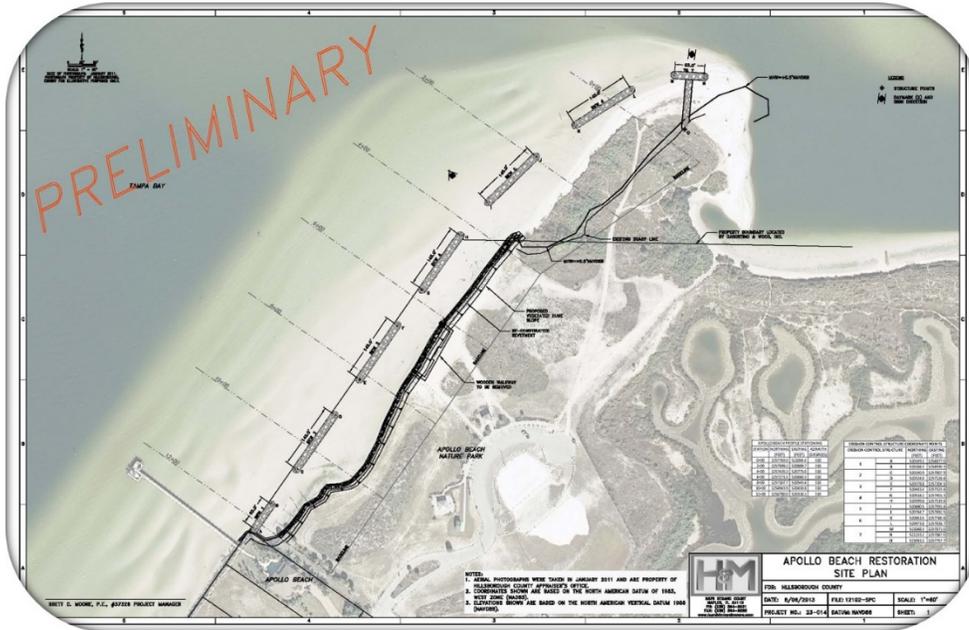
*Before*

The restoration of the severely eroded shoreline at the Apollo Beach Nature Preserve required the design of breakwater structures, revetment stabilization, and incorporated a “living shoreline” feature. The project design included additional shoreline stabilization with planting of dune species and currently seagrass beds are thriving behind the breakwater features.

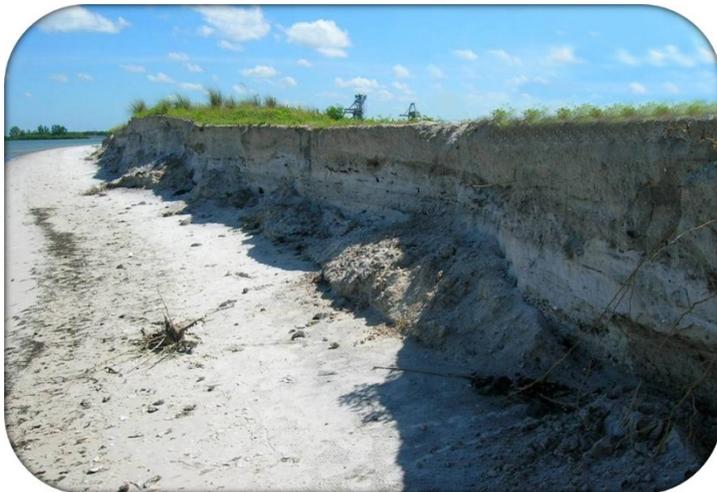
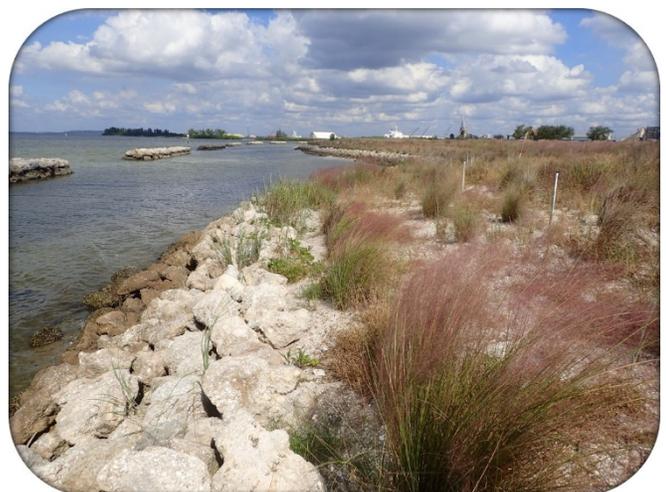
*After*

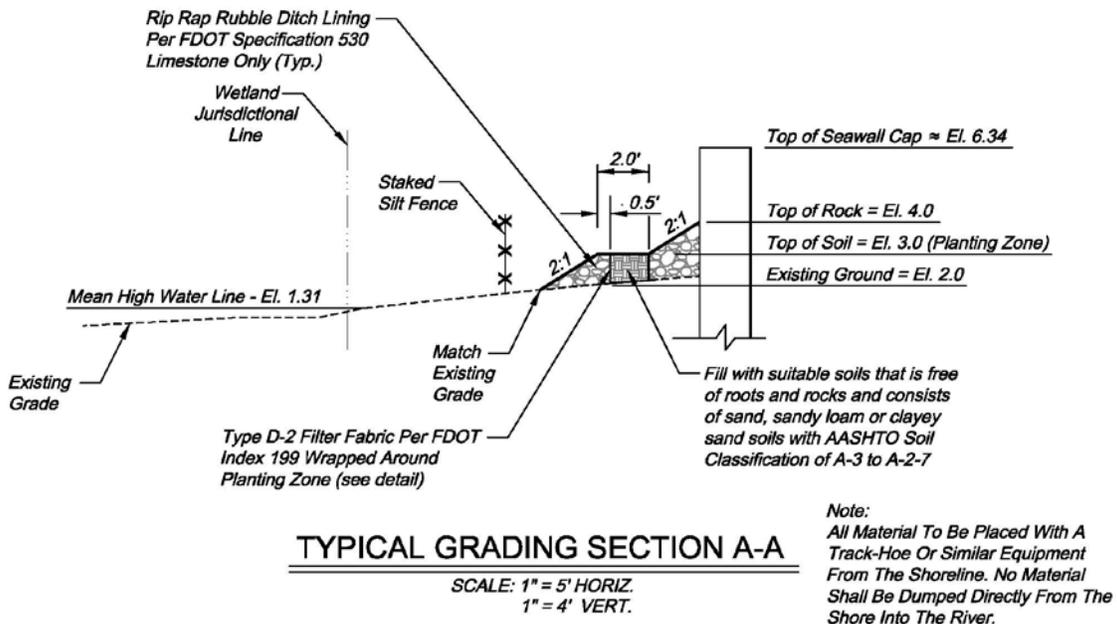
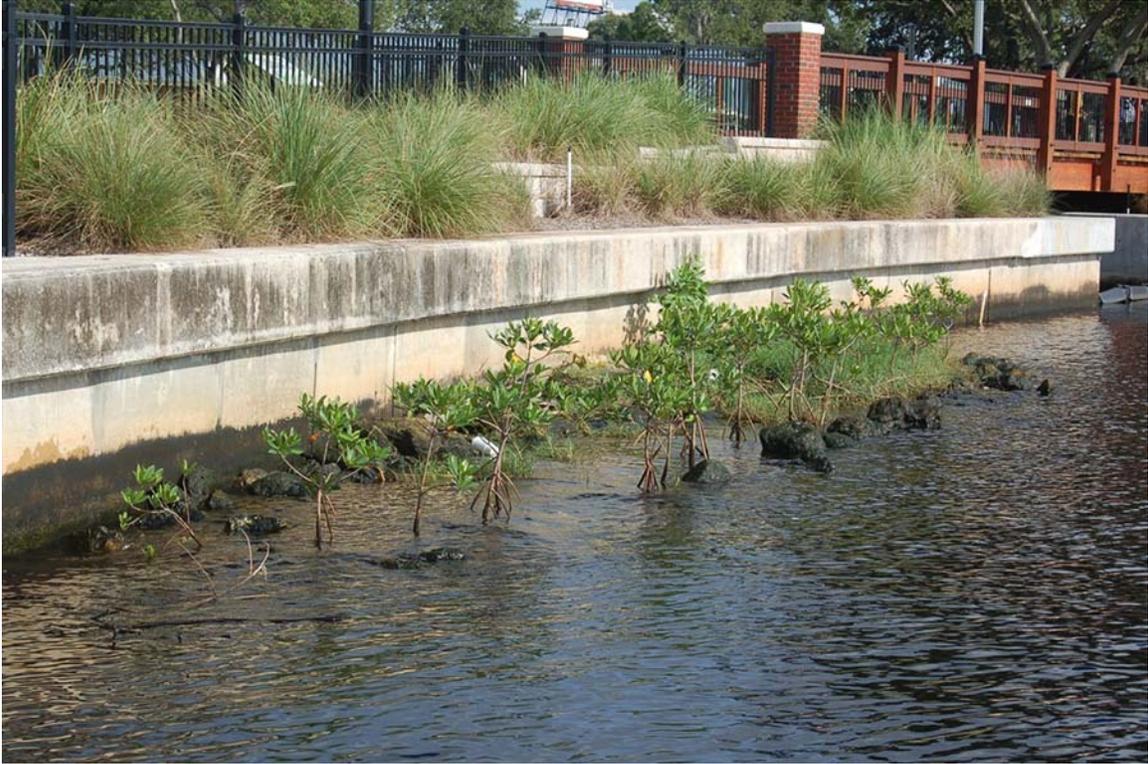
Unfortunately, there are hundreds of thousands of miles of seawall already in place in the US, and in some locations these cannot be removed due to the proximity of infrastructure and utilities or due to very high energy climates. In these cases, seawalls or bulkheads cannot easily be removed or replaced with a living shoreline option. These vertical walls provide little to no ecosystem benefits and do not effectively dissipate wave energy. To improve these circumstances, there are options that are superior to a vertical wall feature alone. These are commonly referred to as Seawall Enhancement Projects (SEP). SEPs include a variety of options that have been successfully deployed such as the addition of rock or rip-rap in front of the seawall. The mere placement of this rock will, at a minimum, help dissipate the wave energy and wave refraction properties which is superior to a vertical wall by itself. The rock also provides interstitial spaces for organisms to thrive. There are other design options that are viable, including the addition of “planters” within the rip-rap that are installed in front of an existing non-removable seawall. These planters require specific design considerations such as water level analysis and the incorporation of suitable sediment embedded within filter fabric to allow the installation of native plants. If these planters are installed within tidal regimes then it may be possible for the design of two distinct planters to capitalize on the high and low tide elevations.

If properly designed, these hybrid rock revetment features allow native plants to thrive thus providing habitat for many more species (fish, crustaceans, crabs, etc.). In the proper locations, mangrove trees can be planted within these planters and these trees will ultimately provide additional habitat opportunities including structure for bird roosting and even nesting opportunities. The red mangrove species, with its root propagule features, will also help hold the rock in place and the entire structure will provide energy dissipation to prolong the life of the seawall structure. If mangroves are likely to colonize the rip rap planters, then the resultant view shed needs to be discussed and understood. For many waterfront land owners, view shed is an extremely important objective and with the addition of a living shoreline or even a SEP feature, their views will potentially be limited if mangroves begin to thrive. To address this concern, mangrove trimming abilities should be incorporated into the regulatory permit process so the landowner can window the mangroves to allow views, while still providing many of beneficial attributes of a living shoreline.

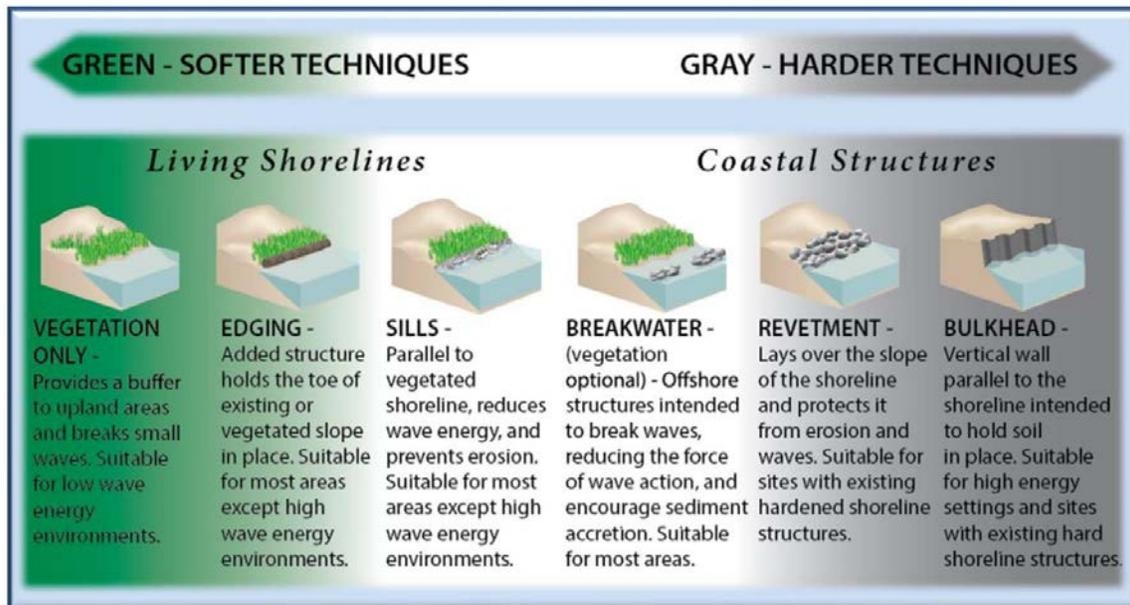
A range of shoreline stabilization techniques (NOAA, 2015).

In high energy areas, a living shoreline may not be sufficient to protect the shoreline from erosional forces. Breakwaters or other structures such as reef balls or concrete pods placed offshore and parallel to the shoreline reduce wave energy. A combination of structures and a planted living shoreline is often a good solution (Section 4 - Apollo Beach). Below is a graphic that depicts some of the more common combination techniques utilized under different energy conditions.
