HIDDEN HARBOR SEDIMENT ABATEMENT STUDY

**Sarasota County
Water Resources**

**Berryman & Henigar, Inc.
1412 Tech Blvd
Tampa, Florida 33619-7865**

March 2005

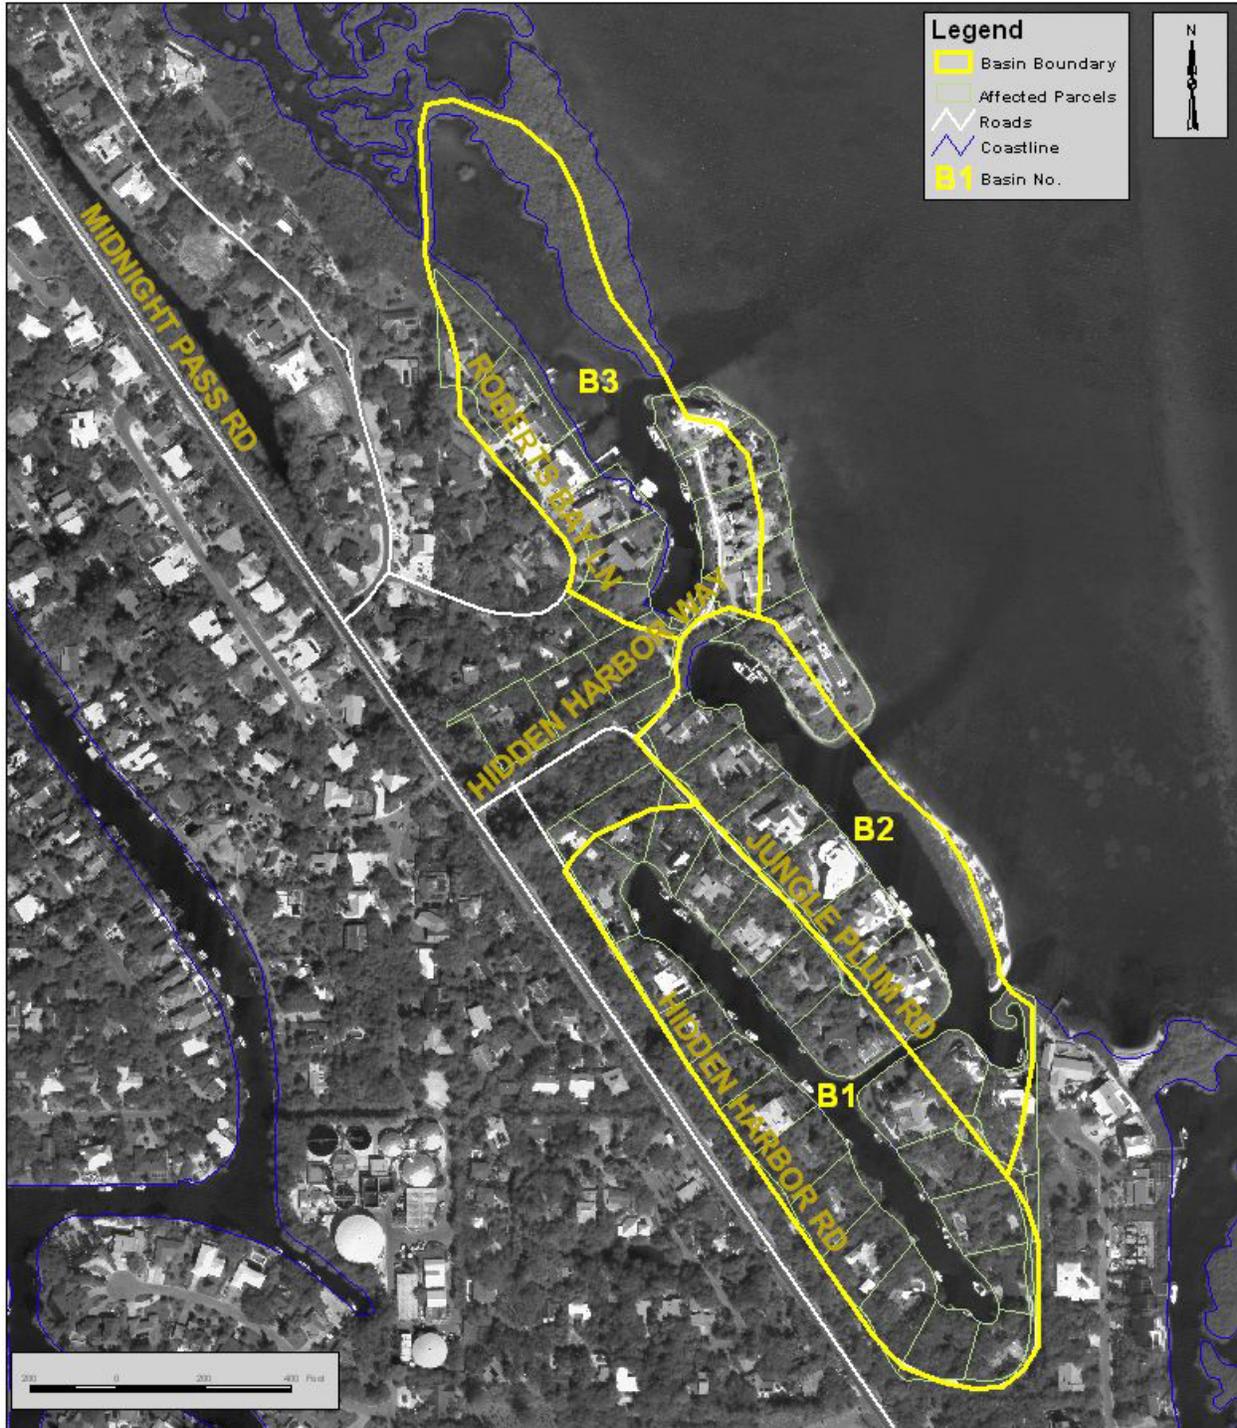
<p>Figure 2</p>	<p>Existing Features Map</p>

The drainage basin for the canal is generally bordered by Hidden Harbor Way and Roberts Bay Lane on the west, Roberts Bay on the east, Tropical Circle on the north, and North View Drive on the south. The overall drainage basin consists of 36 acres of mostly single-family residential lots. See Figure 2, which shows subbasins within the study area.

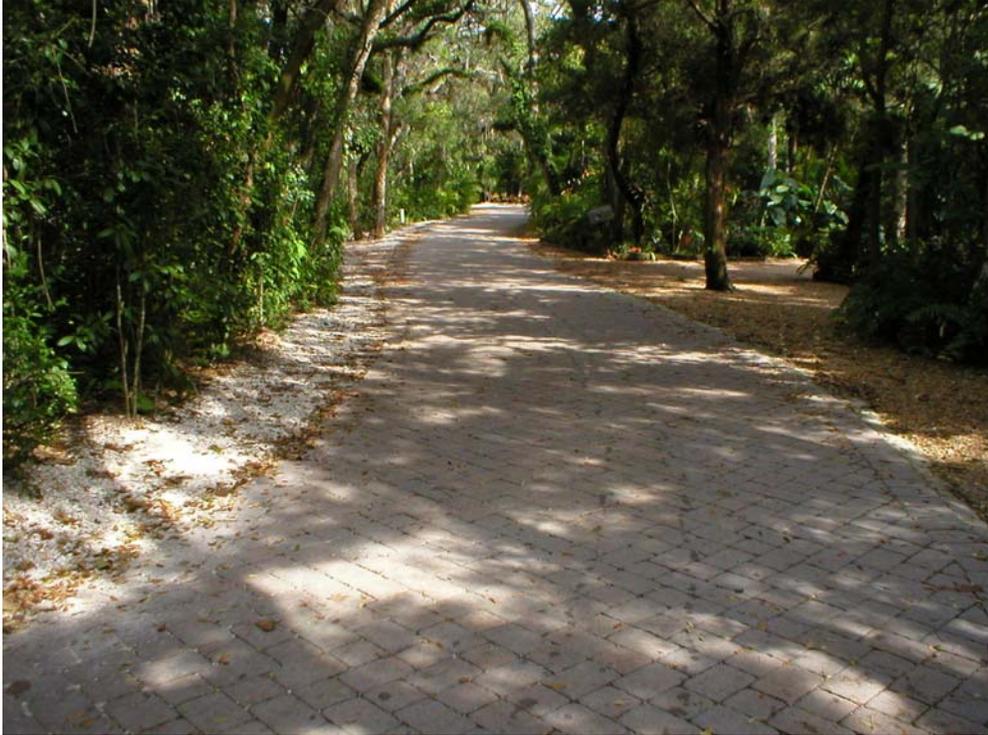
This drainage basin area consists of 11.3 acres of single family residential property and drains properties along Hidden Harbor Road and Jungle Plum Road. This is the largest drainage basin discharging to the canal but the roads consist of pavers (Figure 3) and along with the yards are performing as stormwater treatment systems by reducing the amount of runoff and sediment being discharged to the canal. The rear of the lots has either rip-rap and or mangroves stabilizing the canal side slopes (Figure 4). A cleared lot was found off Hidden Harbor Road that had the proper sediment and erosion controls in place (Figure 5). There was no sediment build up observed along the shoreline at this basin.

Figure 3.
Pavers road on Hidden Harbor Rd. in Basin B1.

This basin drains properties along Hidden Harbor Road and Jungle Plum Road. Although this is the largest drainage basin with the largest pollutants loadings, no new BMPs are recommended for this basin because the pavers roads and onsite retention are working properly as stormwater systems.

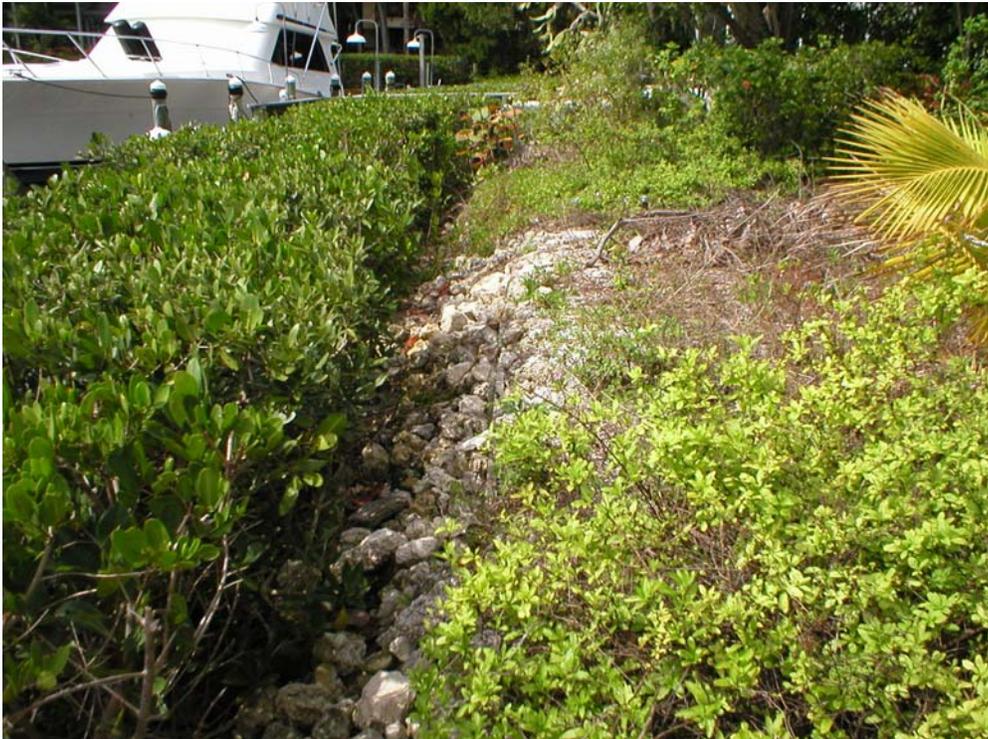
Figure 4.
Rear of residential lot off Jungle Plum Rd. in Basin B1.

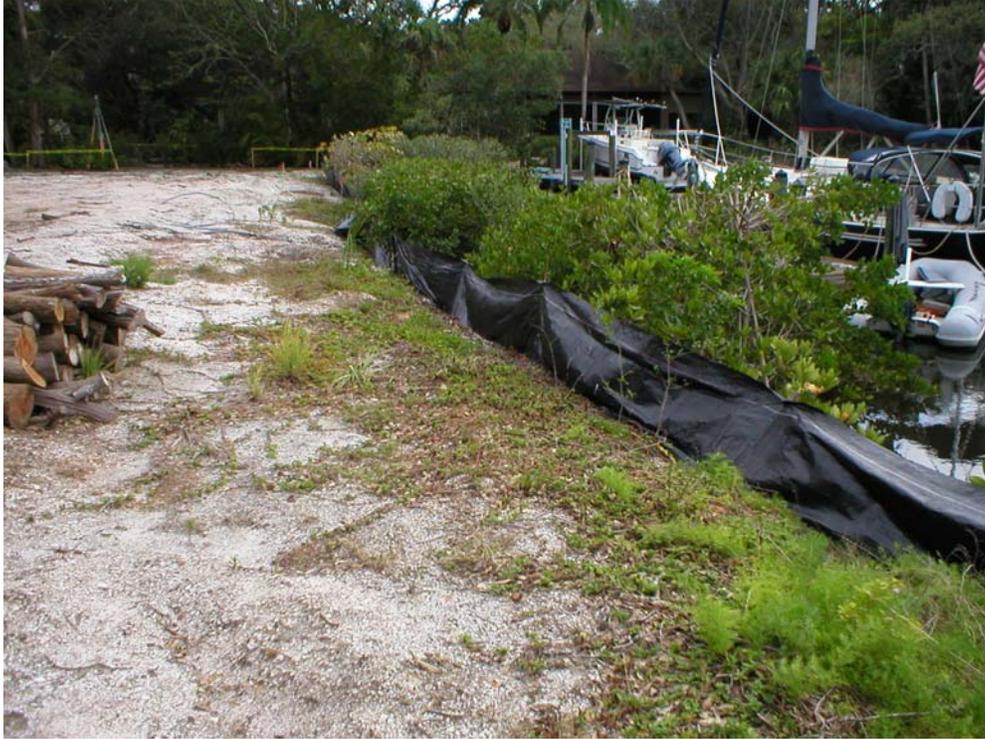
Figure 5.
Construction site with proper sediment and erosion control in Basin B1.

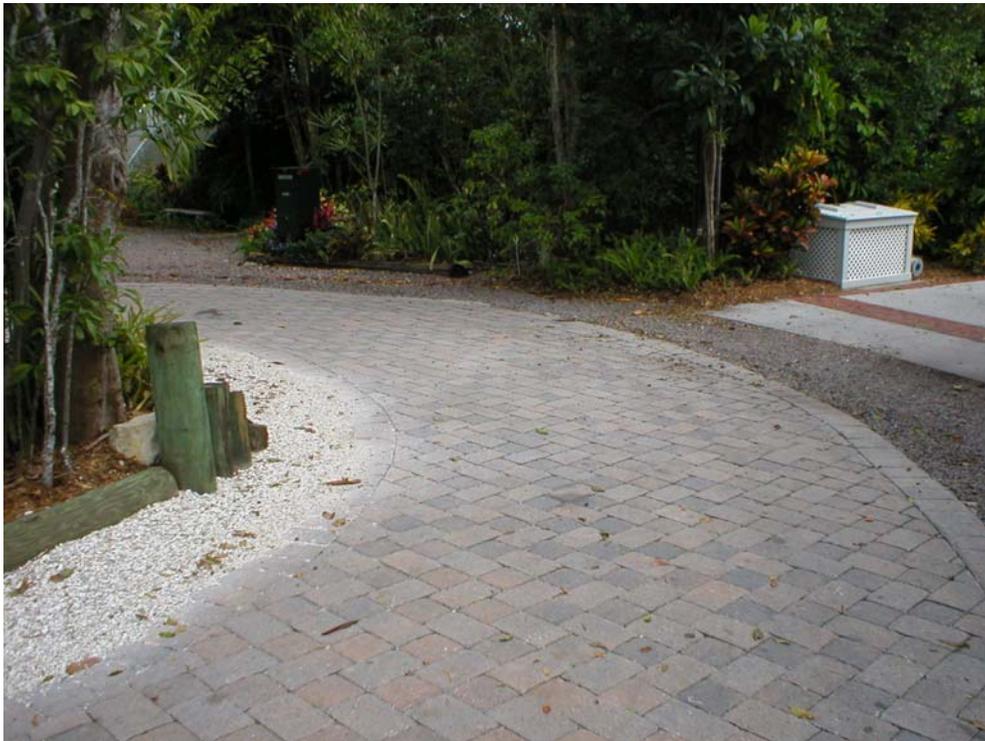
This drainage basin area consists of 7.2 acres of single family residential, low density residential and open space property. This basin drains properties mostly along Jungle Plum Road and a few properties along Hidden Harbor Way and Hidden Harbor Road. The roads also consist of pavers (Figure 6) and along with the yards are performing as stormwater treatment systems by reducing the amount of runoff. Furthermore most houses have gravel (Figure 7) and/or pavers (Figure 8) driveways with very few concrete driveways. A cleared lot was found off Hidden Harbor Way that had failing sediment and erosion controls in place (Figure 9). There was no sediment build up observed along the shoreline at this basin.

Figure 6.
Cul-de-sac at the end of Jungle Plum Rd. in Basin B2.

This basin drains properties mostly along Jungle Plum Road and a few properties along Hidden Harbor Way and Hidden Harbor Road. No new BMPs are recommended for this basin because the pavers roads and onsite retention are working properly as stormwater systems. However, due to failing sediment and erosion controls at a vacant Hidden Harbor Way lot, BHI recommends new silt fences to be installed to avoid further erosion.

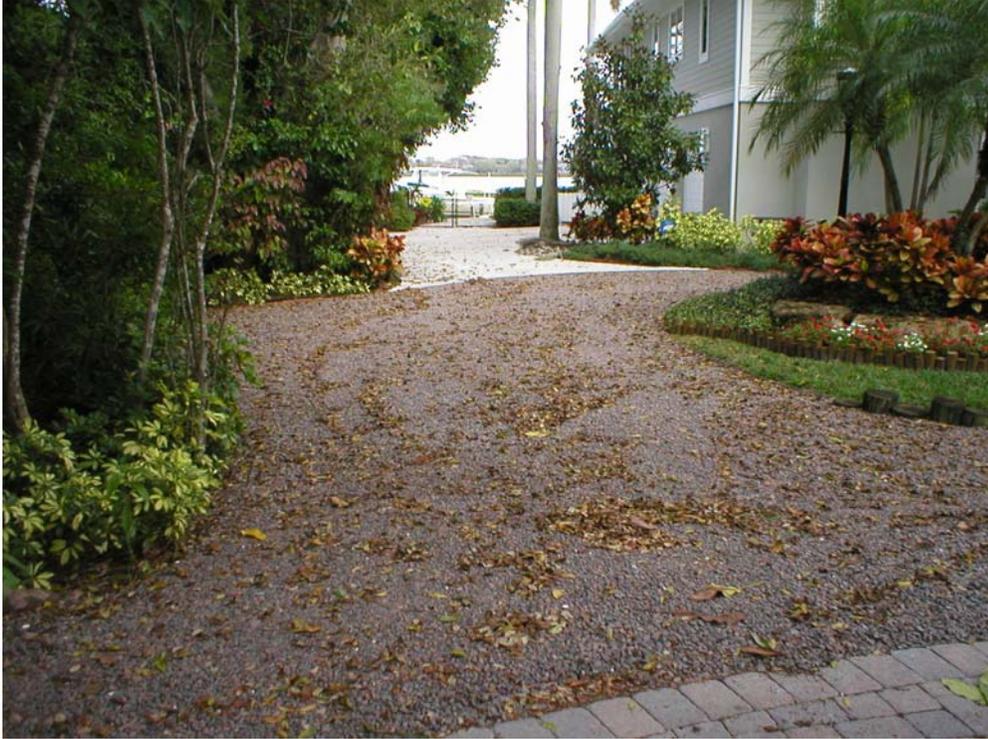
Figure 7.
Gravel driveway on a house in Basin B2.

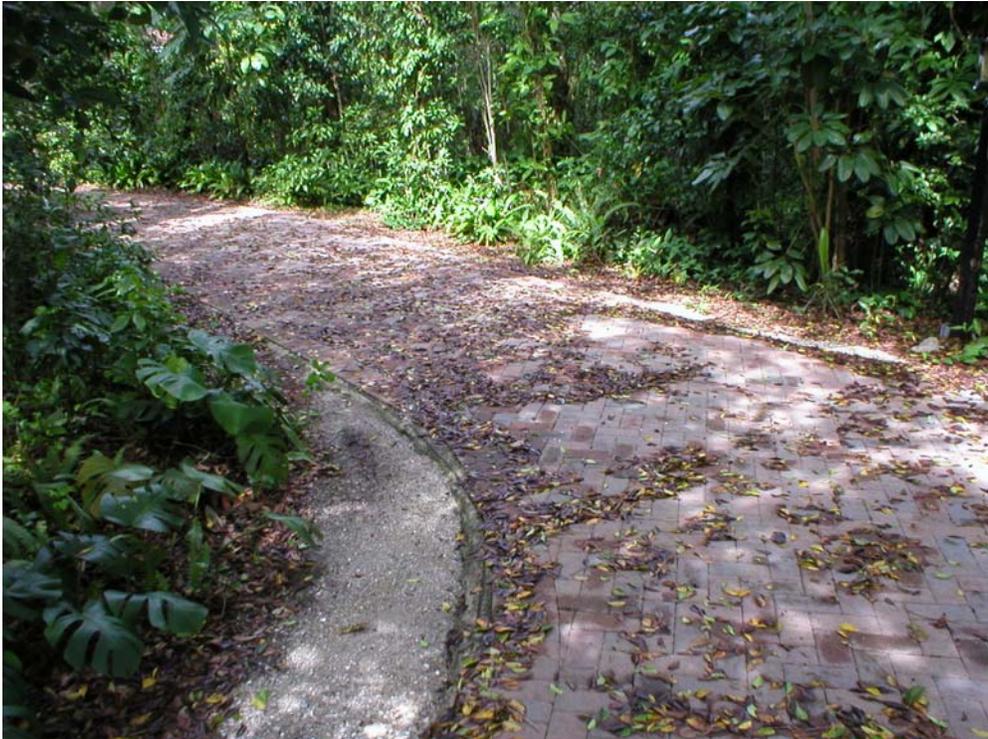
Figure 9.
Pavers driveway on a house in Basin B2.

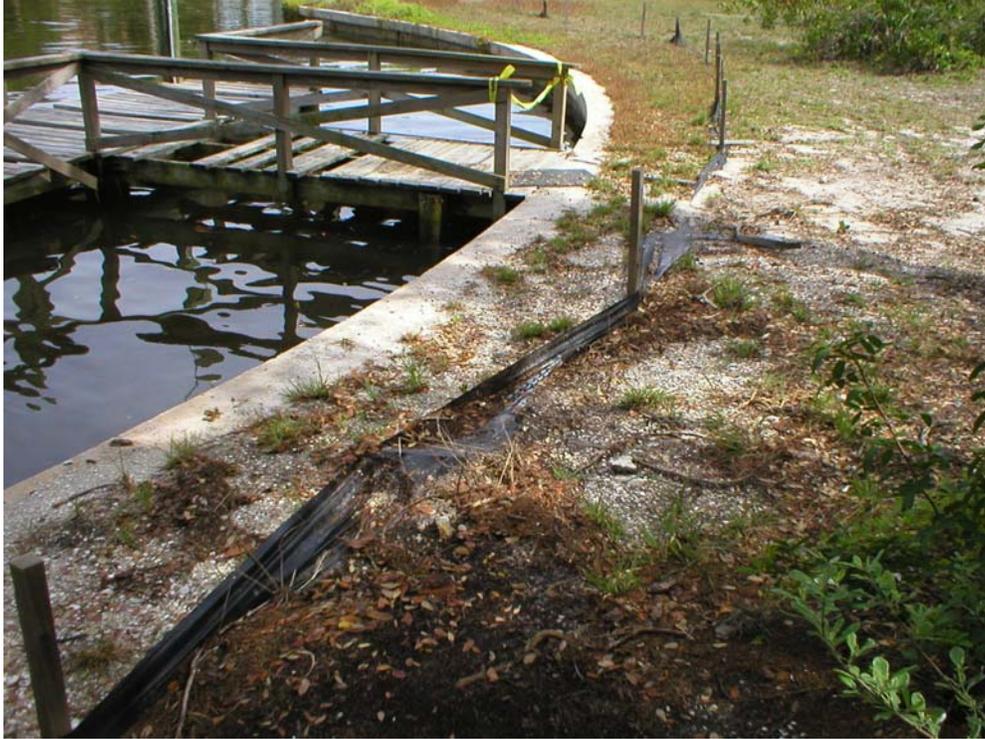
Figure 9.
Failed silt fence in Basin B2

Based on the field investigations and analysis in this report, no structural BMPs are recommended, but due to failing sediment and erosion controls at a vacant Hidden Harbor Way lot, it is being recommended that new silt fences will be installed to avoid further erosion.

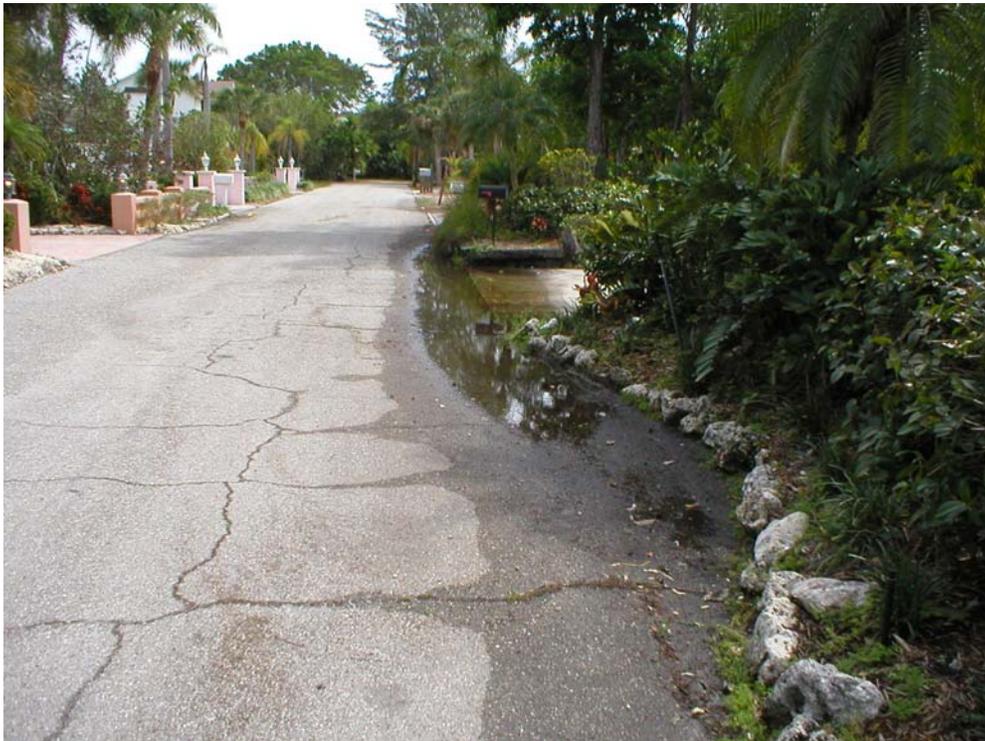
Figure 10.
Ponding on side of paved road along Roberts Bay Ln. in Basin B3.

This drainage basin area consists of 7.6 acres of single family residential and open space property, and it drains properties along Roberts Bay Lane and Hidden Harbor Way. Half of the roads also consist of pavers but the roads along Roberts Bay Lane are paved (Figure 10). Ponding along the sides of the road and in the yards was observed. As a result the paved roads are producing a higher volume of runoff than the pavers roads but the yards are performing as stormwater treatment systems by retaining most of the runoff onsite (Figure 11).

This basin drains properties along Roberts Bay Lane and Hidden Harbor Way. No new BMPs are recommended for this basin, despite the fact that the paved roads along Roberts Bay Lane are producing a higher volume of runoff than the pavers roads, because the yards are performing as stormwater treatment systems by retaining most of the runoff.

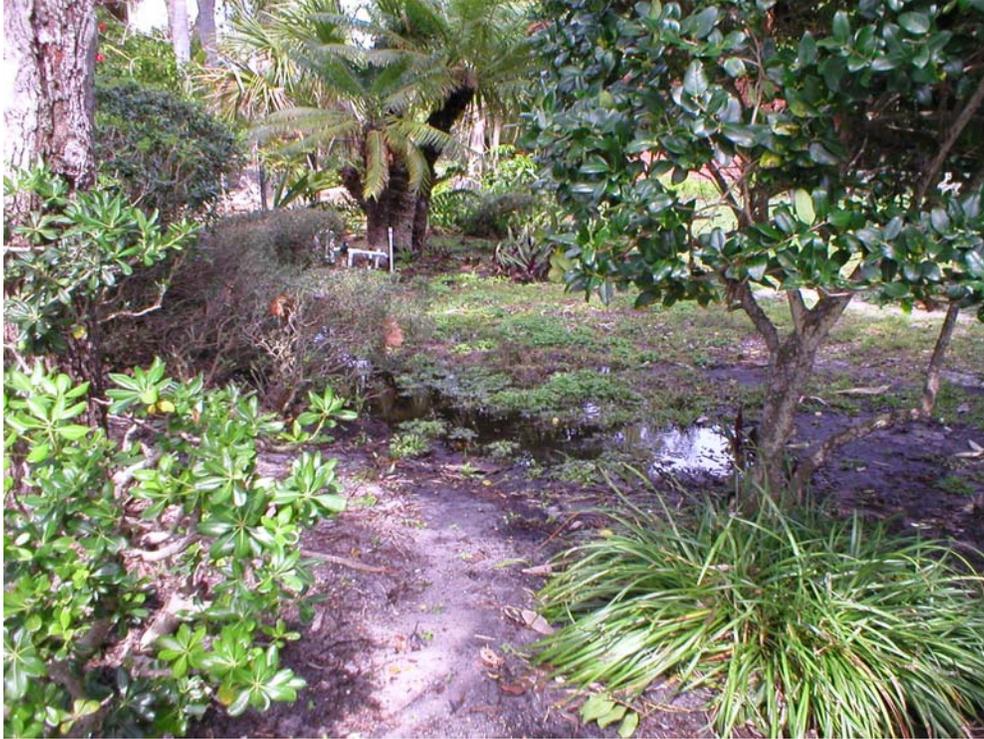
Figure 11.
Ponding on front yard in a house in Roberts Bay Ln. in Basin B3.
