**WATER AND SEDIMENT SAMPLE  
COLLECTION AND ANALYSES  
JULY 1999 - JULY 2002  
PRE- AND POST-RESTORATION COMPARISON**

**HOG CREEK, SARASOTA, FL,  
AND  
PALMA SOLA CREEK, BRADENTON, FL**

**Mote Marine Laboratory Technical Report No. 854**

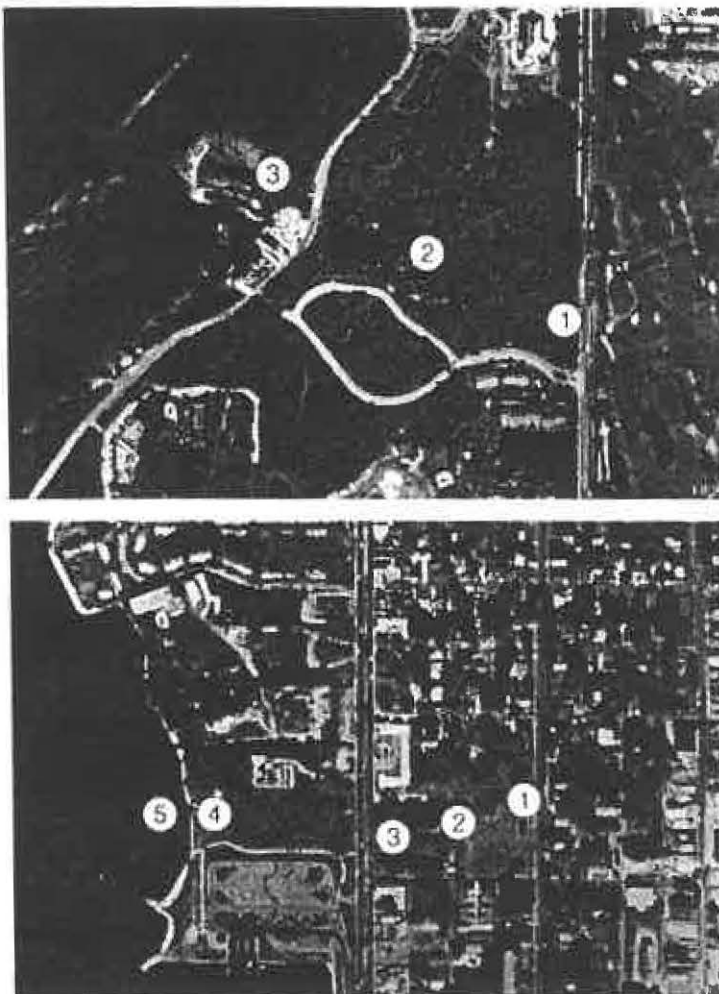
Hog Creek 1 (HC-1) was located at the culverted opening from beneath Coconut Avenue, on the north side of Pioneer Park, in Sarasota, Florida. The culvert appeared to be a stormwater system draining a moderate density residential area. The culvert was often dry, and there was at times a slight base flow from the surrounding wetland area to the small pool at the culvert opening. There was not even standing water present at 2 of the 6 post-restoration samplings. No samplings occurred during storm events when flow from HC-1 would comprise a large fraction of the flows below HC-2. Sediments ranged from muddy sand to leaf debris.

Hog Creek 2 (HC-2) was located at the discharge point of the City of Sarasota reverse osmosis plant, at the north west corner of Pioneer Park. Prior to restoration, the 5' culvert opened into a ~3' wide open channel bordered by extensive submerged and emergent vegetation. Current velocities in the narrow channel maintained a fairly coarse sediment on the stream bed. Restoration efforts have created an enlarged 'mixing pond' before entering the existing channel. The water is generally slightly cloudy and blue in appearance with numerous filamentous white particulates. The pond is presently bordered with emergent vegetation. Flow was measured across the opening of the 5' culvert. Sediments were a muddy, dark sand at the edges of the pool grading into coarser sediments as the stream shallows and increases in velocity.

Hog Creek 3 (HC-3) was located where the creek is routed below U.S. Highway 41 in a rectangular box culvert. Flow on the upstream side was constricted and comparatively rapid with a rocky substrate. Immediately downstream of U.S. 41, a larger pool formed and sediments accumulated. For access and substrate reasons, water quality samples were collected on the upstream side and sediments collected on the downstream side of U.S. 41. Waters were generally clear and spring-like in appearance with no filamentous particulates as noted at HC-2. Flow was downstream. Sediments were a dark muddy sand.

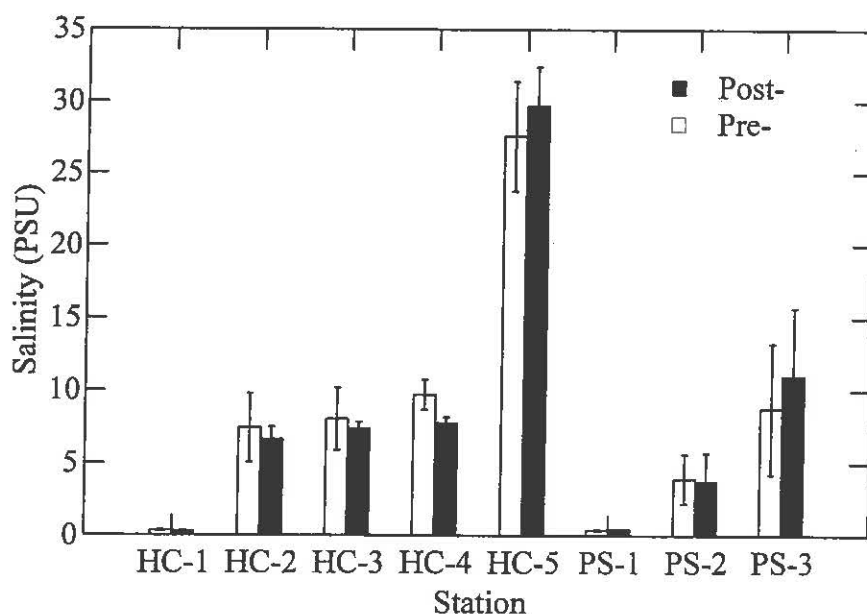
**Figure 2.** Mean salinities (laboratory) for Pre- and Post-restoration by station. Vertical bars indicate  $\pm$  standard error of the mean.

Salinity in Palma Sola Creek ranged between 0.5 and 23 PSU, but stratification made these measurements extremely variable. Tidally unfiltered gradients were comparable between pre- and post-restoration samplings indicating that a general climatic and flow conditions were comparable over the course of the study. Gradients as illustrated for Palma Sola stations, however, can be misleading since PS-2 was established based on salinity rather than on geographic location. (During some samplings, combined with the high flow and the low tide, the station PS-2 (~10 PSU), was located downstream of station PS-3.)

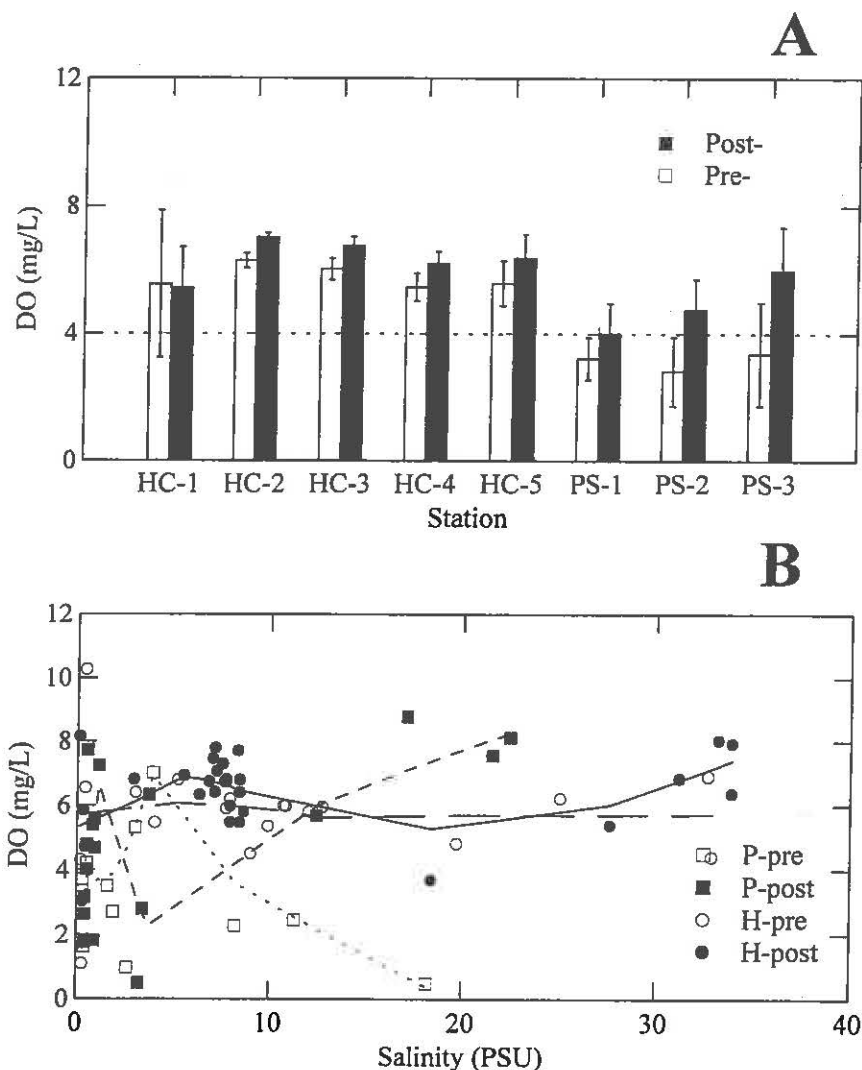
Dissolved oxygen (DO; **Figure 3**) displayed extreme maxima and minima at Station HC-1. Minima below marine Class III instantaneous criteria of 4.0 mg/l were also frequently noted at the Palma Sola stations. The central Hog Creek stations were typically between 5.0 and 7.0 mg/l, and declined with distance downstream. Both HC-5 and PS-3 recorded concentrations of DO higher than the upstream stations, perhaps in response to decreased canopy cover and/or increased turbulence and mixing.

**Figure 3.** A (Top) Mean dissolved oxygen concentration for pre- and post-restoration by station (Class III marine instantaneous criteria = 4.0 mg/L). B (Bottom) Dissolved oxygen concentration as a function of salinity; LOWESS (Locally Weighted Scatterplot Smooth) lines: solid- Hog-post; large dash-Hog-pre; medium dash- Palma Sola-post; fine dash - Palma Sola-pre.

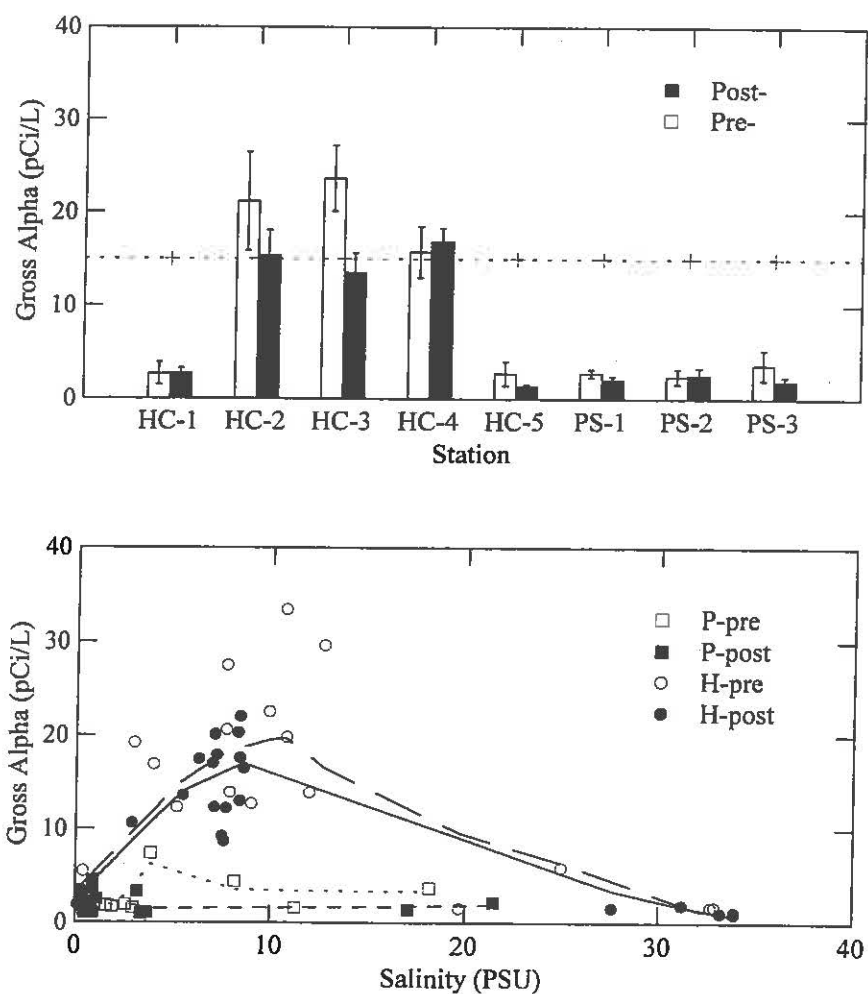
Hog Creek stations HC-2, HC-3, and HC-4 showed substantively higher concentrations of gross alpha radioactivity (**Figure 4**) and  $^{226}\text{Ra}$  (radium) with slightly higher levels of  $^{228}\text{Ra}$  (**Figure 5**). A number of the HC-2 and HC-3 samples (both pre- and post-restoration) exceeded marine Class III criteria of 15 pCi/L for gross alpha. All HC-2 and HC-3 samples (both pre- and post-restoration) exceeded the marine Class III criteria of 5 pCi/L for  $^{226}\text{Ra}$  plus  $^{228}\text{Ra}$  (**Figure 6**). Palma Sola stations were uniformly low for all radiological parameters, at concentrations comparable with HC-1 and HC-5. Post-restoration concentrations for gross alpha radiation at HC-2 and HC-3 were only slightly lower than those from pre-restoration samples. As HC-2 is almost exclusively the reject reverse osmosis water, it is possible that feed water, plant operations, or percentage of reject have altered somewhat.

**Figure 4.** A. Mean gross alpha concentration for pre- and post-restoration by station (Class III marine criteria = 15 pCi/L). B. Gross alpha concentration as a function of salinity - symbol lines are as in Figure 3.

Relationships of gross alpha and  $^{226}\text{Ra}$  plus  $^{228}\text{Ra}$  as a function of salinity also appear in **Figures 4** (above) and **6** (below). Individual data points are shown together with a locally weighted scatterplot smooth (LOWESS) curve indicating the general tendency of the data. The curves illustrate both the differences between Hog and Palma Sola Creeks, as well as indicating little change between pre- and post-restoration conditions for either gross alpha or the combined radium species.

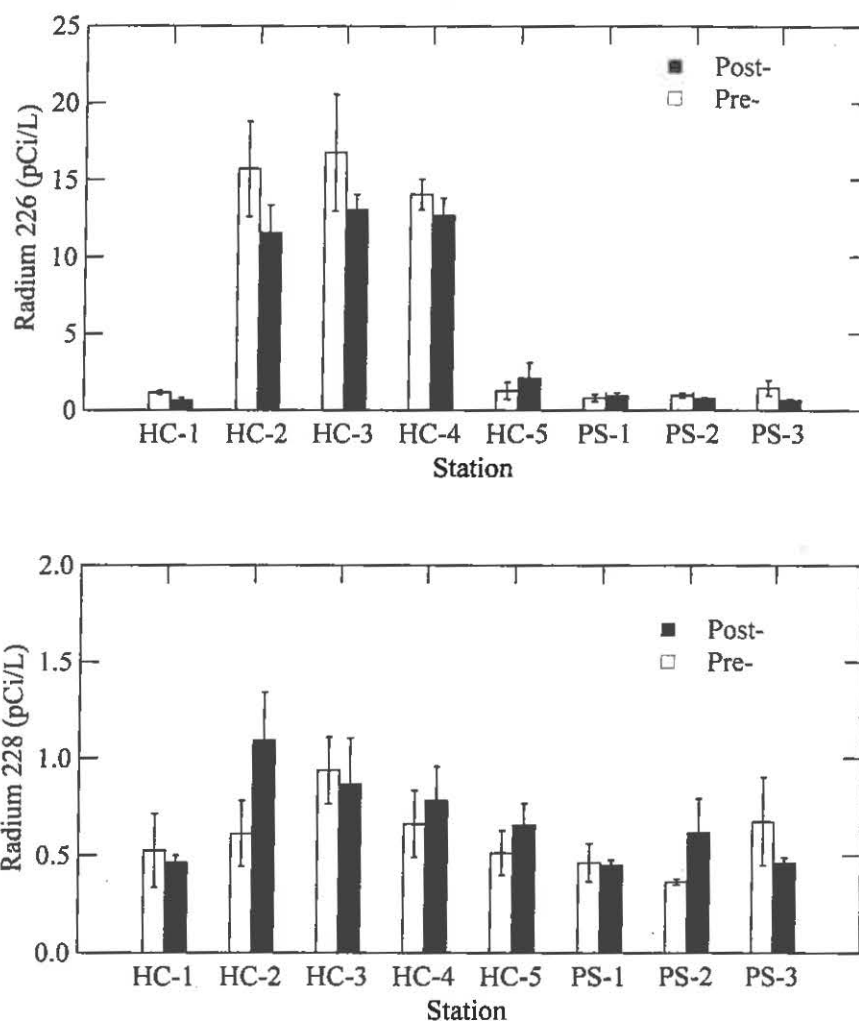
**Figure 5.** A. Mean radium 226 concentration , and B. mean radium 228 concentration for pre- and post-restoration by station.

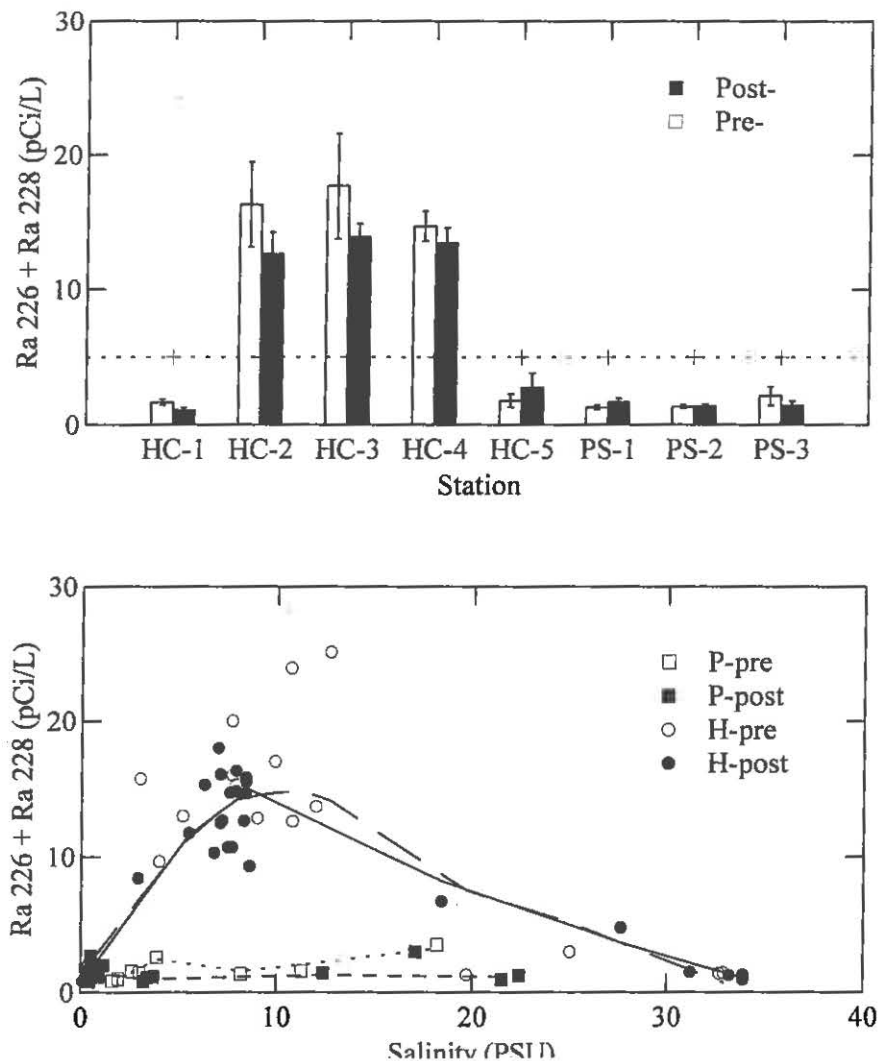
**Figure 6.** A. Mean radium 226 plus radium 228 concentration for pre- and post-restoration by station (Class III marine criteria = 5 pCi/L). B. Radium 226 plus radium 228 concentration as a function of salinity - symbol lines are as in Figure 3.

Pre-restoration conditions in Hog Creek did record the highest concentrations of both analytes. (It is unknown how much seasonal or inter-annual variation in quality of reject water is typical.) Concentrations of both gross alpha and  $^{226}\text{Ra}$  plus  $^{228}\text{Ra}$  at HC-5 did converge to the level of the most saline Palma Sola station.

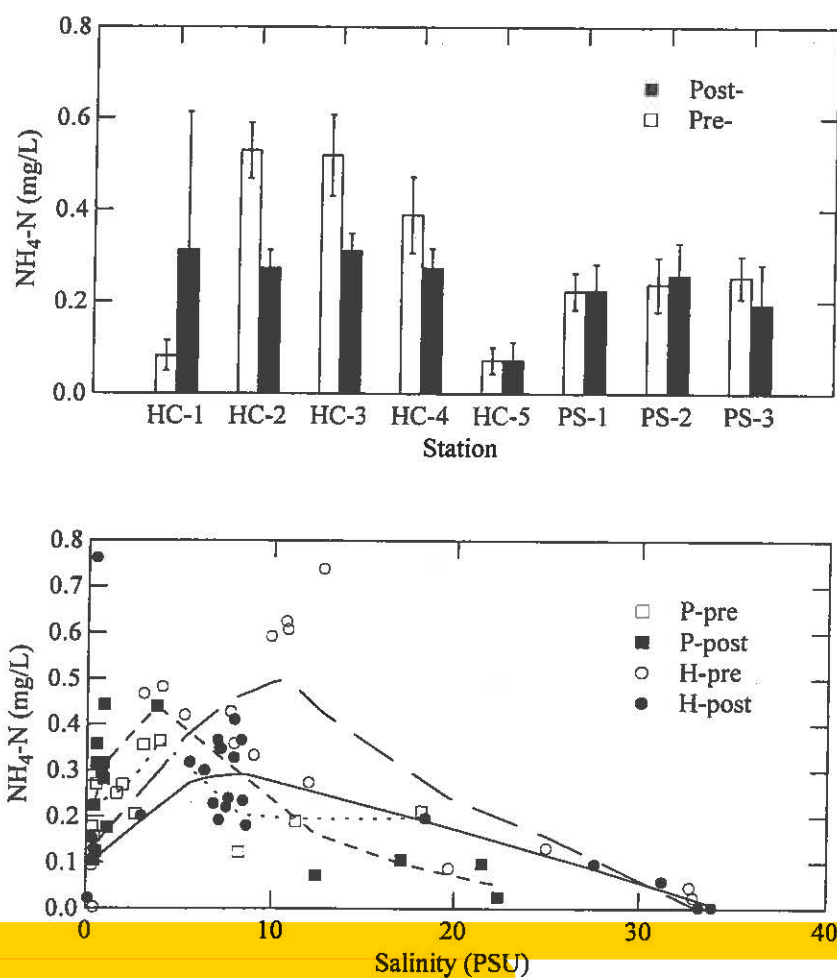
Ammonia-nitrogen concentrations ( $\text{NH}_4\text{-N}$ ; **Figure 7**) in Palma Sola were relatively uniform with respect to salinity. Before restoration, the Hog Creek stations downstream of the plant discharge (HC-2 to HC-3) had higher concentrations of ammonia-nitrogen than either the Palma Sola Creek stations or post-restoration values at the same stations. Changes in plant operation of feed water quality appear likely. Post-restoration values in Hog Creek HC-2 and HC-3 were comparable to Palma Sola creek, where there was little change over the sampling period. LOWESS measures of general tendencies ammonia as a function of salinity were lower for post-restoration Hog Creek than during either period for Palma Sola. Increased residence time due the larger mixing pool of Hog Creek may allow additional opportunities for biotic consumption of ammonium species. Ammonia-nitrogen concentrations at HC-1 were highly variable, and concentrations in Sarasota Bay (HC-5) the lowest observed.

**Figure 7.** A. Mean ammonia -nitrogen concentration for pre- and post-restoration by station. B. Ammonia -nitrogen concentration as a function of salinity - symbol lines are as in Figure 3.

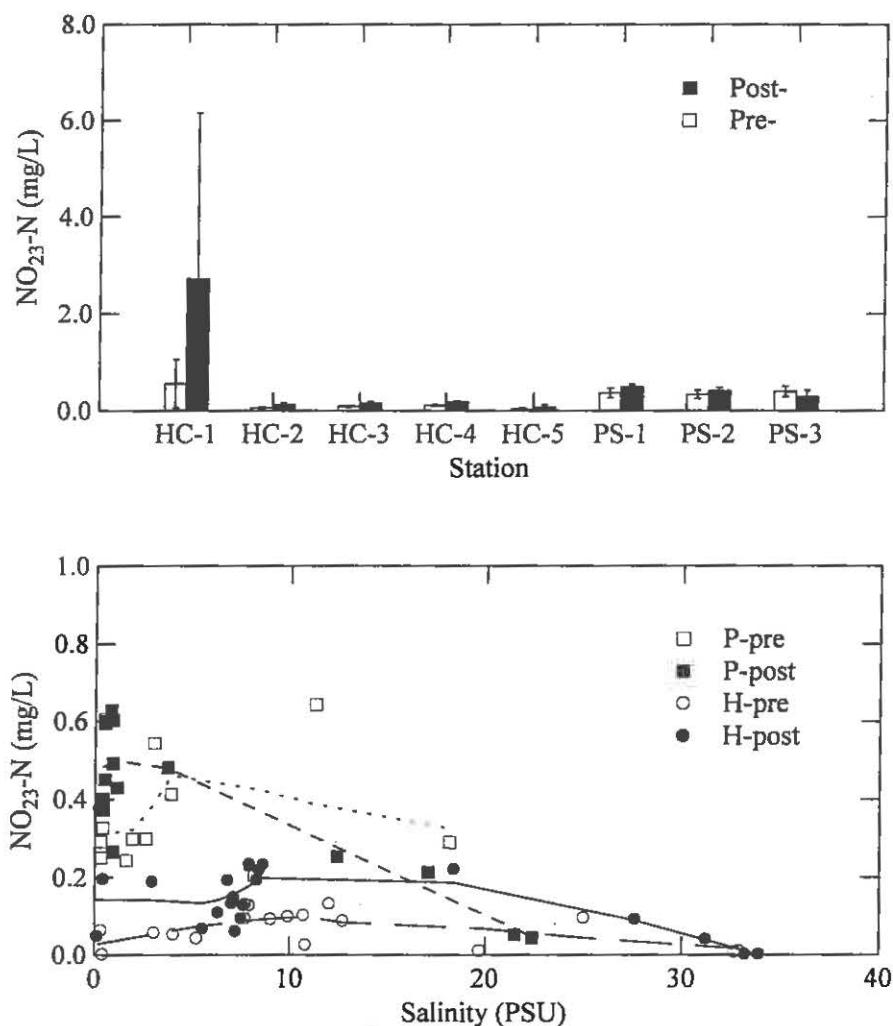
In contrast, nitrate nitrite-nitrogen ( $\text{NO}_{23}\text{-N}$ ; **Figure 8 - top**) was always higher at Palma Sola Creek stations than between HC-2 to HC-5. (Station HC-1 evidenced an unusually high concentration of  $\text{NO}_{23}\text{-N}$  on one occasion that may be related to residential influences such as lawn fertilization. **Figure 8 - bottom**, is plotted without this outlier value.) The higher  $\text{NO}_{23}\text{-N}$  concentrations at Palma Sola may be the result of drainage from the Palma Sola golf course, which is irrigated with treated effluent. A increase in  $\text{NO}_{23}\text{-N}$  was noted at stations HC-2 to HC-4 between pre- and post-restoration. Both Palma Sola and Hog Creek samples converge to similar low values of  $\text{NO}_{23}\text{-N}$  at salinities of about 20 PSU and above. The salinity related gradients of  $\text{NO}_{23}\text{-N}$  are more pronounced for the Palma Sola stations.

**Figure 8.** A. Mean nitrate nitrite-nitrogen concentration for pre- and post-restoration by station. B. Nitrate nitrite-nitrogen concentration as a function of salinity - symbol lines are as in Figure 3.

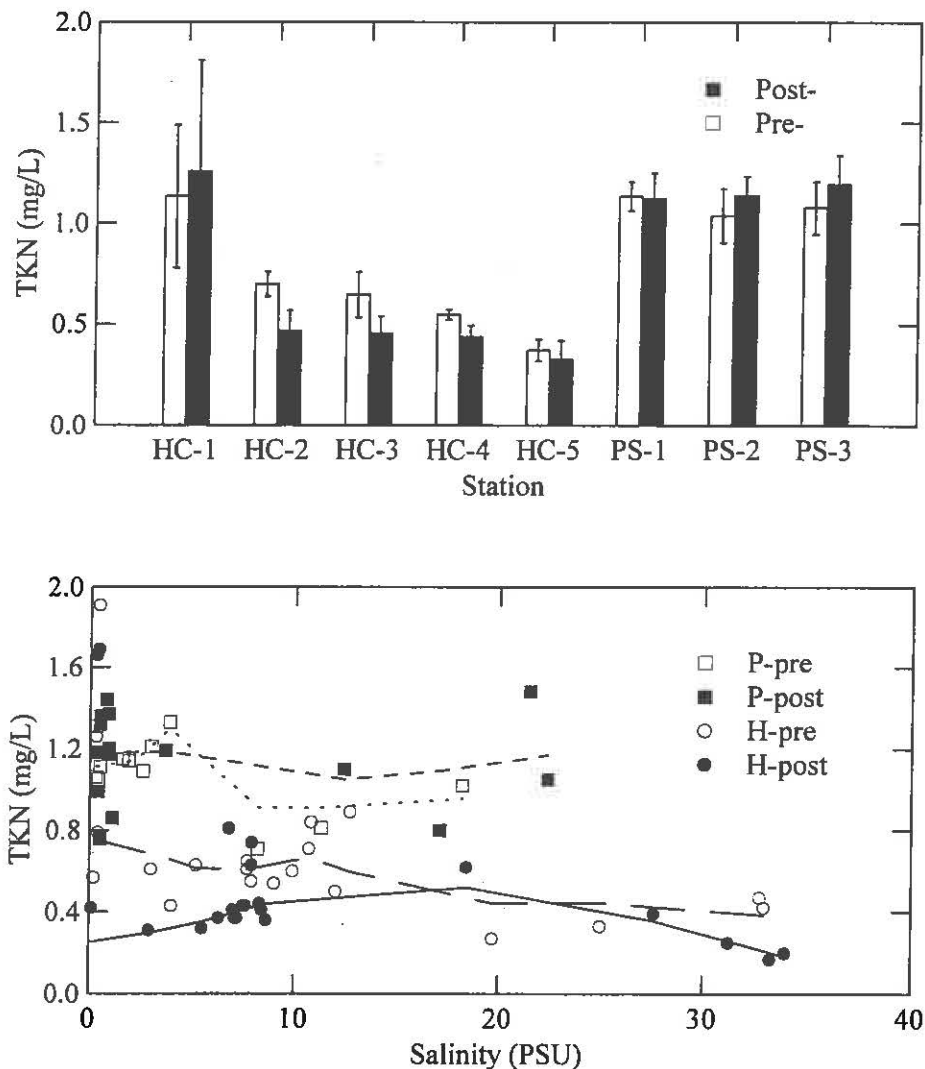
Total Kjeldahl Nitrogen (TKN; **Figure 9**) was also elevated at the Palma Sola stations and displayed little salinity dependence at either Hog or Palma Sola Creeks. A slight decrease in TKN was noted at the central stations of Hog Creek following restoration; decrease being higher at the upper stations.

**Figure 9.** A. Mean total Kjeldahl nitrogen concentration for pre- and post-restoration by station. B. Total Kjeldahl nitrogen concentration as a function of salinity - symbol lines are as in Figure 3.

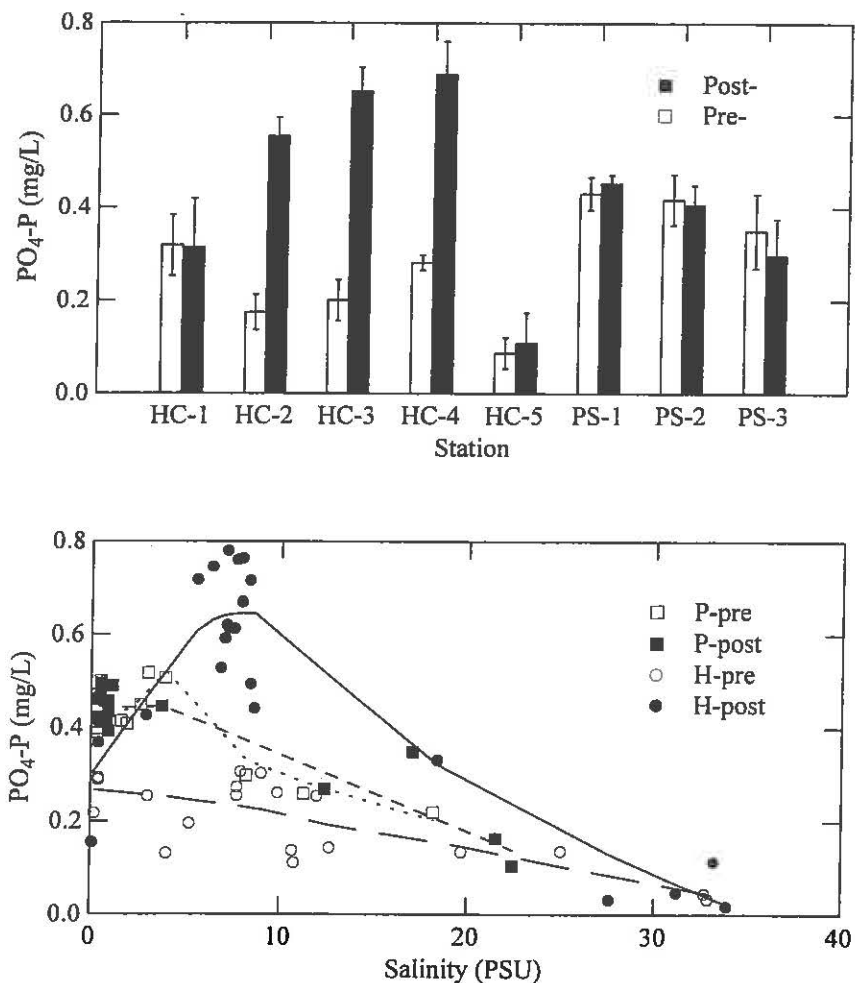
Before restoration, orthophosphate-phosphorus concentrations ( $\text{PO}_4\text{-P}$ ; **Figure 10**) at central Hog Creek stations were lower than those at the Palma Sola creek. The higher concentrations at Palma Sola may again be a result of drainage from Palma Sola golf course. The post-restoration

concentrations at central Hog stations were elevated almost three times, were most pronounced at HC-4, and all were higher than the Palma Sola concentrations. The increase was not attributable to water quality at HC-1 which remained similar for orthophosphate. As HC-2 represented the reject discharge almost exclusively, it was again likely that feed water quality or plant operations have changed. There was little change between pre- and post-restoration time periods for the Palma Sola stations. Increased levels of  $\text{PO}_4\text{-P}$  with distance downstream indicate that the restoration area (both before and after restoration) contribute  $\text{PO}_4\text{-P}$  to the water column. Dilution again reduces  $\text{PO}_4\text{-P}$  at HC-5 to low levels and relationships of  $\text{PO}_4\text{-P}$  with salinity converge for both Palma Sola and Hog Creeks.

**Figure 10.** A. Mean orthophosphate-phosphorus concentration for pre- and post-restoration by station. B. Orthophosphate-phosphorus concentration as a function of salinity - symbol lines are as in Figure 3.

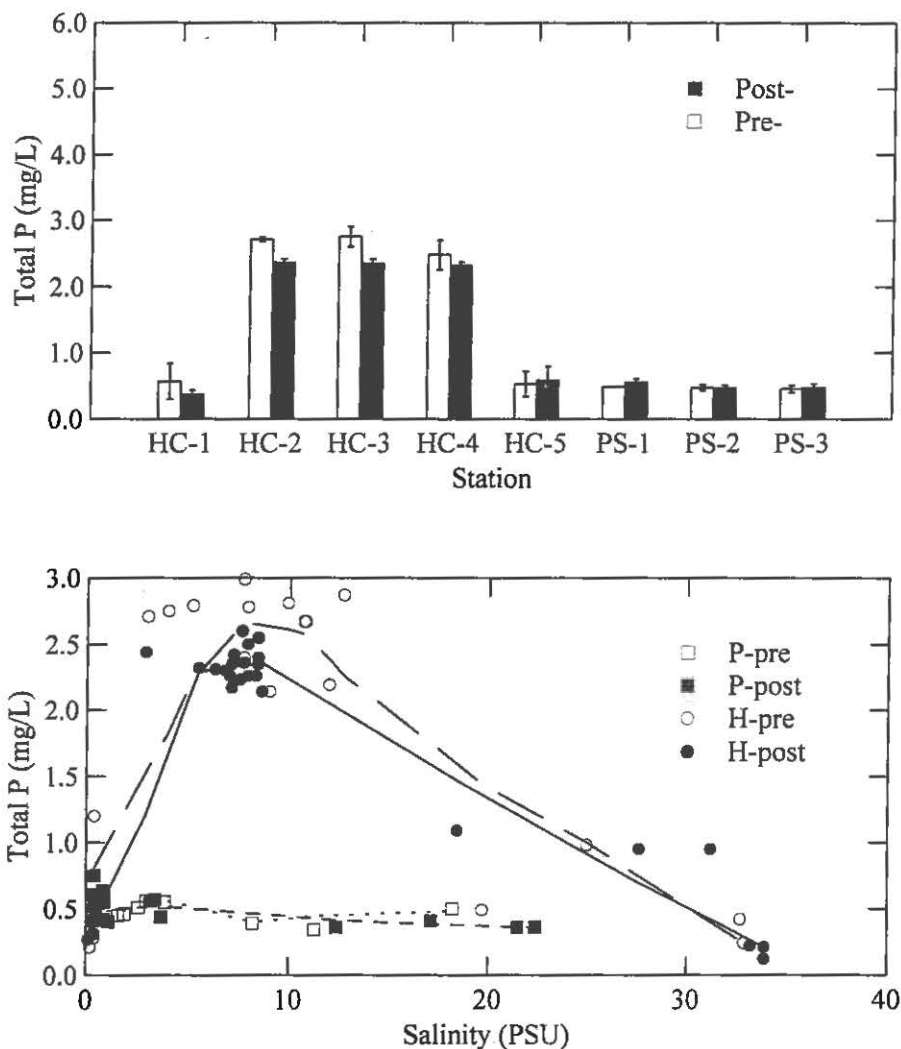
The total phosphorus concentrations however, of the central stations of Hog Creek (HC-2, HC-3 and HC-4) were all similar to one another and much higher than those of the HC-1, HC-5 or the Palma Sola Creek stations (**Figure 11**). The post-restoration concentrations at Hog Creek are slightly lower, the decrease is especially noted at HC-2 and HC-3, while the Palma Sola stations showed little change over time. The Palma Sola stations exhibited little salinity dependence, while the higher salinities at HC-5 apparently resulted in more dilution of total phosphorus and a resulting salinity dependence. Again total phosphorus concentrations of the two creeks converge at higher salinities. Ratios of total nitrogen to total phosphorus (TN:TP; **Figure 12**) show little change from pre- to post-

**Figure 11.** A. Mean total phosphorus concentration for pre- and post-restoration by station. B. Total phosphorus concentration as a function of salinity - symbol lines are as in Figure 3.

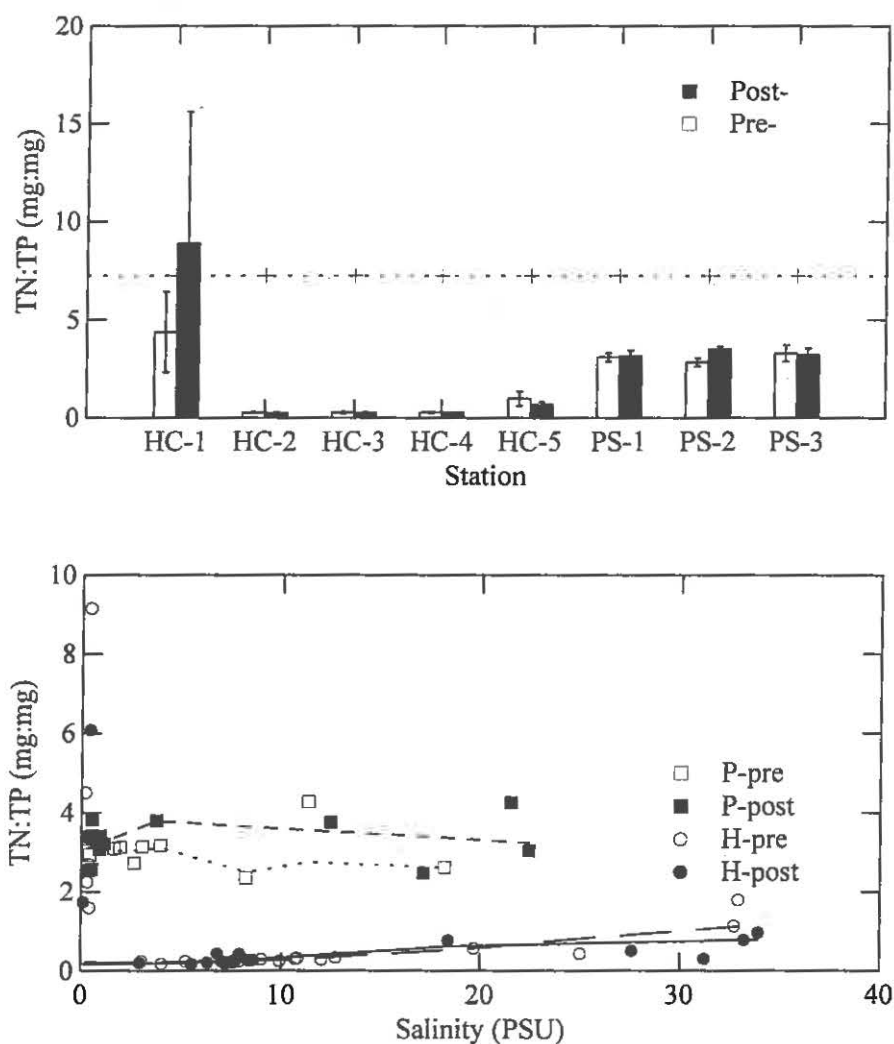
restoration time periods in either creek. Almost all values are below 7.2 mg:mg, indicating a nitrogen limited system. Due to the elevated phosphorus concentrations in Hog Creek, TN:TP ratios were even lower there, except at HC-1 where high nitrate-nitrite-nitrogen levels increased the ratios.

**Figure 12.** A. Mean total nitrogen : total phosphorus for pre- and post-restoration by station. B. Total nitrogen : total phosphorus as a function of salinity - symbol lines are as in Figure 3.

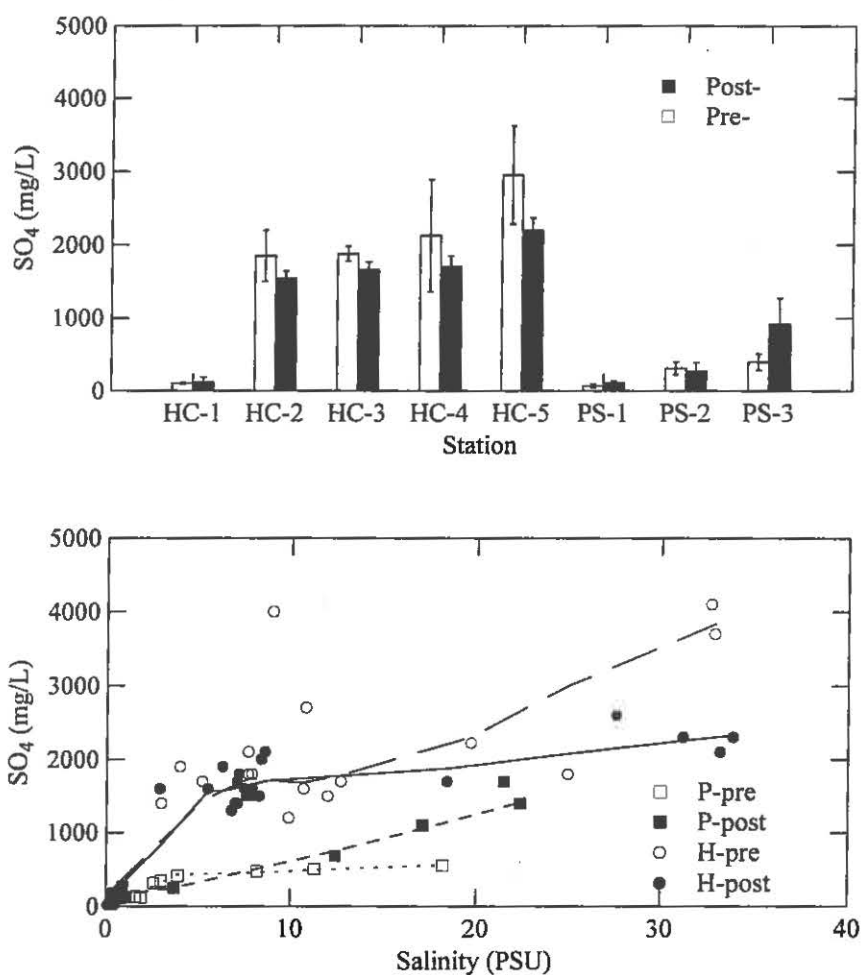
Sulfates ( $\text{SO}_4$ ), with higher concentrations in seawater, exhibit reverse gradients when compared to nutrient data and should exhibit nearly linear increases with salinity. While sulfate concentrations (**Figure 13**) at high and low salinities are comparable for Hog and Palma Sola Creeks, and for both pre- and post-restoration, the central Hog Creek stations have sulfate concentrations elevated above that expected for the observed salinities. Stations HC-2, HC-3 and HC-4 were higher than the equivalent Palma Sola Creek stations. Concentrations at HC-5 are near the oceanic average values of 2700 mg/L and where one would expect based on a linear extrapolation of the Palma Sola  $\text{SO}_4$ :salinity relationship. Differences between pre- and post-restoration for both creeks were generally not noteworthy.

**Figure 13.** A. Mean sulfate concentration for pre- and post-restoration by station. B. Sulfate concentration as a function of salinity - symbol lines are as in Figure 3.

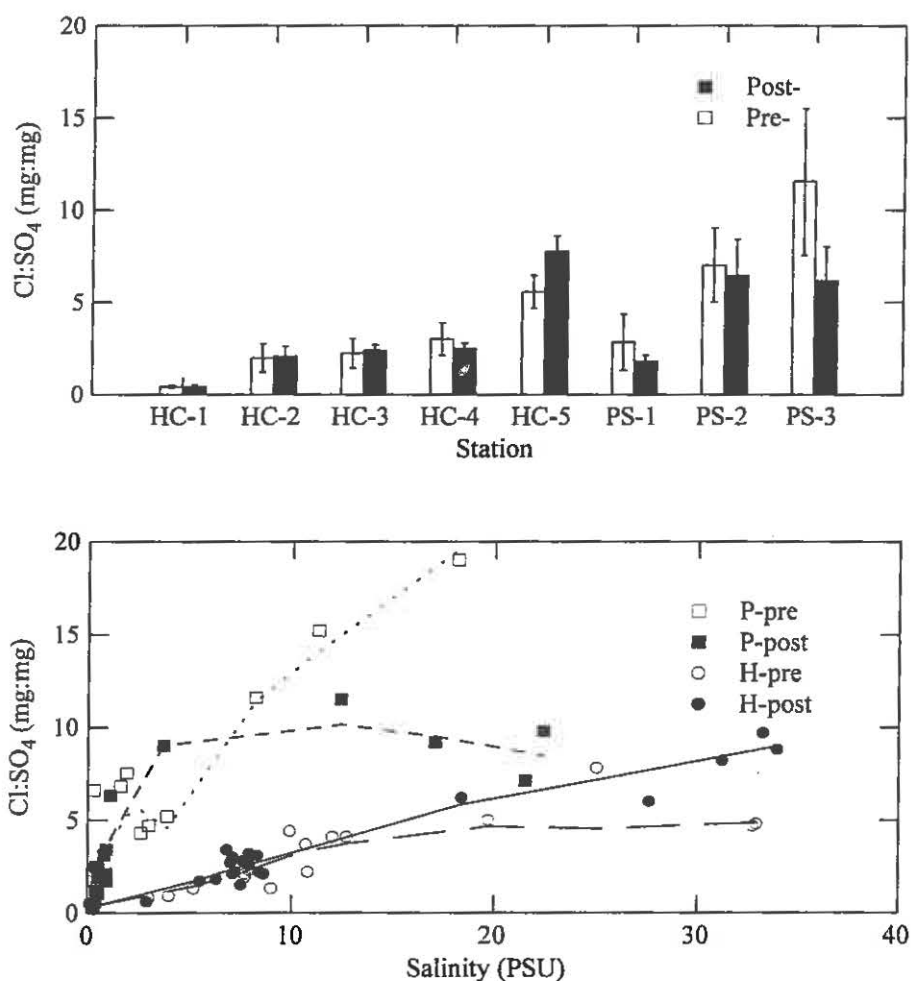
As a result of the elevated  $\text{SO}_4$  concentrations, the chloride:sulfate ratios ( $\text{Cl}:\text{SO}_4$ ) of the central Hog Creek stations were smaller than for the comparable salinities at the Palma Sola stations (Figure 14). Again pre- to post-restoration differences were generally not noteworthy. The ratios at PS-1 were larger than at HC-1 and were attributable to elevated chloride concentrations that are characteristic of treated domestic wastewater and to the overall low concentration of ions at these two stations. A number of the pre-restoration samples from Palma Sola Creek were complicated by the intense stratification at this site. Sample fractions were such that chloride and laboratory salinity were analyzed from one container, and sulfate from another. Discrepancies in water masses samples between the two containers resulted in higher than normal  $\text{Cl}:\text{SO}_4$  ratios for Palma Sola Creek. Later samples where an intermediate container was used, have similar ratios of  $\text{Cl}:\text{SO}_4$  for both PS-3 and HC-5 and both near the oceanic mean of 7.2.

**Figure 14.** A. Mean chloride : sulfate for pre- and post-restoration by station. B. Chloride : sulfate as a function of salinity - symbol lines are as in Figure 3.

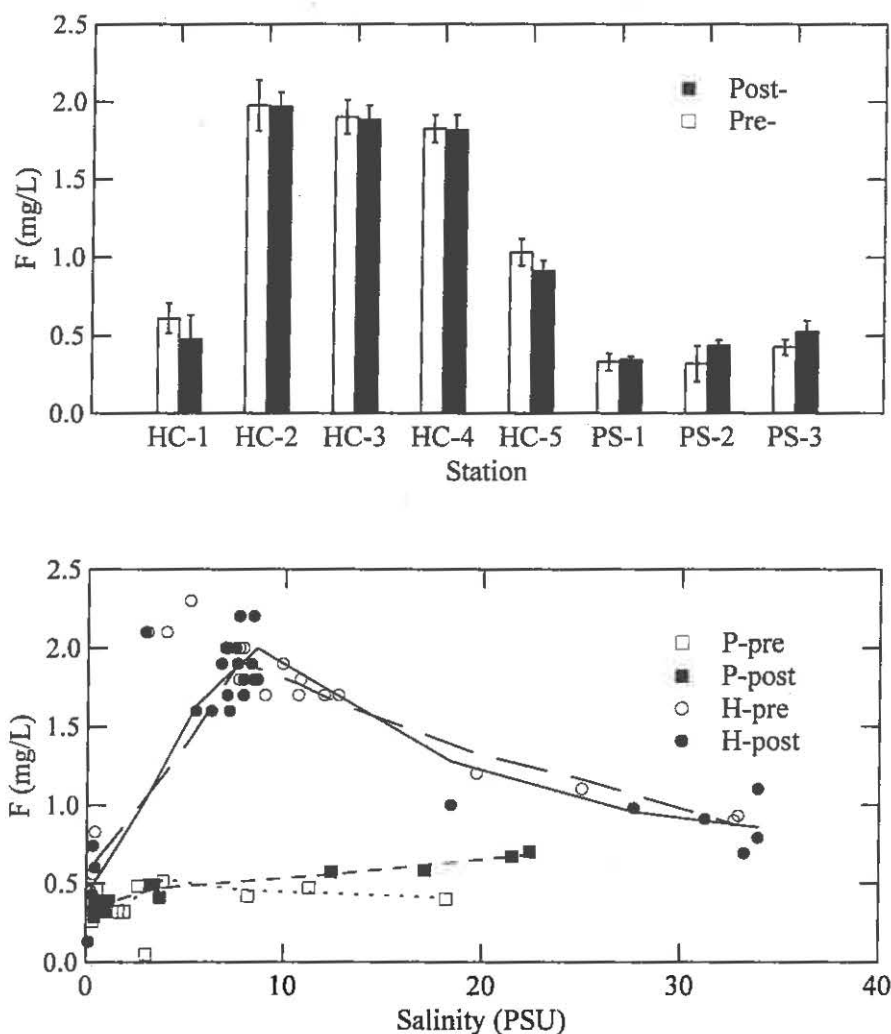
Fluoride concentrations (**Figure 15**) were remarkably stable over the study period at all sites. The central Hog Creek stations were elevated due to the reject water and were higher than those of Palma Sola Creek, but all were lower than the Class III marine criteria of 5 mg/L. The concentrations declined with an increase in salinity at Hog Creek and increased with increasing salinity in Palma Sola Creek. Both creek systems converge to similar values at higher salinities.

**Figure 15.** A. Mean fluoride concentration for pre- and post-restoration by station. B. Fluoride concentration as a function of salinity - symbol lines are as in Figure 3.

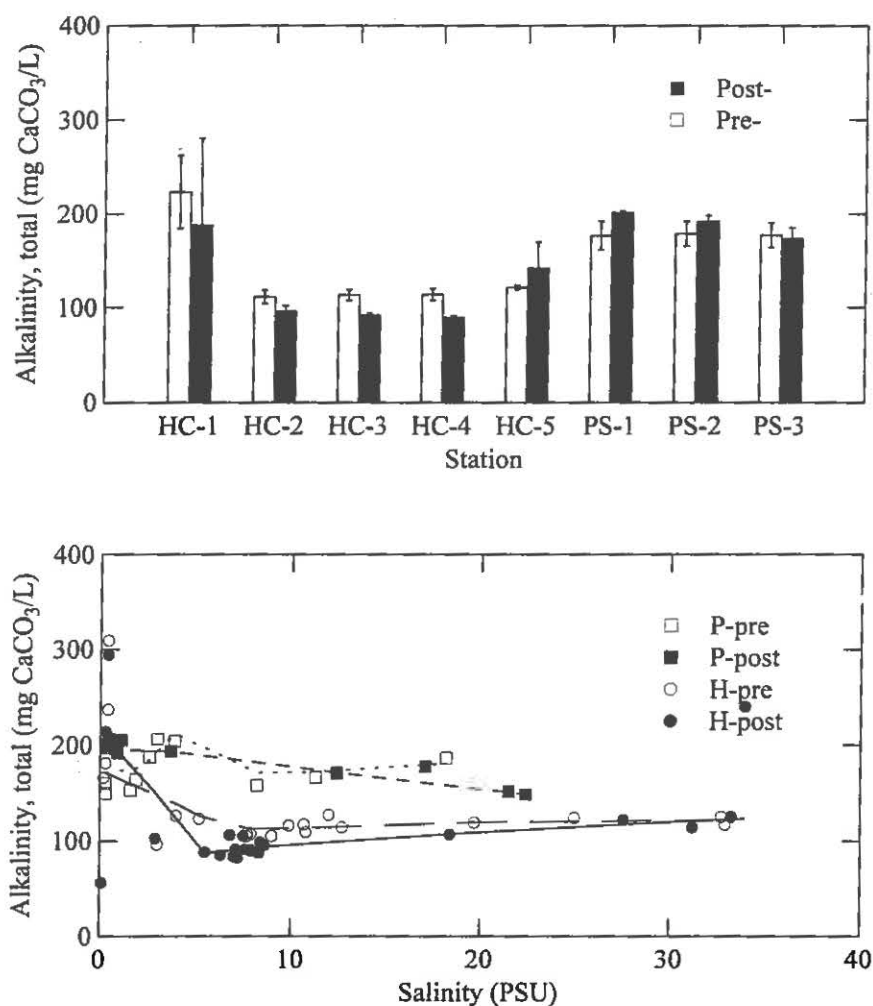
Alkalinity (**Figure 16**) was depressed at the central Hog Creek stations, below both HC-1 and all the Palma Sola stations. Post-restoration values at HC-2 to HC-4 were lower than pre-restoration values implying a change in plant operation and little attenuation within the creek itself. Values of alkalinity from both creek systems converged at higher salinities.

**Figure 16.** A. Mean total alkalinity concentration for pre- and post-restoration by station. B. Total alkalinity concentration as a function of salinity - symbol lines are as in Figure 3.

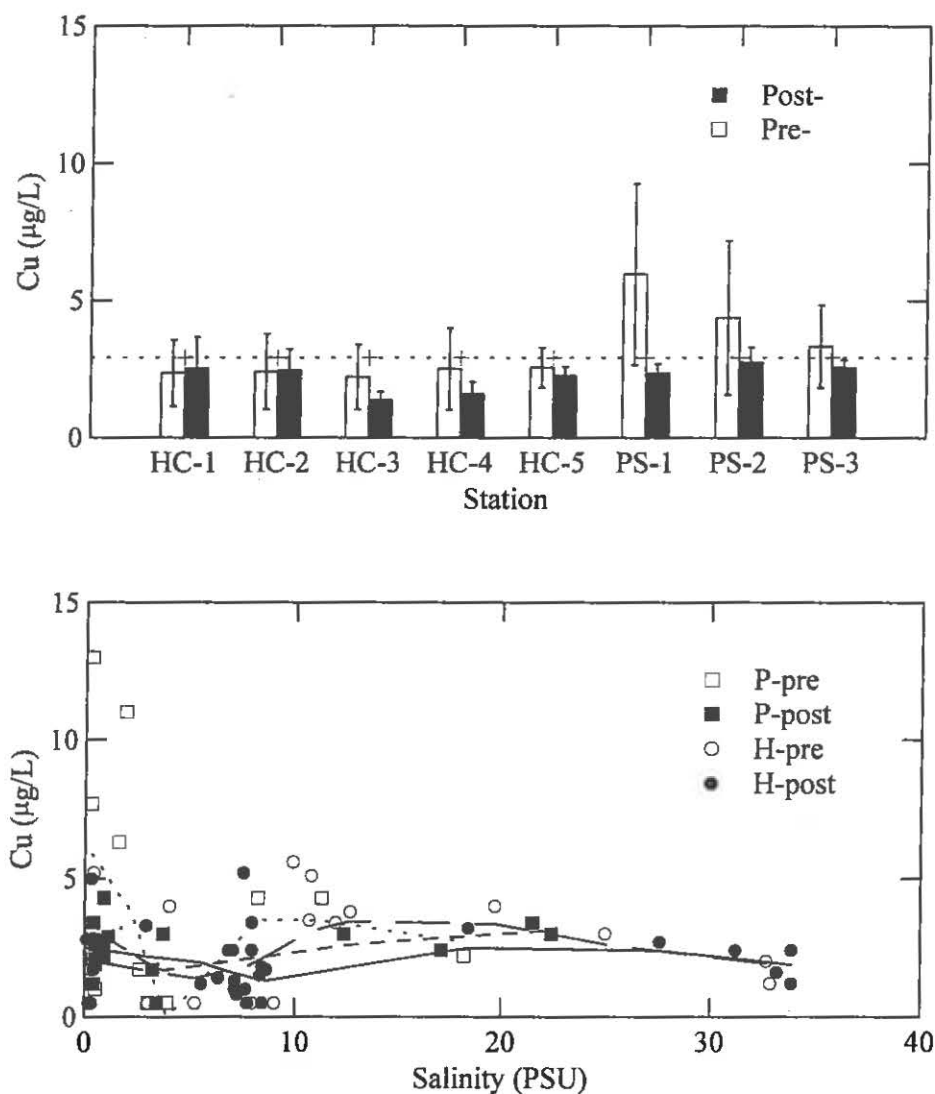
All of the stations, had concentrations exceeding the Class III marine criteria of 2.9 mg/L for copper (Cu; **Figure 17**). There was little salinity dependence for either creek and salinity relationships were generally comparable between systems at the higher salinity values. Palma Sola Creek, Stations PS-1 and PS-2 had particularly elevated copper concentrations during the pre-restoration period. Copper is again a common contaminant in treated domestic wastewater.

**Figure 17.** A. Mean copper concentration for pre- and post-restoration by station (Class III marine criteria = 2.9 µg/L). B. Copper concentration as a function of salinity - symbol lines are as in Figure 3.

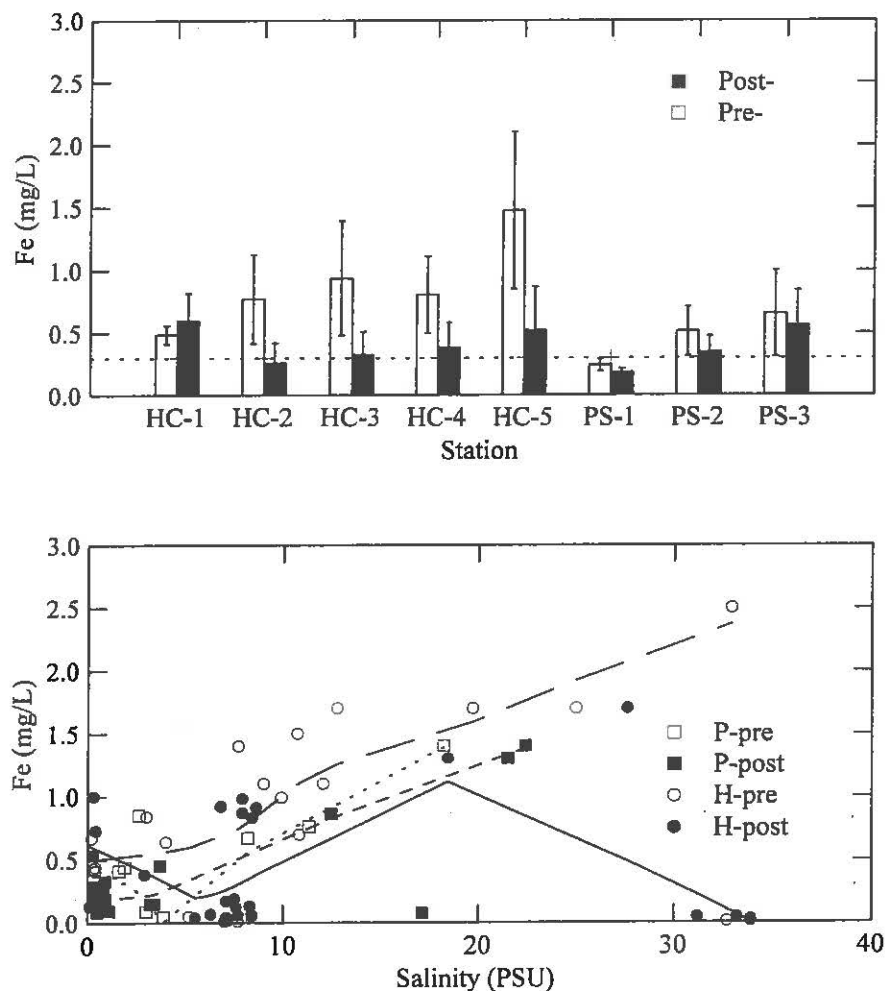
Iron concentrations (Fe; **Figure 18**) generally declined between pre- and post-restoration periods, particularly for the Hog Creek stations. Declines again appear related to plant operations. Interestingly, levels increased with increasing salinity and based on the Fe:salinity relationships, there was little difference between Hog and Palma Sola Creeks. Iron levels were depressed at HC-5 during a number of the post-restoration samplings and may reflect uptake by phytoplankton. Many samples were above the Class III marine criteria of 0.3 mg/L.

**Figure 18.** A. Mean iron concentration for pre- and post-restoration by station (Class III marine criteria = 0.3 mg/L). B. Iron concentration as a function of salinity - symbol lines are as in Figure 3.

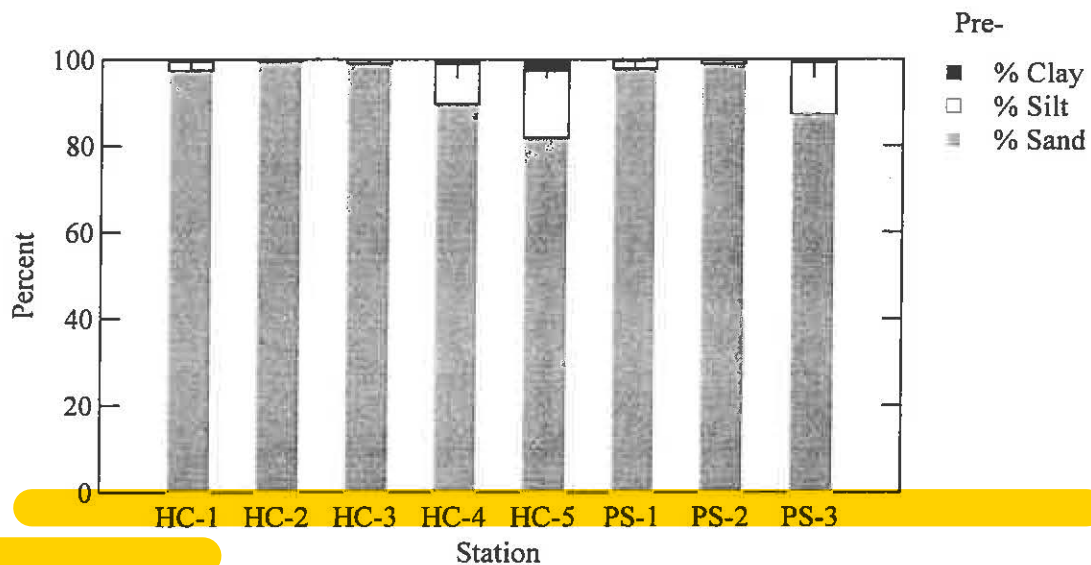
Pre- restoration sediments were predominantly sandy (Figure 19); percent sand was highest under the high energy conditions of HC-2 and HC-3. Based on sand content, HC-4 experienced a reduction in energy, with a larger fraction of silts and clays at HC-5. Palma Sola sediments were also predominantly sandy, with a larger fraction of fines where the channel opened (PS-3). While high flows were not observed in Palma Sola Creek during any sampling, the coarse grain size indicates either occasional high flows or a lack of fines contributed to the system.

**Figure 19.** Percent particle size distribution - pre-restoration by station.

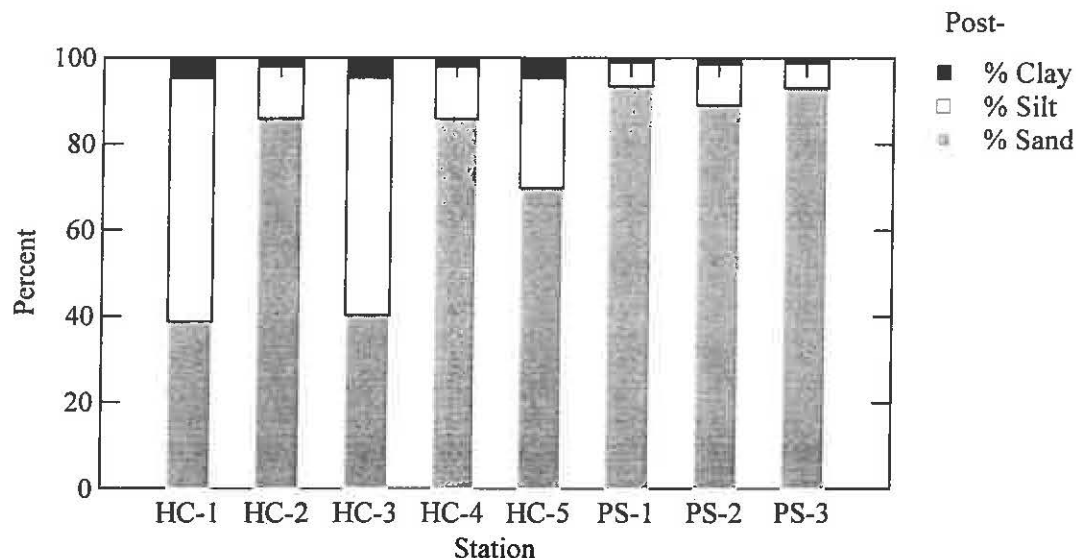
Following restoration (**Figure 20**), sediments at a number of stations had increased in the proportion of fine grain sized material. Changes in both creeks may be related either to construction activities and/or the relatively dry conditions experienced during the post-restoration time period. Enlargement of the mixing pool on Hog Creek created a lower velocity environment that would permit fine sediments to settle and accumulate, especially at HC-2 and HC-3. Increases in fines at HC-1, where restoration construction activities should be minimal, indicated that either watershed activities or system heterogeneity resulted in varying fines. In an area that should have been the most stable, HC-5, percent silt and clay fraction combined almost doubled. It is possible that construction or watershed activities contributed a thin veneer of fine sediment to the region.

**Figure 20.** Percent particle size distribution - post-restoration by station.

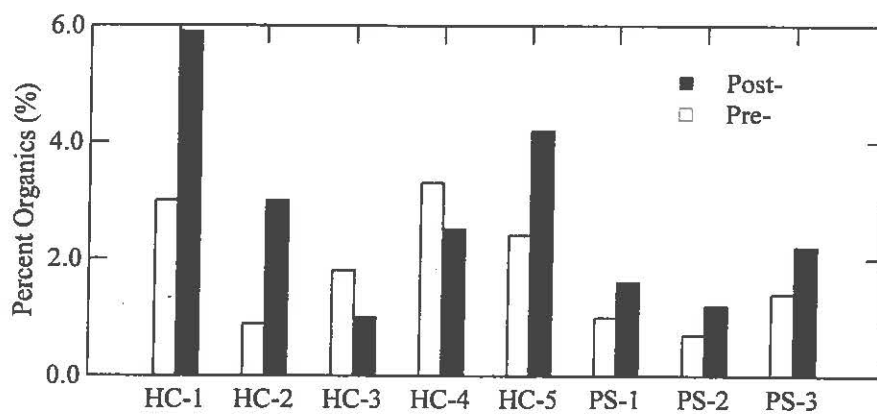
At some stations (HC-1, HC-2, and HC-5), the increase in fines was accompanied by an increase in percent organics (**Figure 21**). Changes in organics at these three stations were greater than the increases observed in Palma Sola Creek. Similarly, total organic carbon (TOC; **Figure 22**) also increased at several stations, with increases at HC-2 and HC-4 greater than that observed in Palma Sola Creek. In particular, the high post-restoration TOC value at HC-4 indicates that some of the organic material present was of a relatively coarse size fraction and non-homogenously distributed.

**Figure 21.** Percent organic content for pre- and post-restoration by station.
