**WATER AND SEDIMENT SAMPLE  
COLLECTION AND ANALYSES  
JULY 1999 - JULY 2002  
PRE- AND POST-RESTORATION COMPARISON**

**HOG CREEK, SARASOTA, FL,  
AND  
PALMA SOLA CREEK, BRADENTON, FL**

**Mote Marine Laboratory Technical Report No. 854**

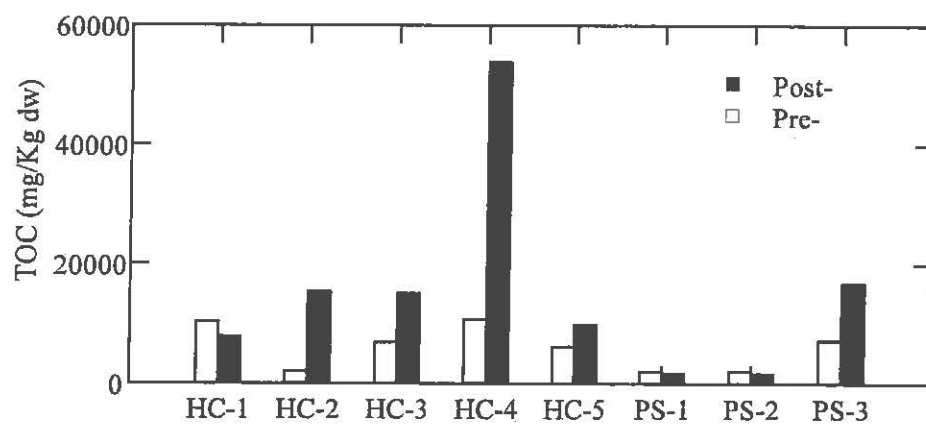
**Figure 22.** Total organic carbon content for pre- and post-restoration by station

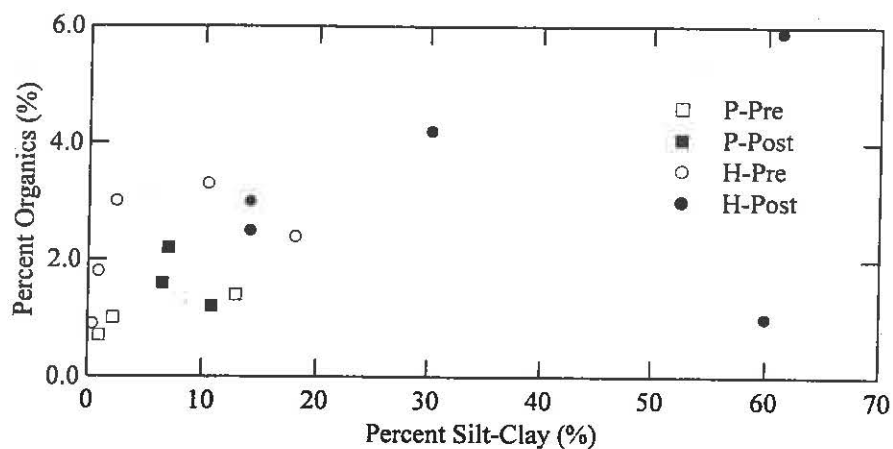
A plot of percent organics (**Figure 23**) as a function of percent silt-clay size fraction indicates that pre-restoration Palma Sola stations were roughly comparable to post-restoration values. Pre-restoration Hog Creek stations were relatively higher in percent organics than the Palma Sola stations of similar grain size distributions. Following restoration, the Hog Creek stations increased the percentage of fines without increasing the organic content, particularly for Station HC-3. The high organics at post-restoration HC-1 appears to be similar in ratio to the increase in fines observed. Changes in HC-1, therefore were attributed to sampling a heterogeneous environment, while changes at the lower Hog Creek stations were attributed to an increase in mineral fines in the sediments. This postulate is consistent with the exposure of a different, finer sediment during the excavation of the mixing pool.

**Figure 23.** Percent organic content as a function of percent silt and clay for pre- and post-restoration.

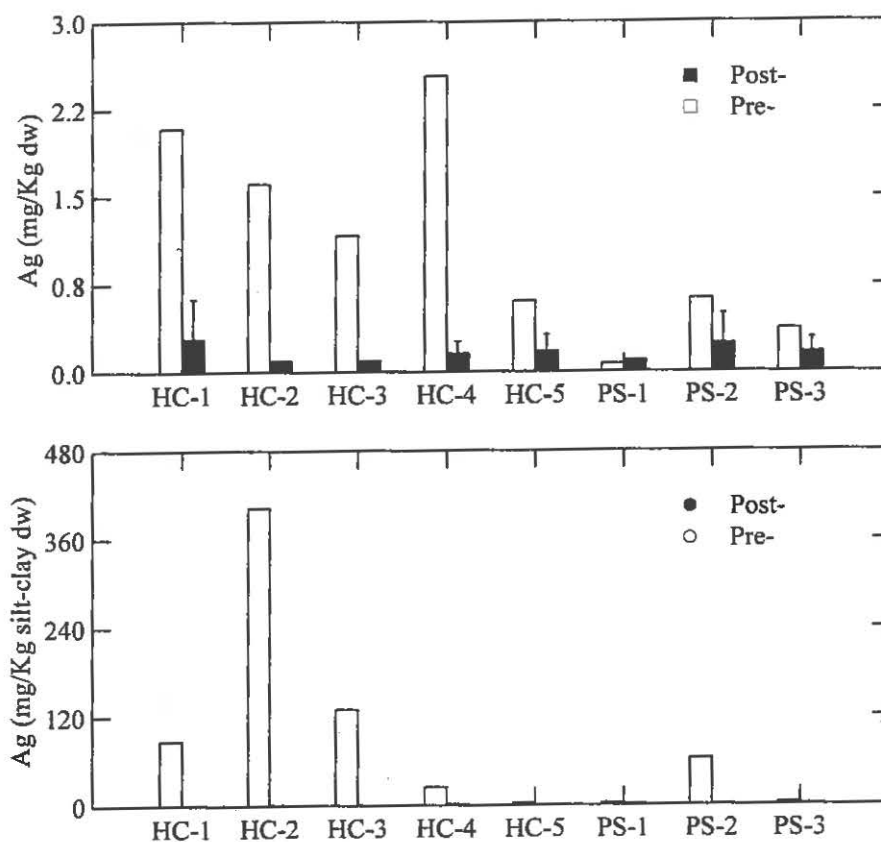
**Figure 24.** A. Bulk silver concentration for pre- and post-restoration by station. B. Silver content normalized by percent silt and clay for pre- and post-restoration by station.

For arsenic, lead, and copper, one station in Hog Creek would have a single elevated concentration indicating heterogeneous distribution. The elevated concentrations, however, were at different stations (HC-3 and HC-4) and during different time periods. In order to view the remaining stations, these elevated values were not illustrated in **Figure 24** through **33**.

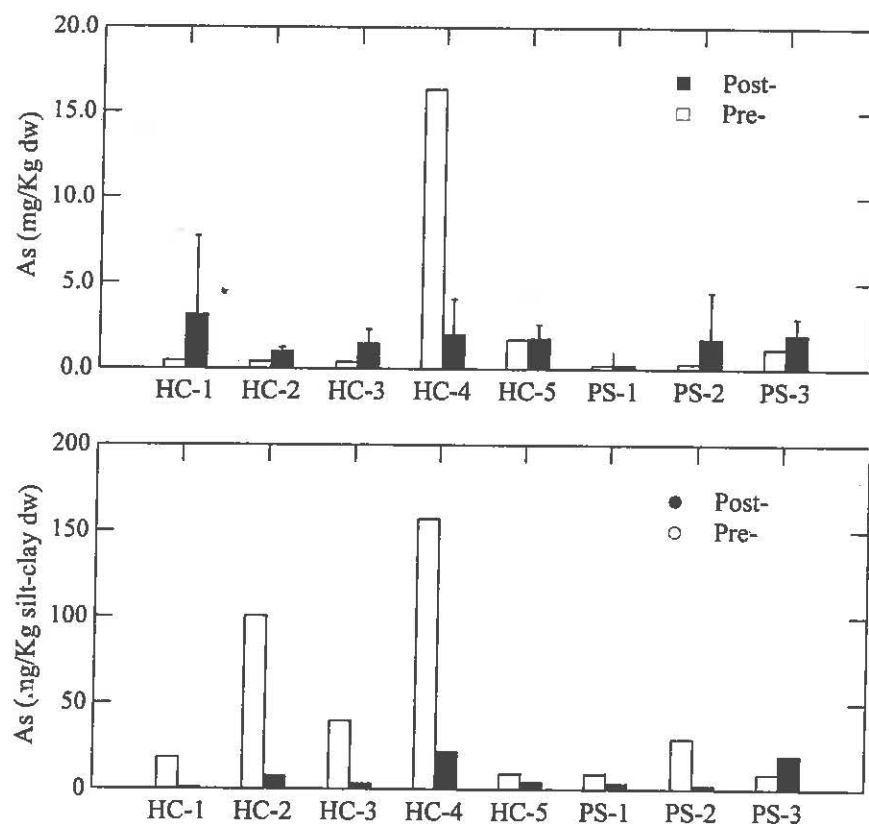
**Figure 25.** A. Bulk arsenic concentration for pre- and post-restoration by station. B. Arsenic content normalized by percent silt and clay for pre- and post-restoration by station.

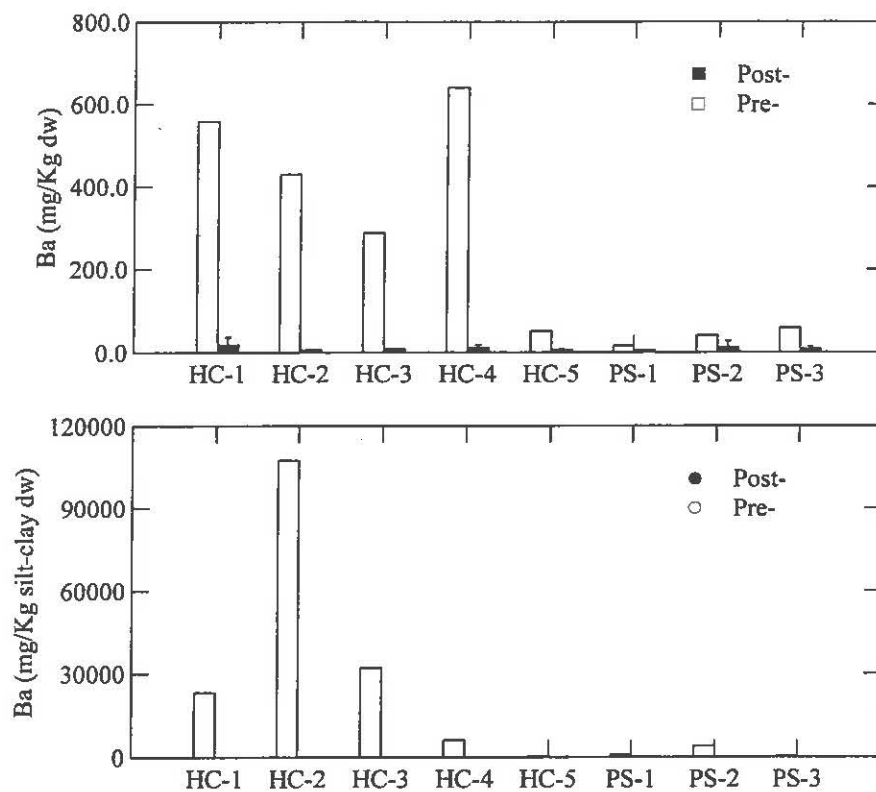
**Figure 26.** A. Bulk barium concentration for pre- and post-restoration by station. B. Barium content normalized by percent silt and clay for pre- and post-restoration by station.

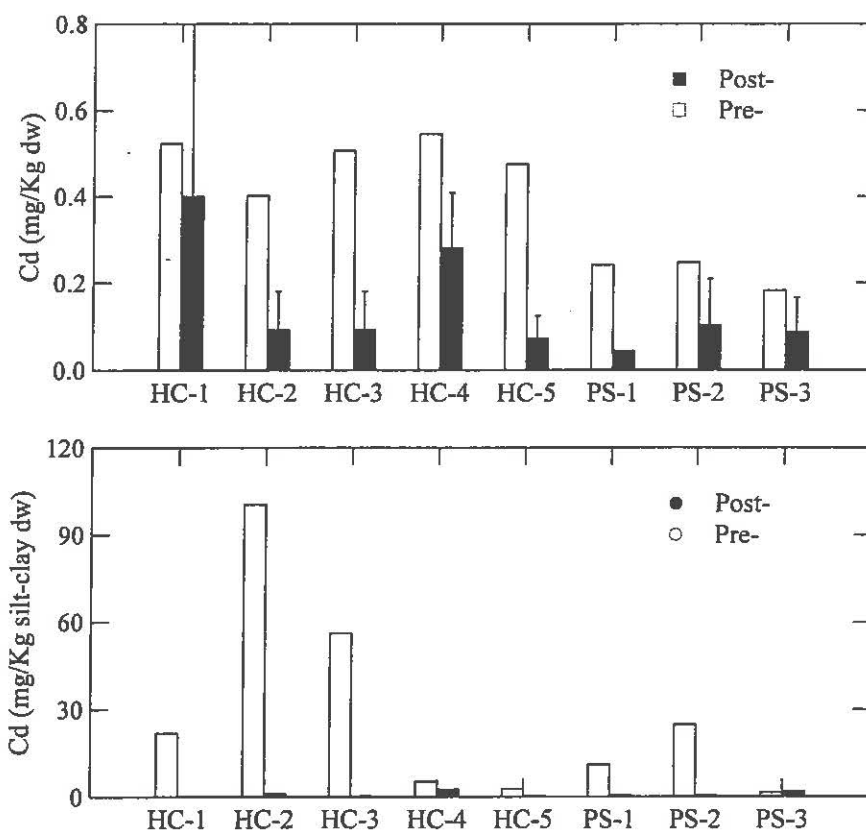
**Figure 27.** A. Bulk cadmium concentration for pre- and post-restoration by station. B. Cadmium content normalized by percent silt and clay for pre- and post-restoration by station.

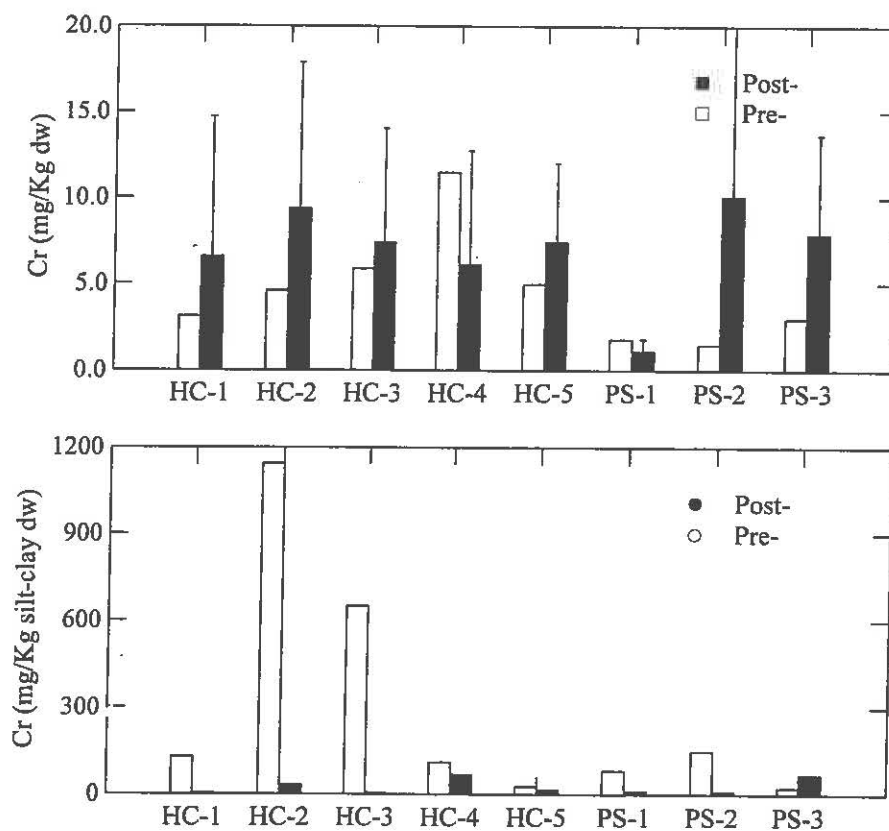
**Figure 28.** A. Bulk chromium concentration for pre- and post-restoration by station. B. Chromium content normalized by percent silt and clay for pre- and post-restoration by station.

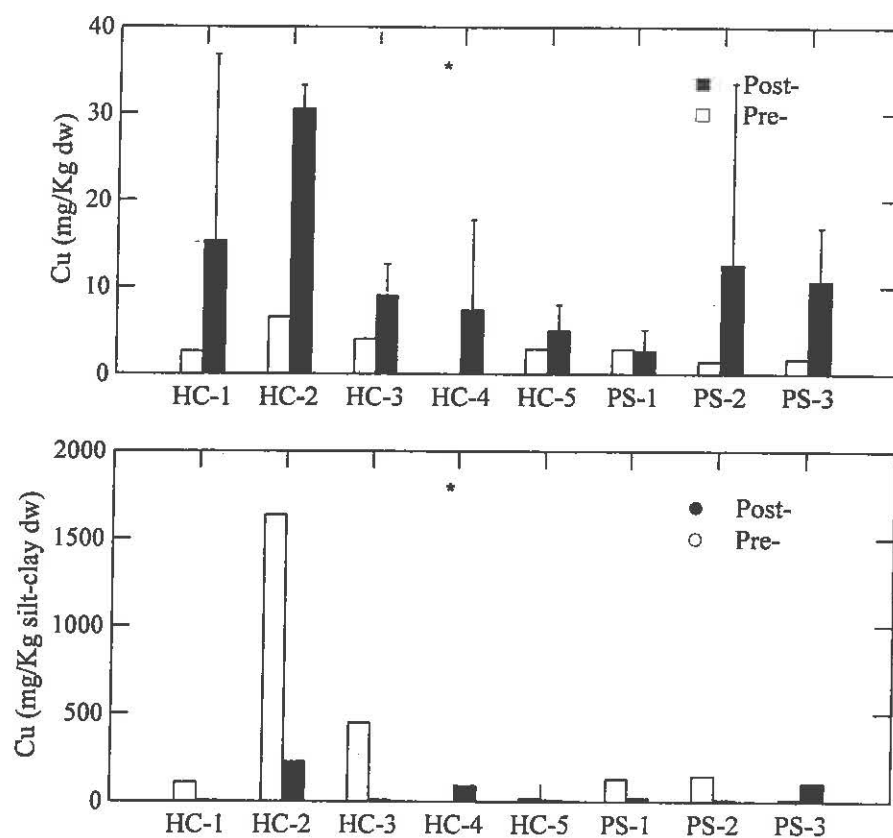
**Figure 29.** A. Bulk copper concentration for pre- and post-restoration by station. \*- indicates an outlier value not incorporated in the plot. B. Copper content normalized by percent silt and clay for pre- and post-restoration by station. \*- indicates an outlier value not incorporated in the plot.

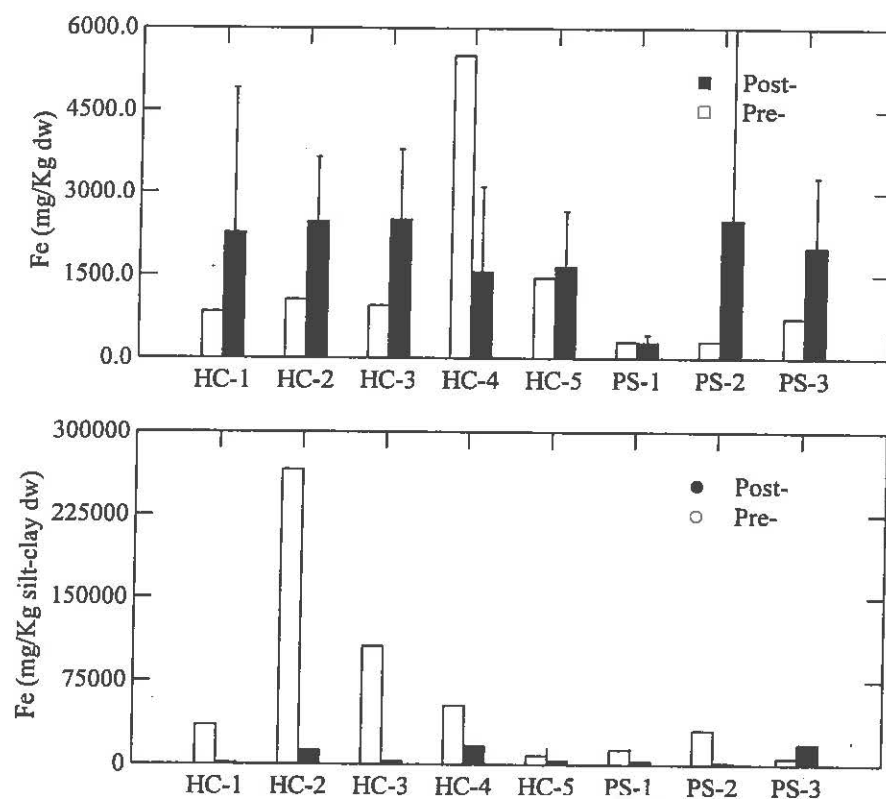
**Figure 30.** A. Bulk iron concentration for pre- and post-restoration by station. B. Iron content normalized by percent silt and clay for pre- and post-restoration by station.

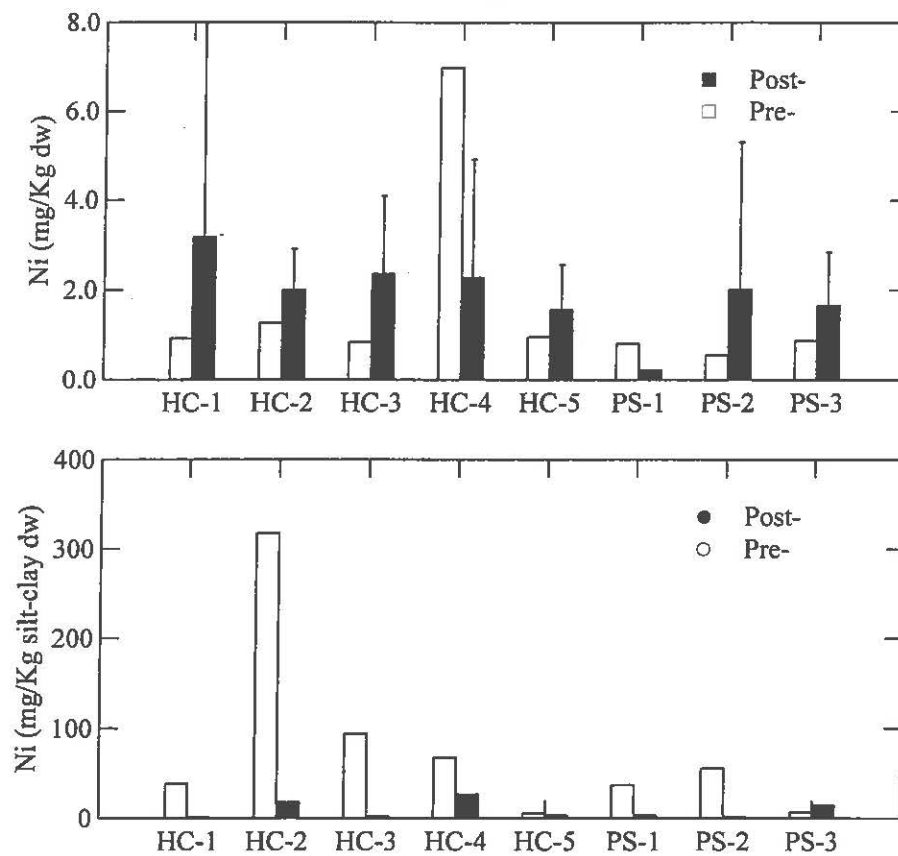
**Figure 31.** A. Bulk nickel concentration for pre- and post-restoration by station. B. Nickel content normalized by percent silt and clay for pre- and post-restoration by station.

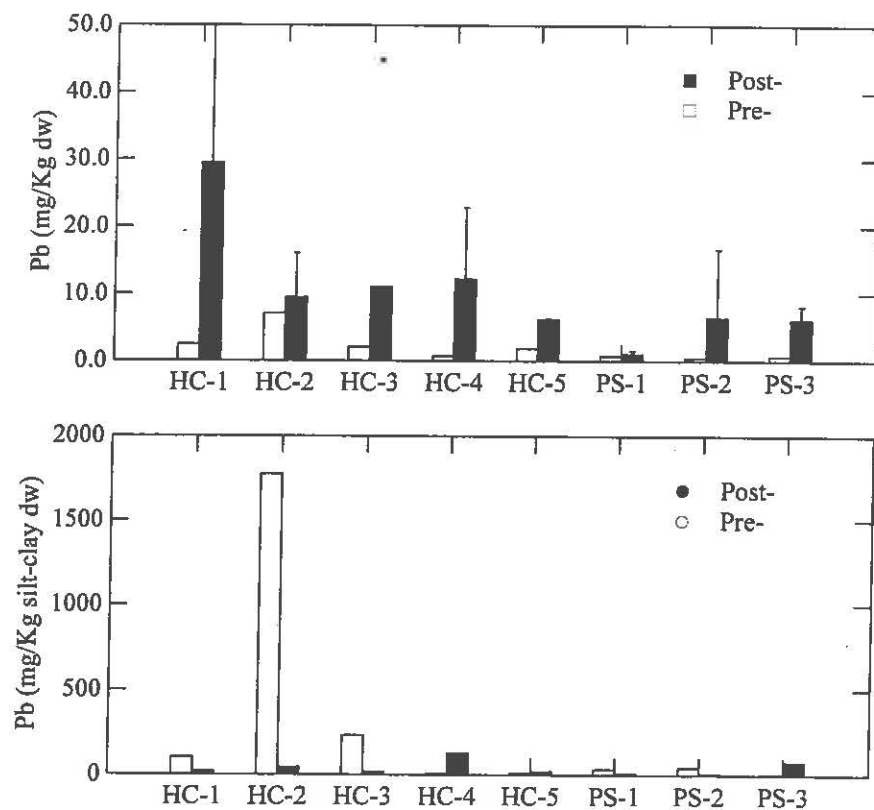
**Figure 32.** A. Bulk lead concentration for pre- and post-restoration by station. \*- indicates an outlier value not incorporated in the plot. B. Lead content normalized by percent silt and clay for pre- and post-restoration by station.

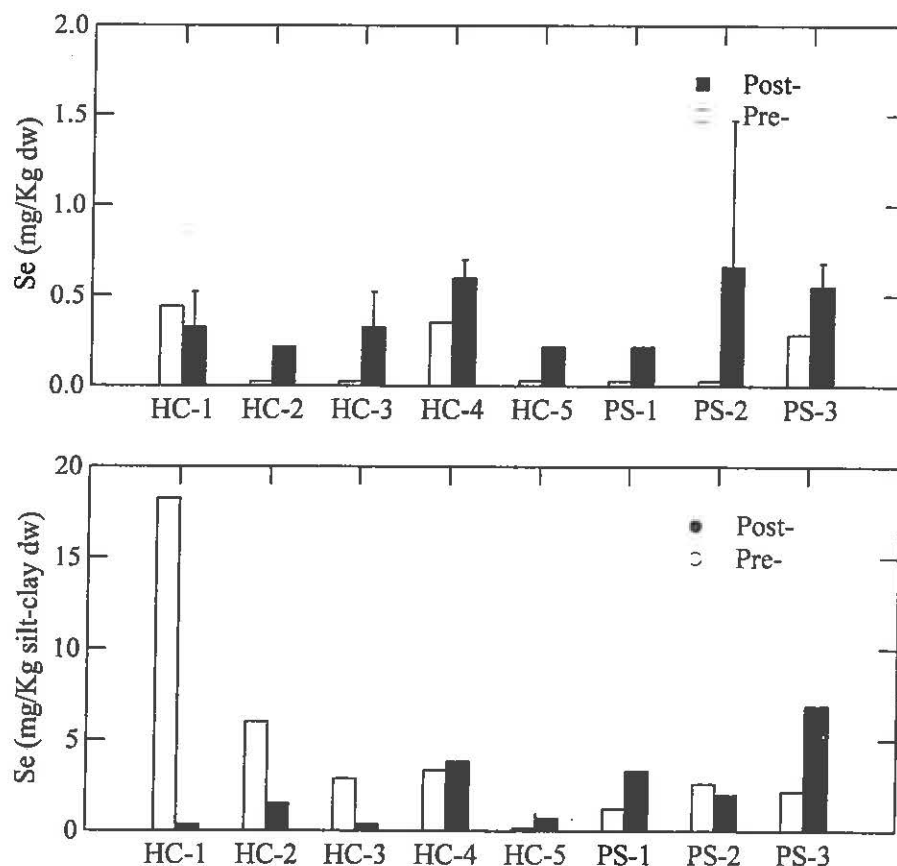
**Figure 33.** A. Bulk selenium concentration for pre- and post-restoration by station. B. Selenium content normalized by percent silt and clay for pre- and post-restoration by station.

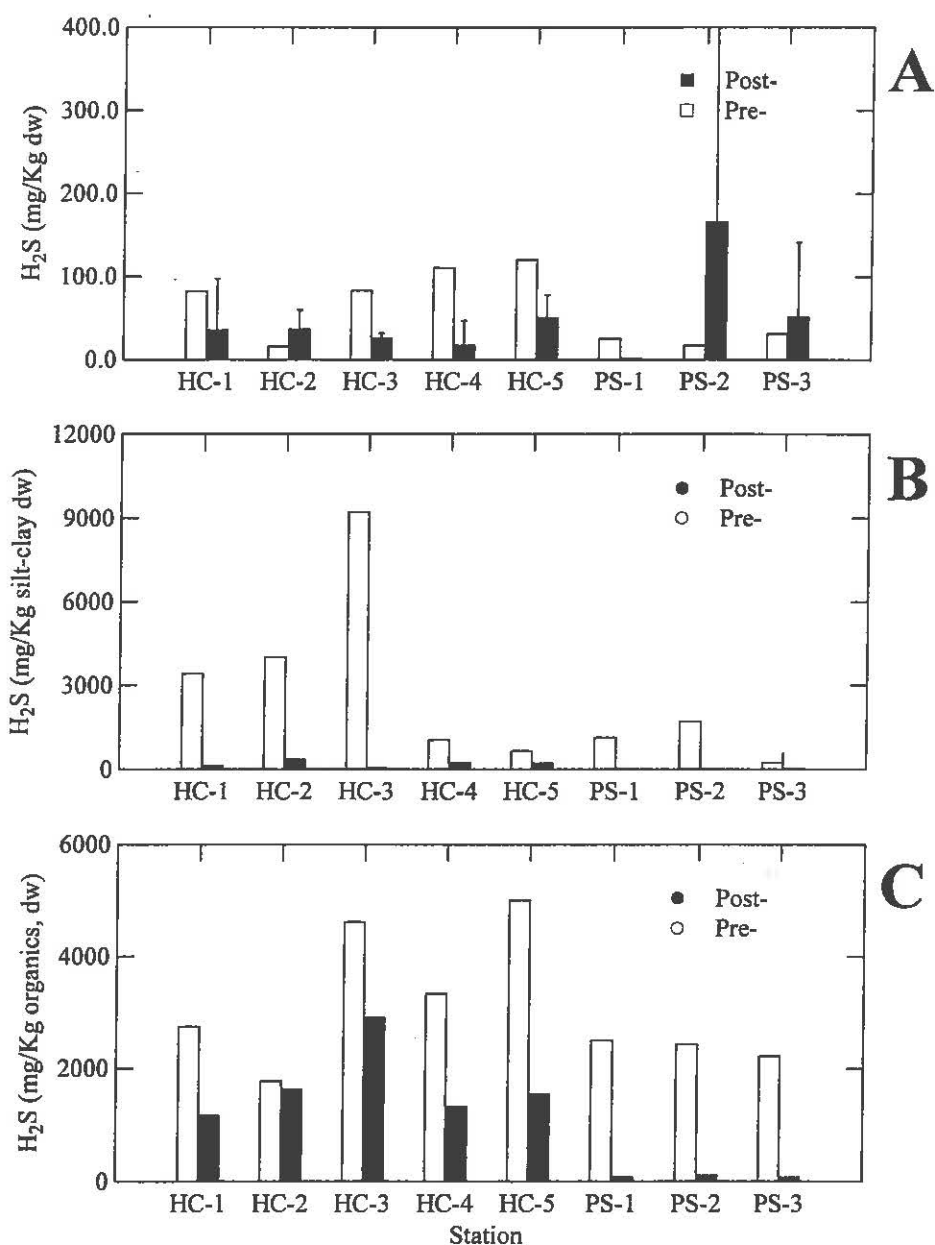
Sediment sulfides ( $H_2S$ ; **Figure 34**) presented a comparable picture to metal concentrations. Normalized to silt-clay sized material, Station HC-3, pre-restoration, had the maximum concentration. For bulk values and concentrations normalized to either percent silt-clay or to percentage organics, post-restoration values in Hog Creek were generally lower and approached values observed in Palma Sola creek.

**Figure 34.** A. Bulk hydrogen sulfide concentration for pre- and post-restoration by station. B. Hydrogen sulfide content normalized by percent silt and clay for pre- and post-restoration by station. C. Hydrogen sulfide content normalized by percent organics for pre- and post-restoration by station.
