RED BUG SLOUGH RESTORATION (W624)
FINAL PROJECT REPORT

Hydrologic Modeling Report for Red Bug Slough Preserve Restoration Project

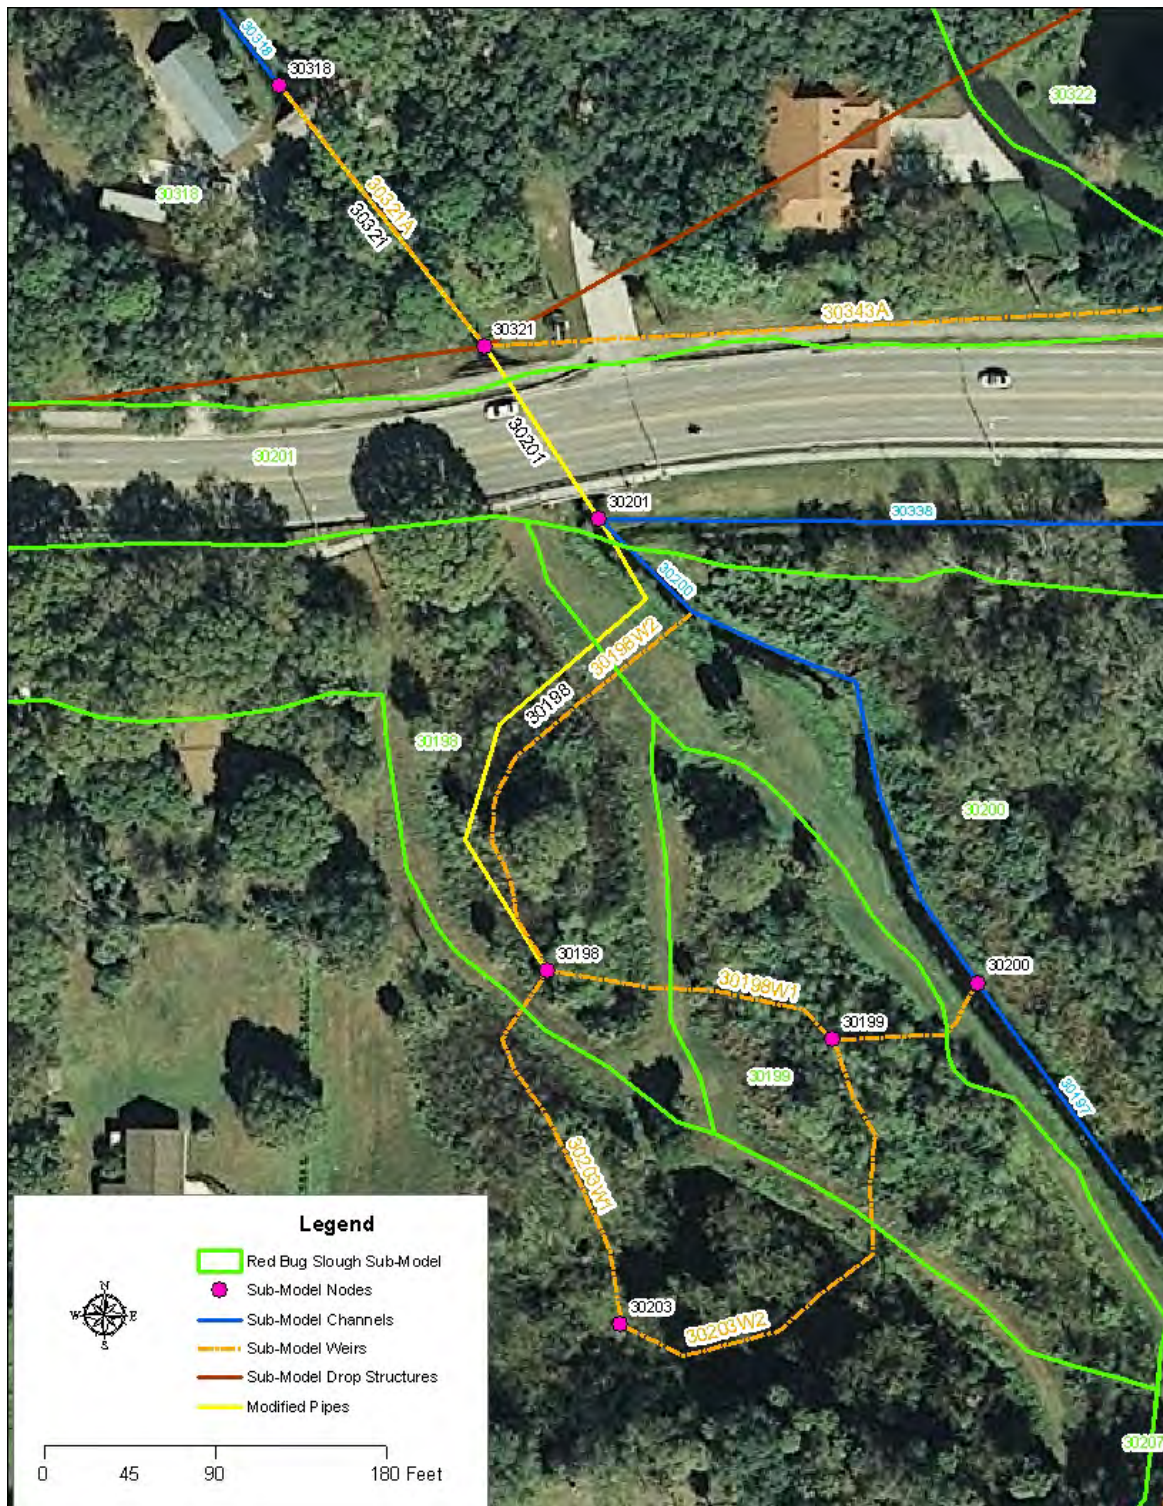
Figure 3. Area of Modeled Proposed Improvements (Restoration Area 1)

Improvements to RBS are considered in the areas shown in Figure 3 and in the plan sheets from the 30% Plan set located in the Appendix. The objectives of the proposed modifications to the system are to:

The following changes were made to the model to evaluate the benefits of these proposed modifications.

1. The cross-section of RBS between Stations 13+00 and 46+30 will be modified to include a littoral shelf. The shelf will be at an elevation of 15 feet NGVD and will be approximately 10 feet wide.

2. Re-grade the western bank of the RBS near Station 42+00. There is a natural depression in the bank that allows the adjacent wetland to drain quickly after a storm event. The natural depression has a low point at elevation 15.25 NGVD that connects basin 30199 to the channel. This will be re-graded to a consistent elevation of 16.1 feet NGVD. The model assumes that a 50 foot long weir is installed in the re-graded berm at elevation 16.1 ft NGVD.

3. Build flow ways to connect basins 30199 and 30203. The model assumes a 50-foot wide flow way at an invert elevation of 14.1 NGVD.
4. Build a flow way to connect basins 30203 and 30198. The model assumes a 25-foot wide flow way at invert elevation 14.1 NGVD.

5. Water is allowed to leave the wetland systems adjacent to RBS via an 8-inch diameter pipe with upstream invert of 15.6 feet and a downstream invert of 15.0 ft NGVD.
