Technical Memo

To: Ben Quartermaine, P.E., Engineering and Operations Manager, Sarasota County Public Utilities

From: Mary Szafraniec, PhD, PWS, Senior Scientist, Amec Foster Wheeler
John Kiefer, PhD, PE, Principal Engineer, Amec Foster Wheeler
Project No. 600048.2

Re: Task 3: Phillippi Creek Channel System Classification

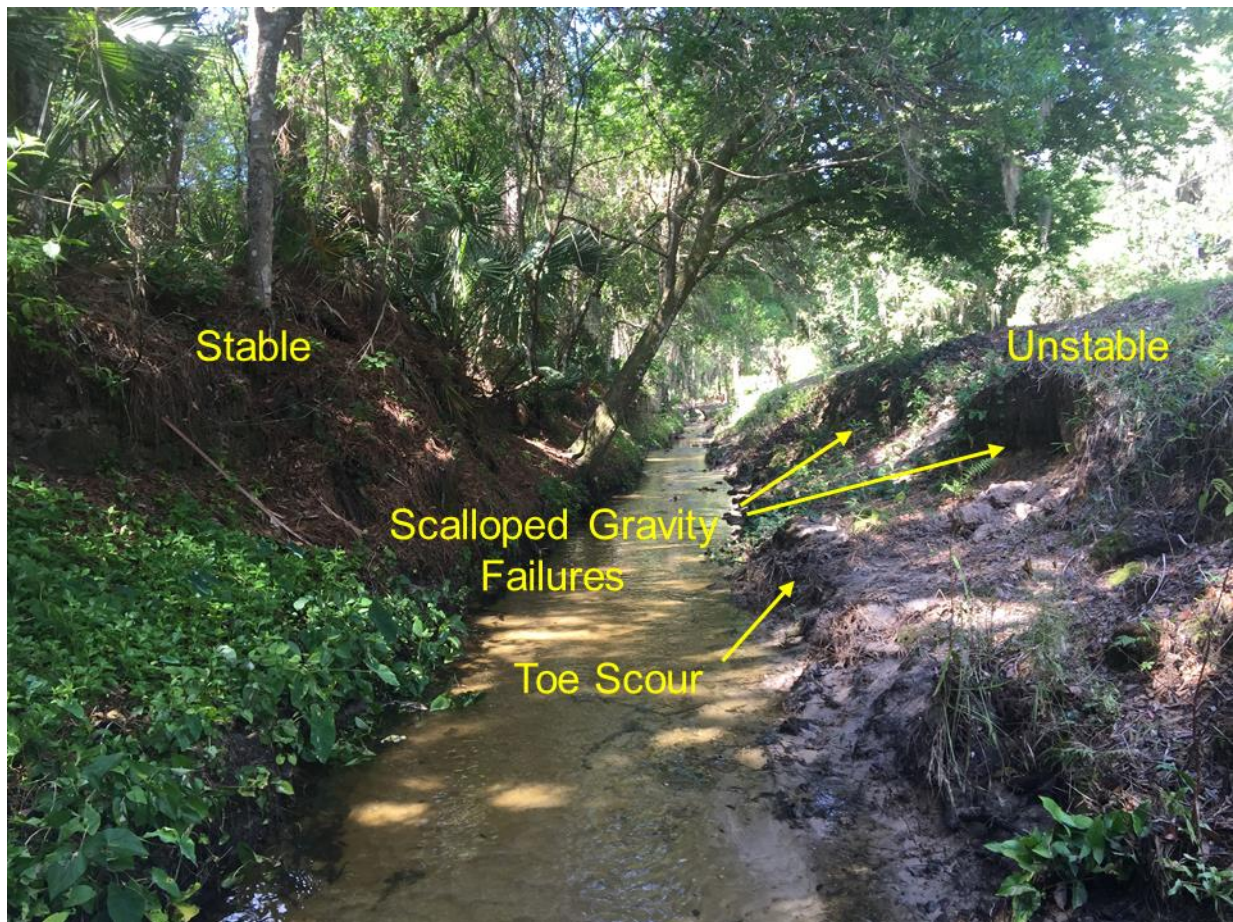
Various forms of erosion were observed on 11 (28%) of the 40 canal banks investigated, affecting 9 (45%) of the 20 canals visited. Erosion occurred across much of the watershed, including a variety of large and small canals. Our team noted that more forms of erosion and greater frequency of erosion occurred on mowed versus forested banks. This was particularly striking because in many instances one bank of a canal was mowed or otherwise non-woody and unstable, while its opposite partner was wooded and stable (**Figure 2**). In almost all cases where such pairs were observed and the mowed bank was eroding, the woody bank was stable.

Figure 2. Stable Woody versus Unstable Non-Woody Banks (Canal 302).

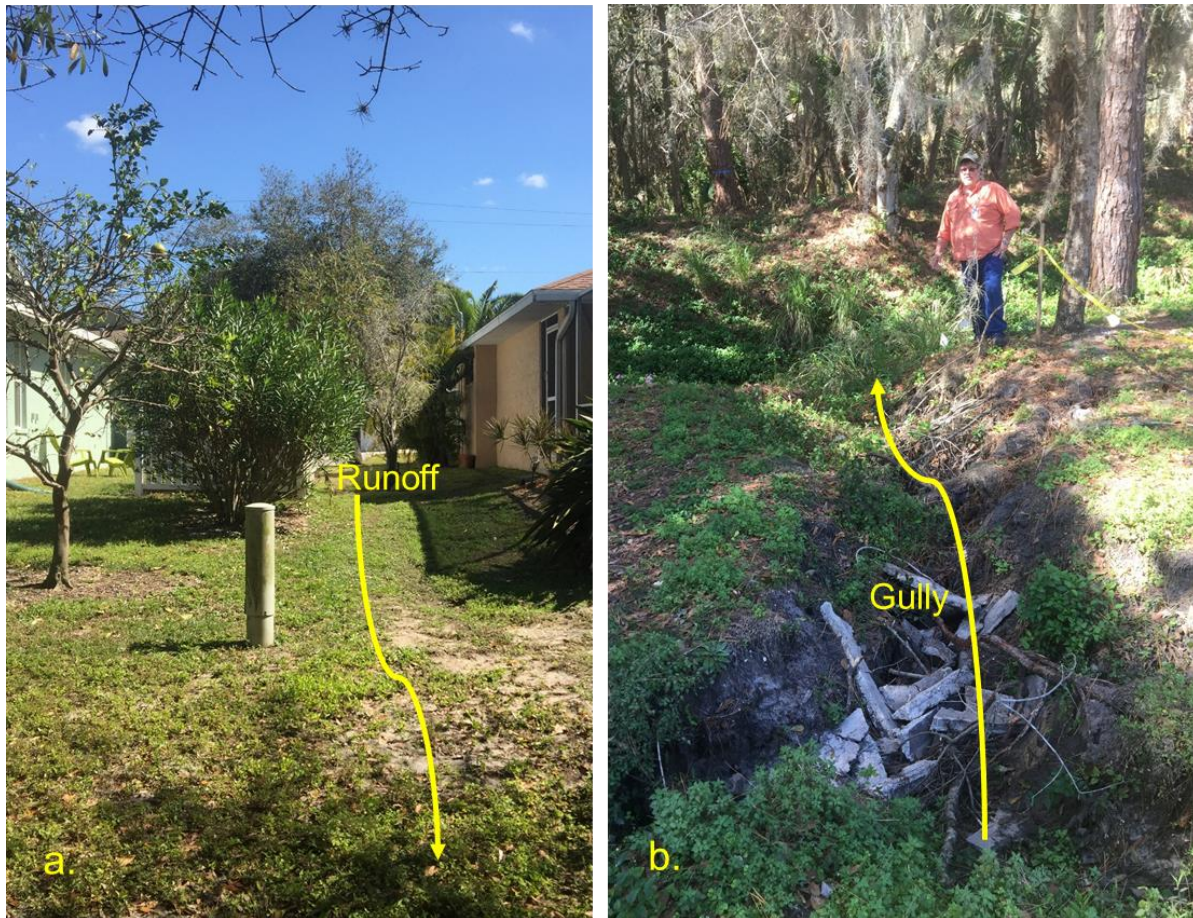
Figure 4. Pluvial Erosion (Lake Sarasota Canal).

a. Path of concentrated roof runoff to canal

b. Resulting gully erosion on canal bank immediately downstream of roof runoff path

Bank instabilities included shallow plane failures, rills, gullies, and toe scour (**Figures 3 and 4**). The form of erosion and position on the bank indicated that the majority of the erosion was caused by gravity failure and by pluvial forces (direct precipitation and overland flow across the top of the bank toward the stream). These kinds of erosion indicate banks that are not adequately internally reinforced by strong vegetation roots, are poorly armored by vegetative cover, or are too heavy to support their own weight (often due to unsustainable combinations of bank height and slope).

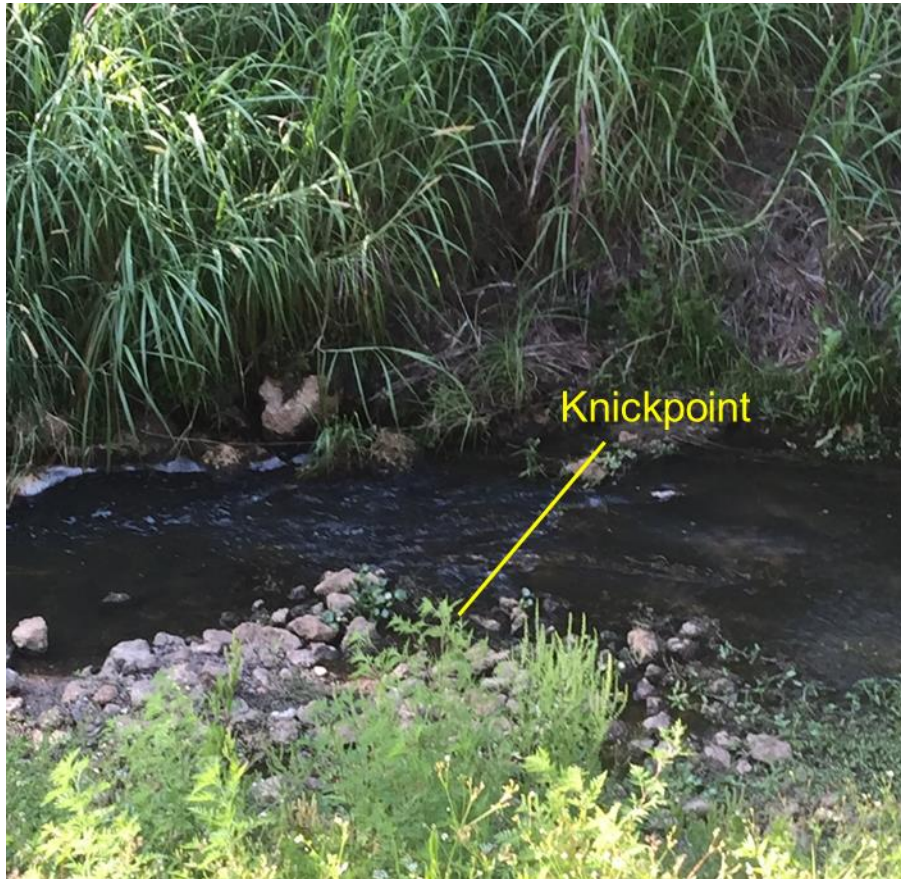
Figure 5. Degradation with Migrating Knickpoint (Canal 15).

Notably, bed scour (degradation) was only observed on one canal. Channel degradation is a serious issue and grade control treatments should be deployed rapidly to contain such erosion before it can destabilize both banks as it migrates upstream. This was implemented in the canal where it was observed using riprap (**Figure 5**). Bed scour is indicated by channels with combinations of exposed resistant layers, rather ubiquitous massive gravity failures, and migrating knickpoints. Since degradation is also characteristic of hydromodification effects, its general absence suggest hydromodification is not an issue in most of the drainage network, thus reinforcing the observations of bank condition in that regard.

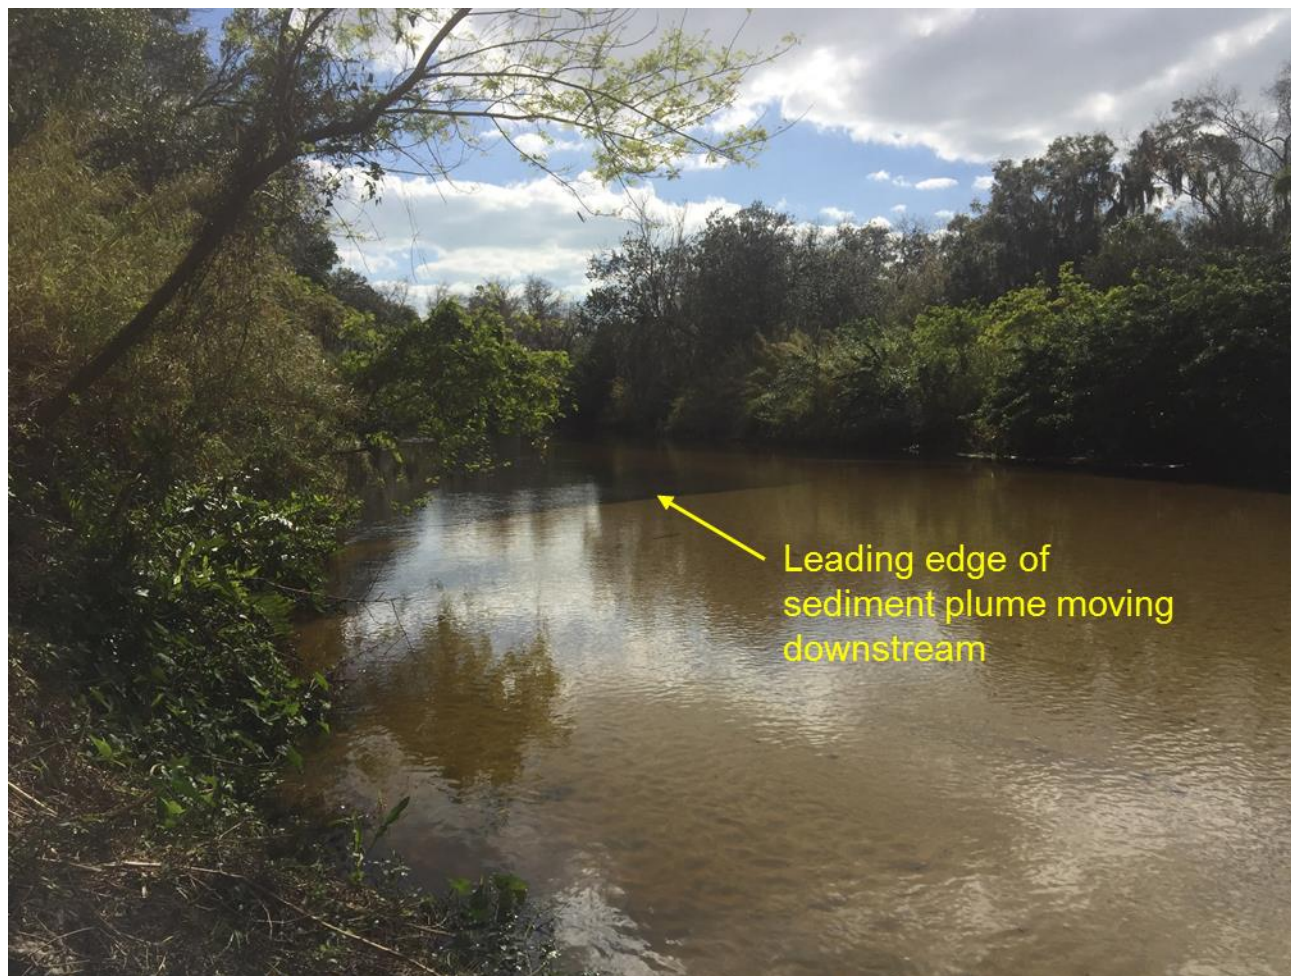
**Figure 6. Aggradation and Sediment Plume
(Phillippi Creek downstream of Pinecraft Park)**

Some canal beds indicated sediment accumulation (aggradation) (**Figure 6**). Aggradation is almost a given in the main stem canals located in the lowest and flattest areas in the drainage network. It means the canals receive more sediment than they can routinely transport. This could be caused by certain kinds of water withdrawals or by excessive sediment yields from stream or watershed erosion. Based on what is known about the watershed and our team's direct observations, excessive sediment yield is an issue and the SEU has implemented sediment trap projects accordingly. Two such traps were observed and appear to be working well.

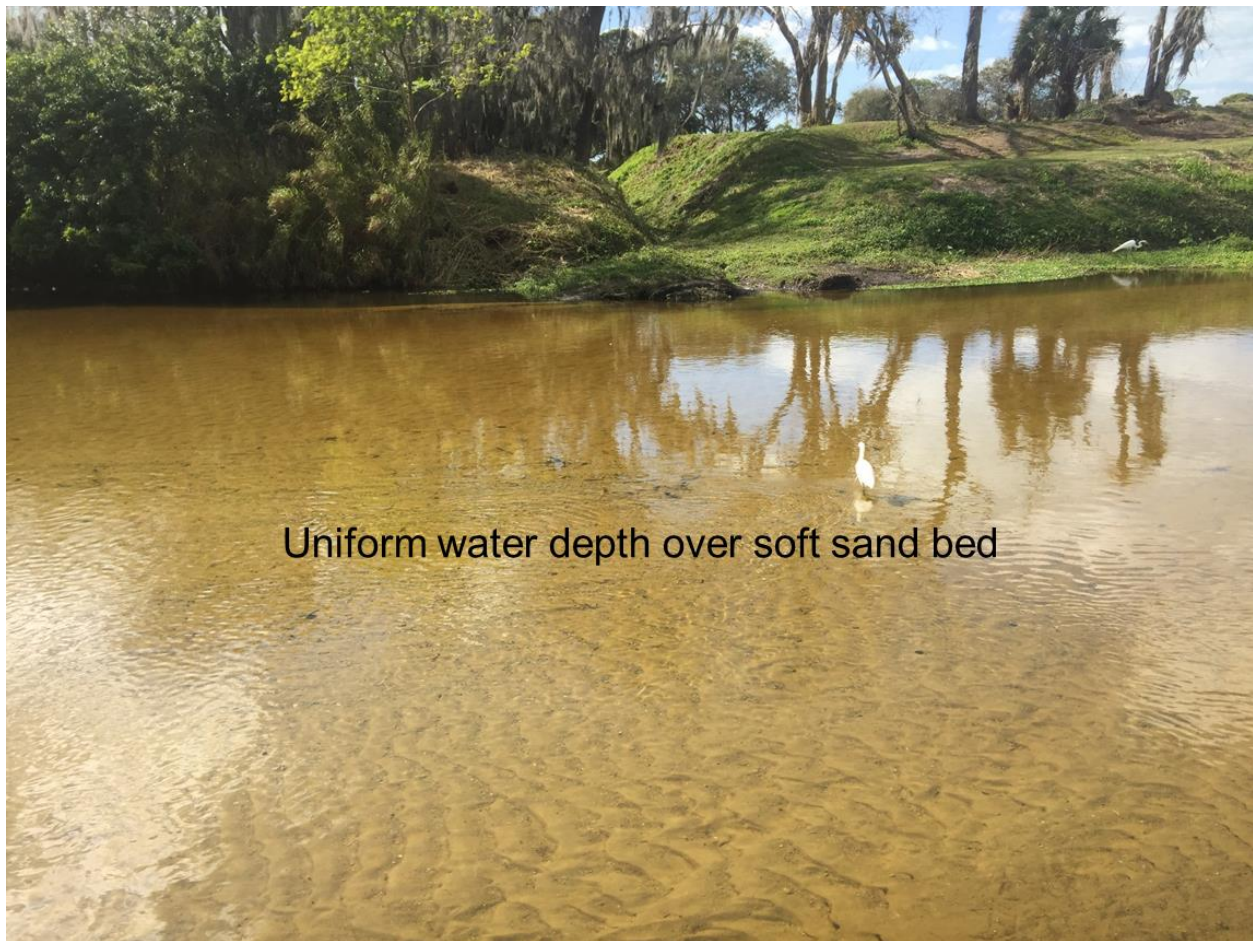
**Figure 7. Aggradation Associated with Aquatic Habitat Simplification
(Phillippi Creek at Pinecraft Park)**

Phillippi Creek's sediment loads are mostly from bank erosion, but reliable evidence of sediment transport was also observed from sparsely vegetated lawns to canals at 2 of the 20 studied canals. Canals receiving stormwater from dense lawns did not have such loads. Aggradation is problematic because sediments can clog culverts at road crossings, raise floodwaters, bury and simplify aquatic habitat, and carry pollutants downstream (**Figure 7**).

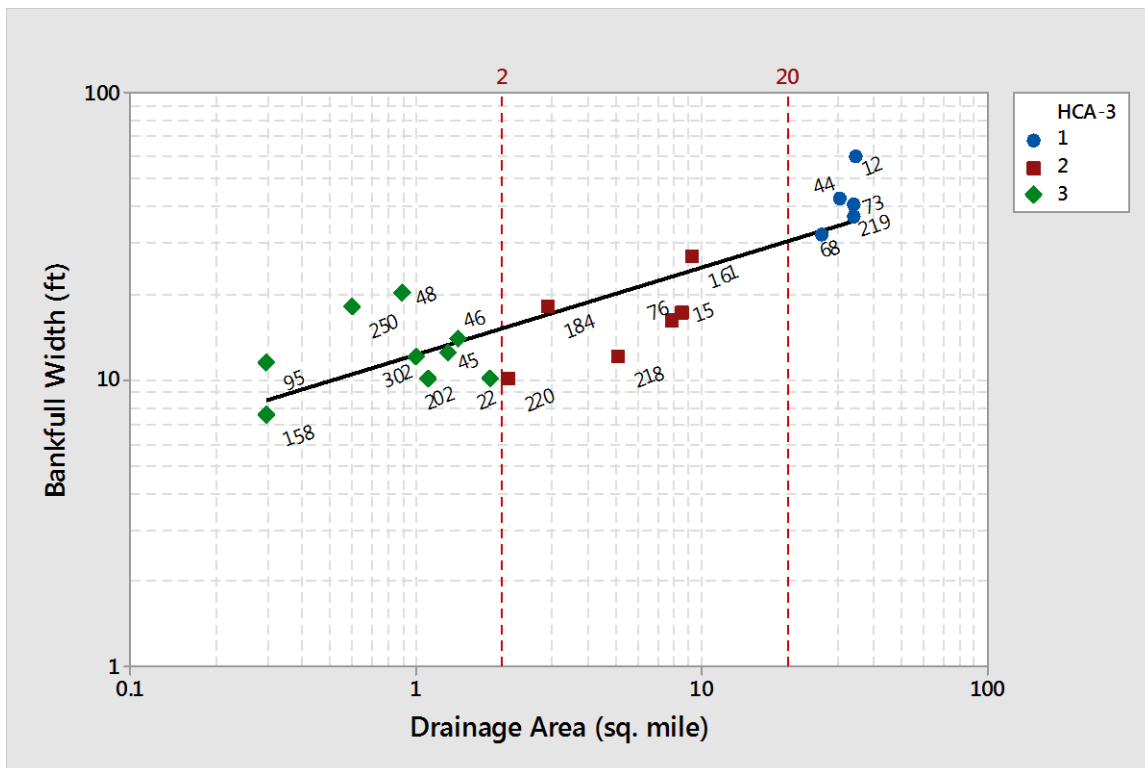
Figure 11. Canal Bankfull Width versus Drainage Area (3 Clusters).

Each cluster group may represent different hydrologic and ecologic forcing functions that are clearly represented in the data. Although not shown, for the most part, PCA results supported the results for the 2 canal segment groups that were also identified by cluster analysis as shown in **Figure 8**. The final separation between the canal segment sites following the varimax rotation was also very similar to what was found with cluster analysis. A scatter plot of canal bankfull² width versus drainage area shows that canals assigned to Group 1 in the PCA and HCA analyses were uniformly wider and drained larger watersheds versus those in Group 2 (**Figure 9**). When 3 groups are assigned from the HCA results, canals continued to be divided along a size gradient (**Figures 10 and 11**).

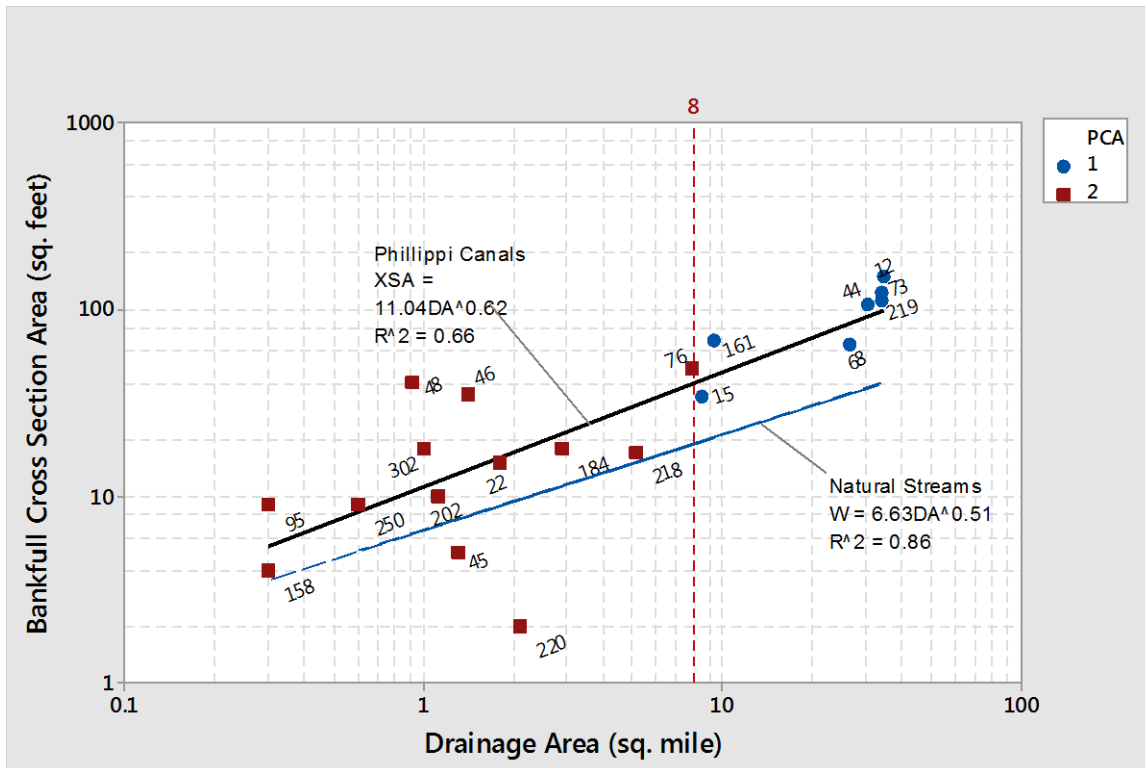
An array of regression comparisons were made to help understand canal condition and how it departs from natural conditions. The small group of Phillippi canals observed had a lot of variability in their bankfull cross section area, contributing to a lower r^2 value (0.66) when regressing bankfull channel dimension against drainage area versus that of natural streams in the same hydrophysiographic region (0.86) (**Figure 13**). Further, although overlap occurs, the Phillippi canals averaged larger bankfull channel sections than natural channels draining similar sized watersheds, especially the larger canals. Keep in mind that bankfull dimensions are being compared. This aspect of channel dimension represents the outcome of geomorphic processes associated with how channels adjust to the sediment and water volumes delivered from their watersheds. It usually takes at least two decades for bankfull dimension to evolve and achieve equilibrium after valley construction, which most of the canals appeared to have had time to accomplish.

Figure 13. Bankfull Cross Section Area versus Drainage Area.

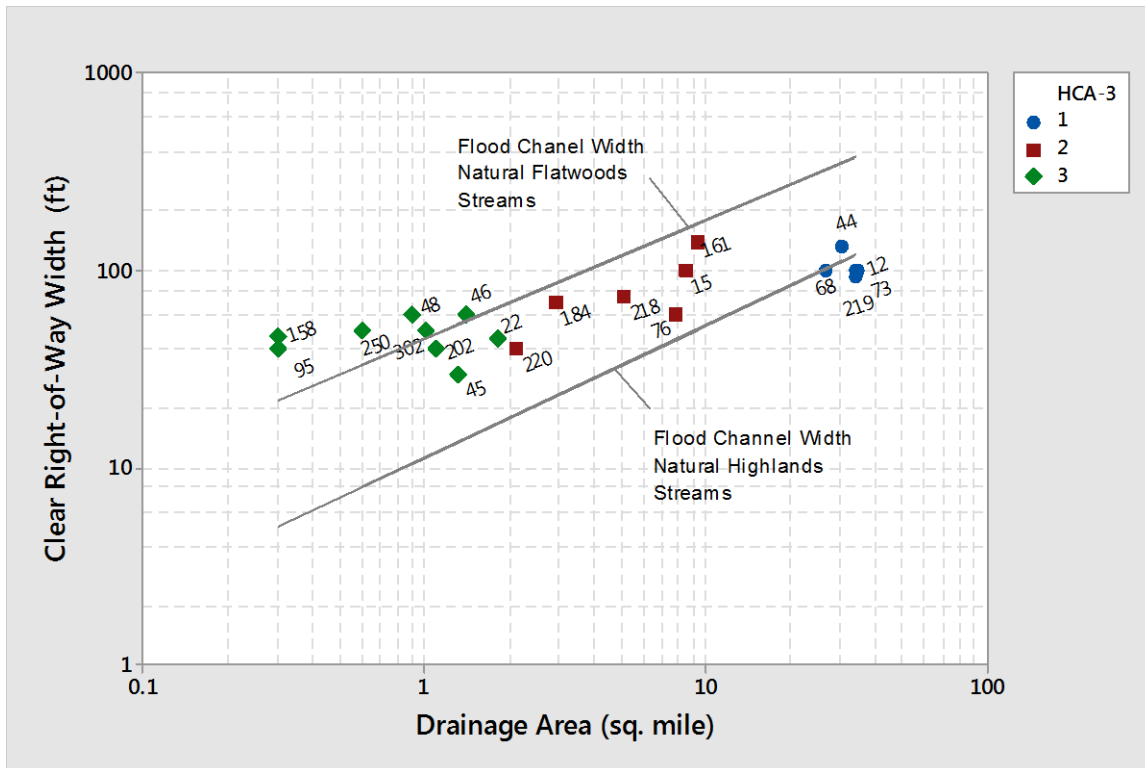
The previous discussion categorized canals using the 2 Group concept. It is useful to also examine the available corridor width data using the 3 Group concept. Doing so, it appears that most Group 3 canals draining small watersheds (less than 2 square miles) have accessible ROW widths more than ample to create headwater streams similar to their natural analogues (**Figure 17**). This includes fully meandering plan forms as well as natural floodplain width. Group 2 canals draining intermediate basins ranging from 2 to 20 square miles could generally be restored at the small end of natural Flatwoods stream corridors or have ample room to accommodate the full dimension and pattern of two-stage natural Highlands streams. The largest canals, Group 1, could not support Flatwoods sized corridors, but appear to generally be large enough hto support Highlands corridor dimensions and pattern.

Figure 17. Canal Right-of-Way Width versus Drainage Area, Compared to Active Floodplain Width of Natural Streams

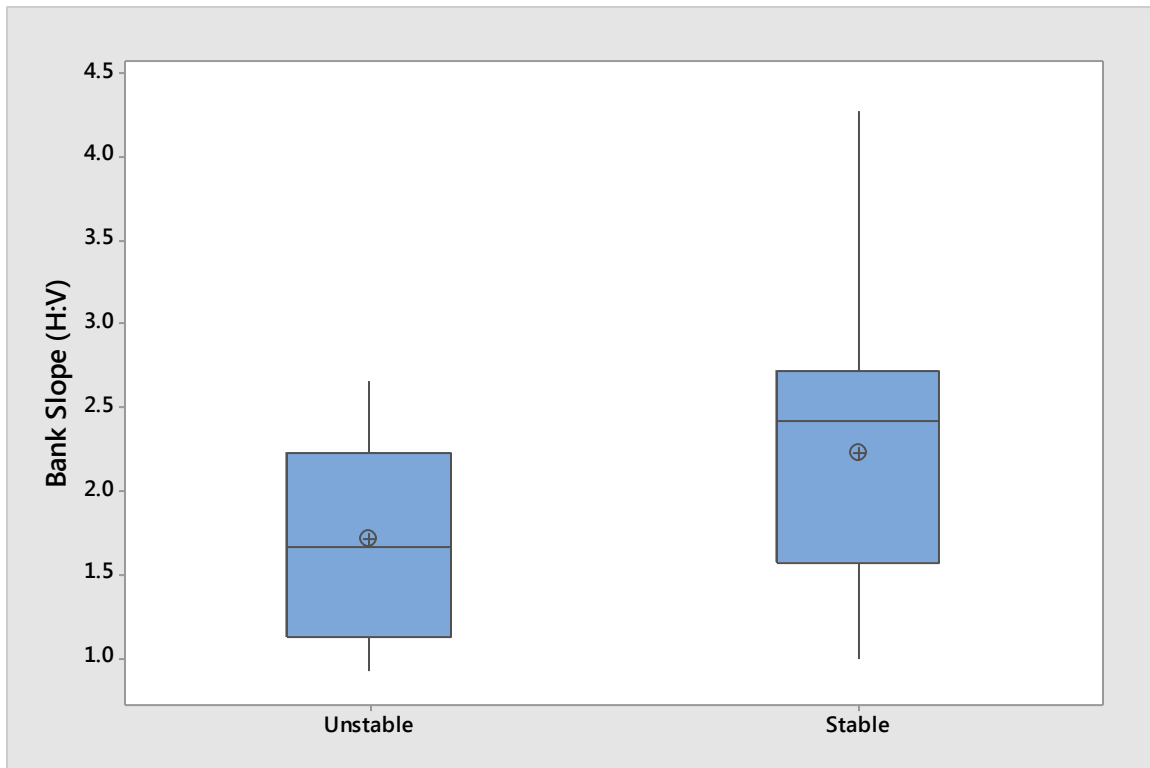
Figure 19. Side Slopes of Stable and Unstable Canal Banks
