PINECRAFT SEDIMENT ABATEMENT STUDY

**Sarasota County
Water Resources**

**Berryman & Henigar, Inc.
1412 Tech Blvd
Tampa, Florida 33619-7865**

May 2005

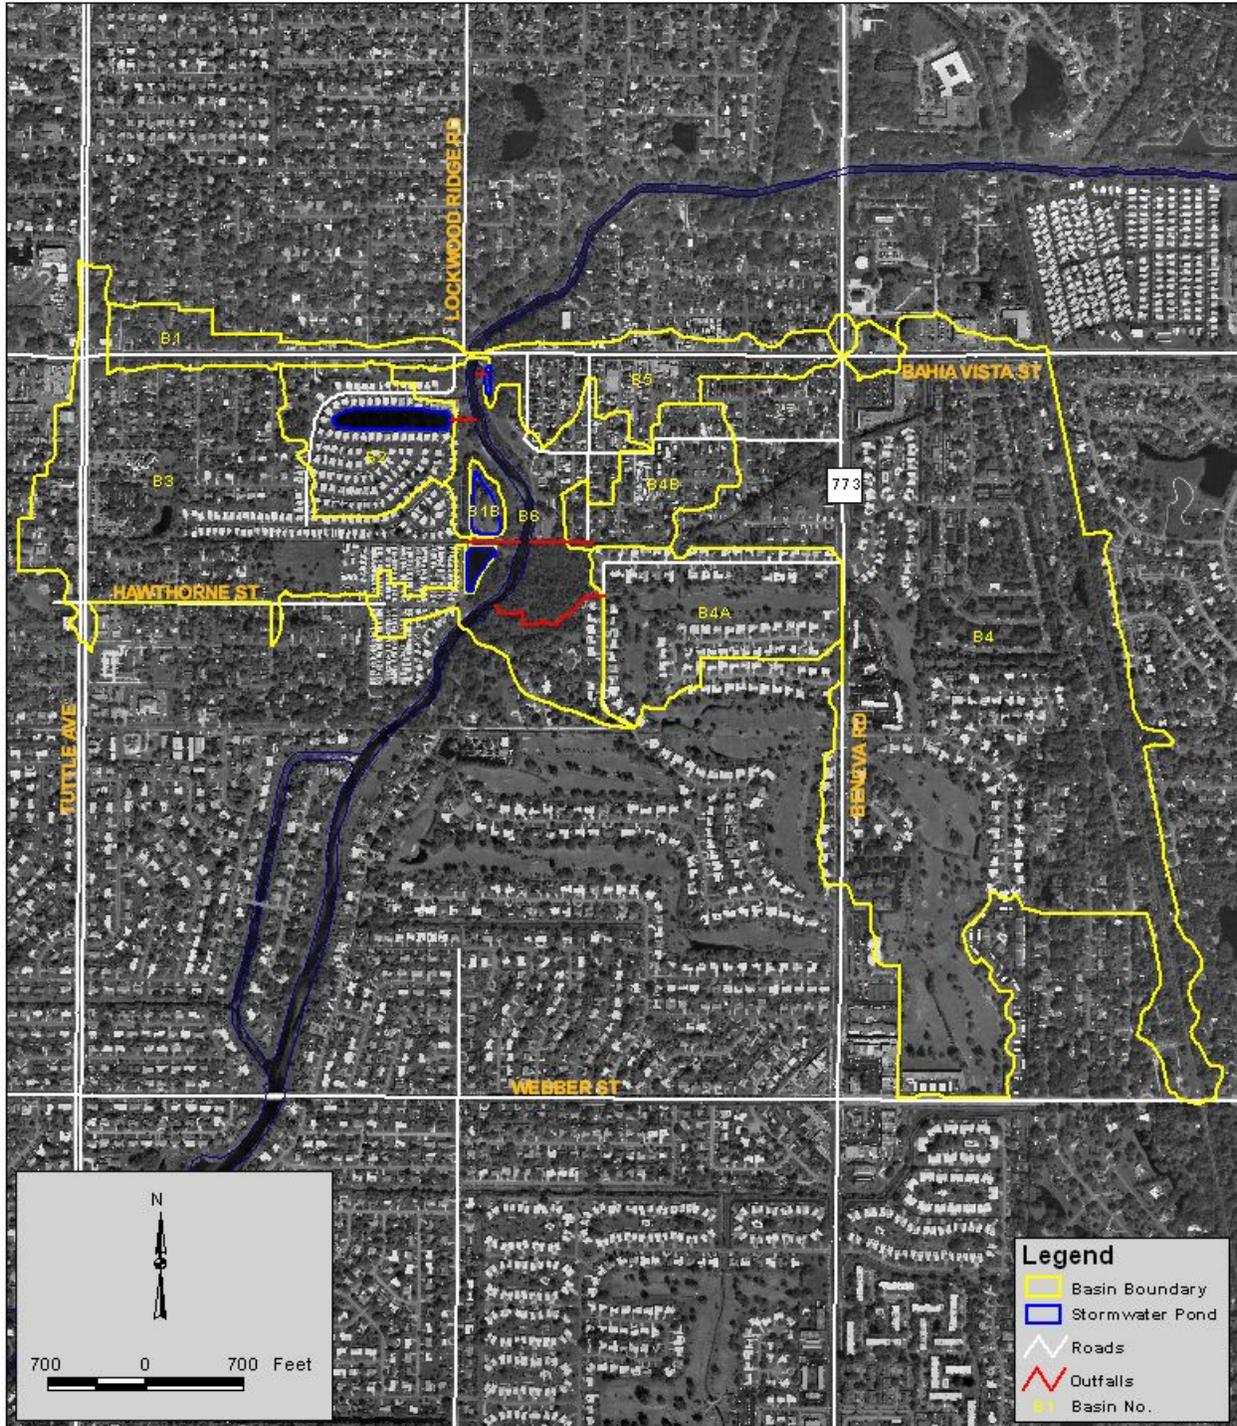
Figure 2

The drainage basin for the channel is generally bordered by Tuttle Avenue on the west, Ingram Avenue on the east, Bahia Vista Street on the north, and Webber Street on the south. The overall drainage basin consists of 504 acres of mixed land uses. See Figure 2, which shows subbasins within the study area.

Existing Features Map

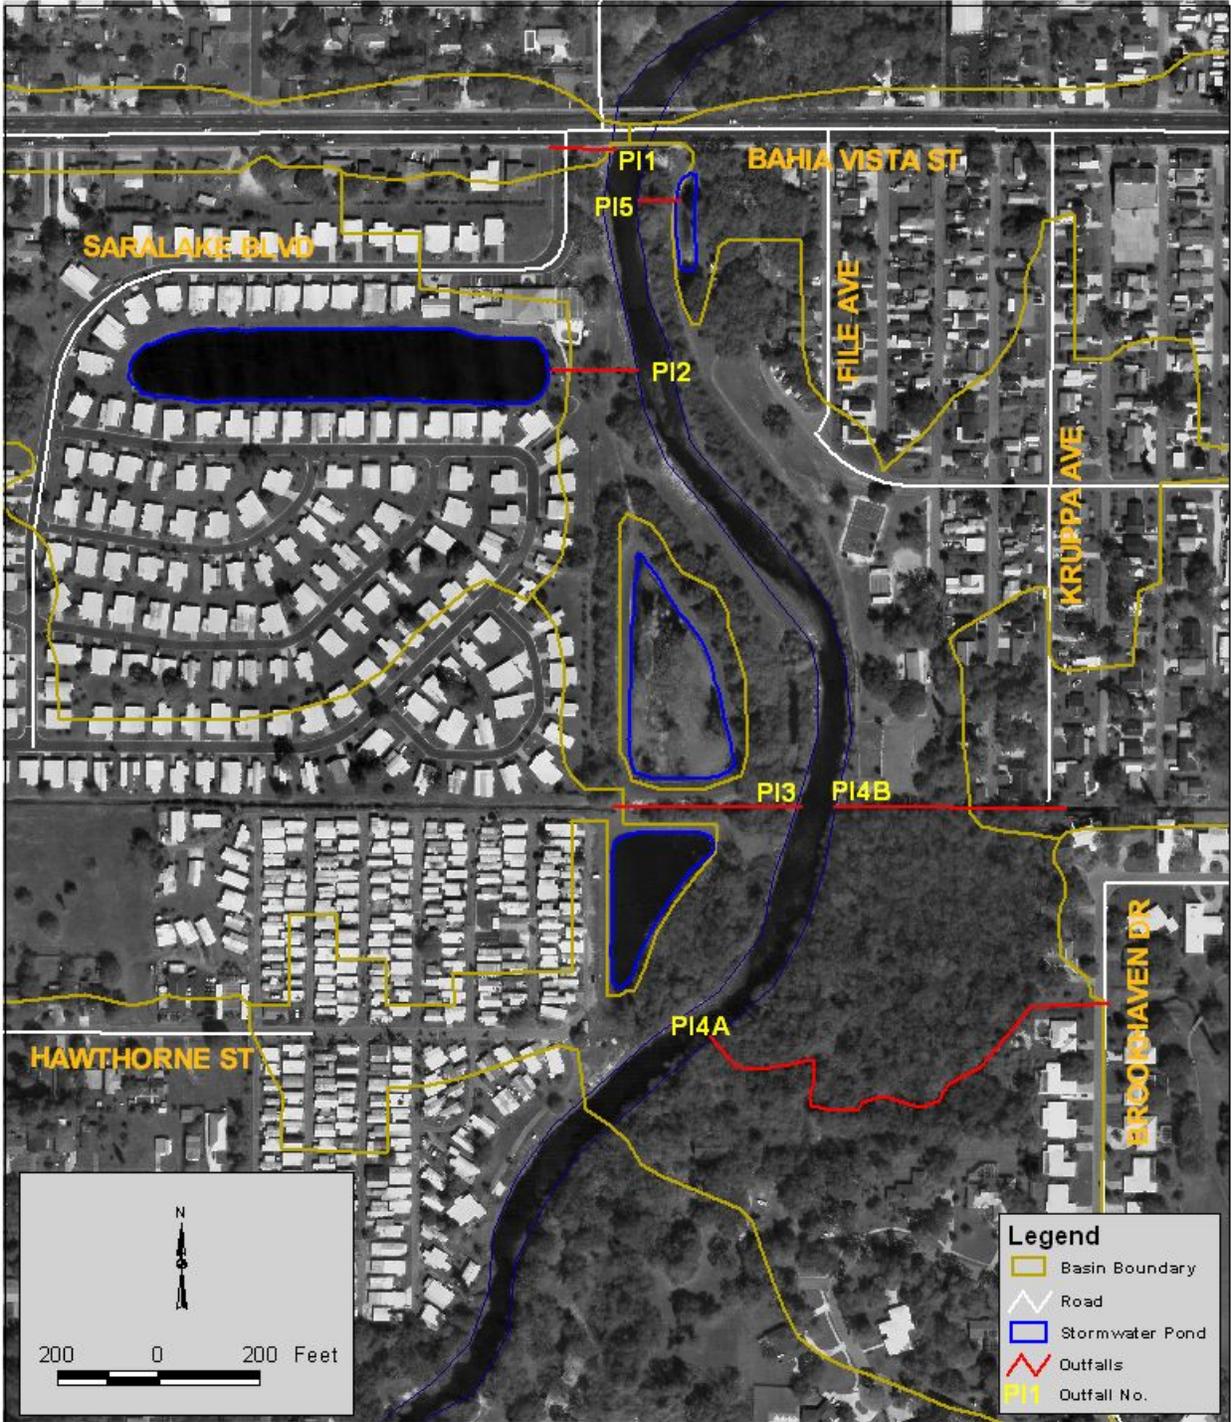
Figure 3

There are six stormwater outfalls that discharge to the channel. The outfalls are shown on the Existing Conditions Outfall Map, Figure 3. Each outfall is identified and discussed below.

**Existing Conditions
Outfall Map**

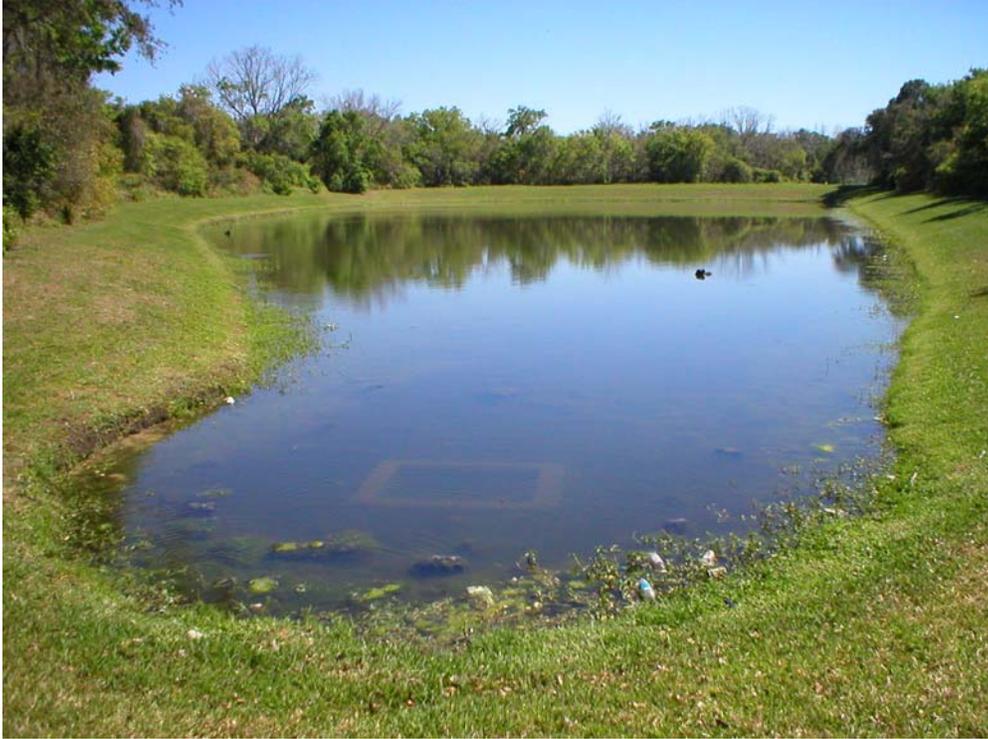
This drainage basin area consists of 15.9 acres of mostly single family residential property, but it also includes roadway and commercial properties, and drains properties along Bahia Vista Street west of Phillippi Creek. There is an offsite stormwater treatment pond, located in basin 1B (Figure 4), that partially serves this basin but there is also a 36" Reinforced Concrete Pipe (RCP) pipe, outfall PI1, that directly discharges to the upper portion of the channel (Figure 5). There was no sediment build up observed along the shoreline at this basin.

Figure 4.
Offsite stormwater pond in Basin 1B.

This drainage basin drains properties along Bahia Vista Street west of Phillippi Creek, it is partially treated by an offsite stormwater treatment pond but it also has a pipe that drains to the upper portion of the channel through Outfall PI1. No new BMPs are recommended for this outfall because of the basin size and because the existing offsite stormwater pond is working properly.

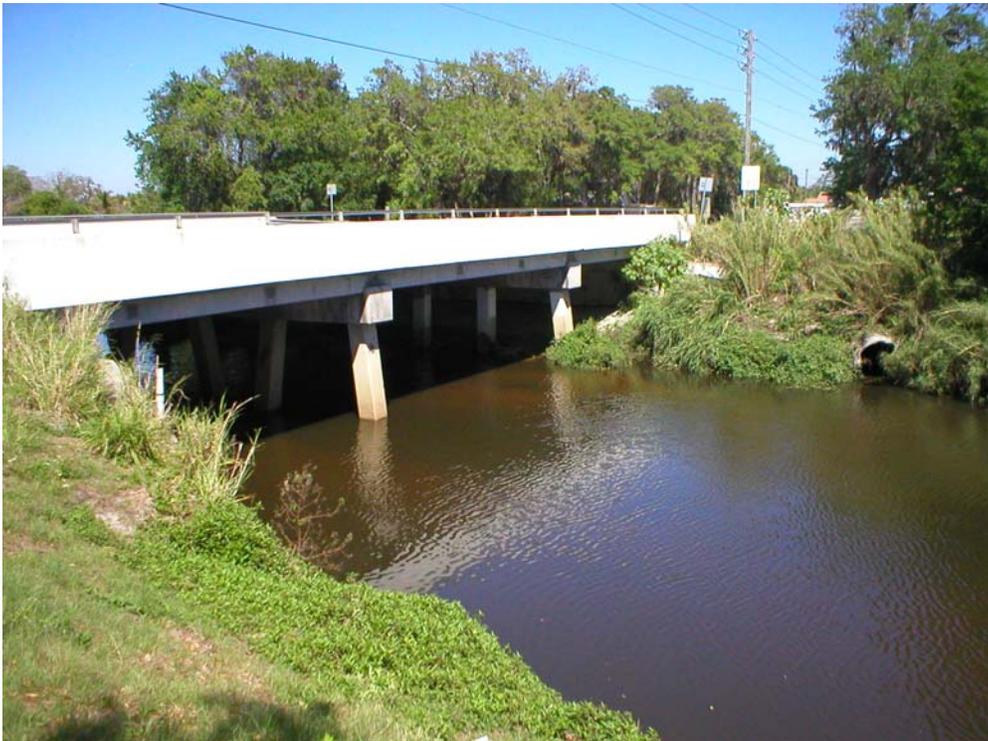
Figure 5.
Looking northeast at Bahia Vista St. Bridge. Uppermost portion of channel.

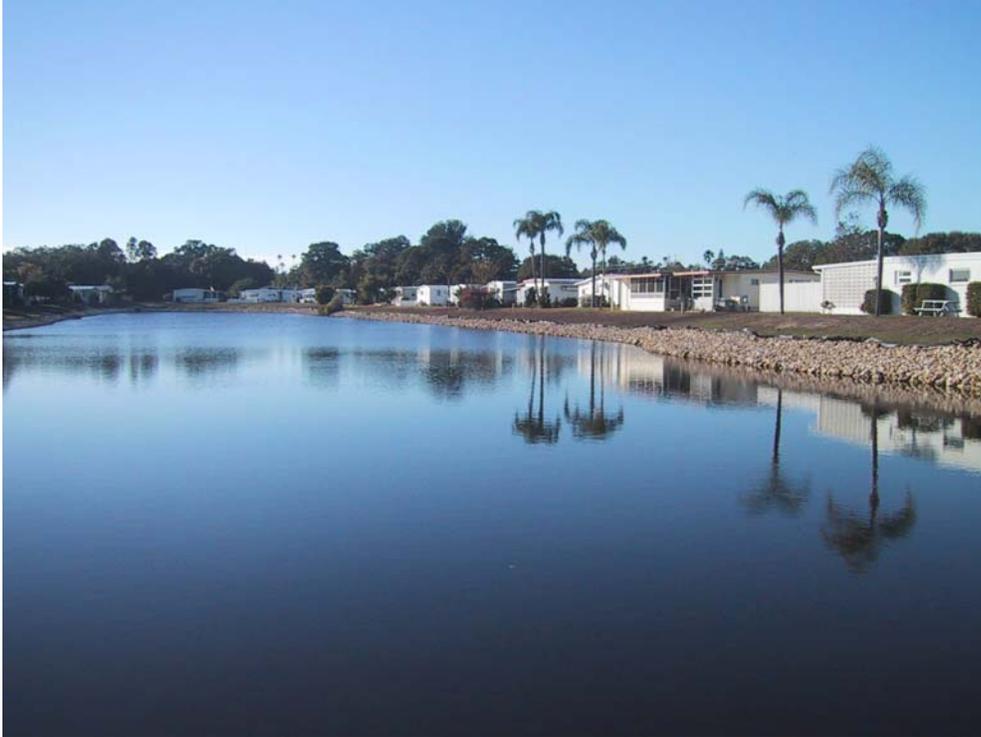
This drainage basin area consists of 21.1 acres of single family and multi family residential properties. This basin drains properties along Sara Lake Boulevard, Viola Drive and Joline Drive. There is a stormwater treatment pond (Figure 6) that serves this basin and it discharges to the channel via a 53"x34" pipe, outfall PI2 (Figure 7). Erosion of the steep slopes of the channel was observed at this outfall.

Figure 6.
Stormwater pond in Basin B2. Note rip-rap installed at toe of slope.

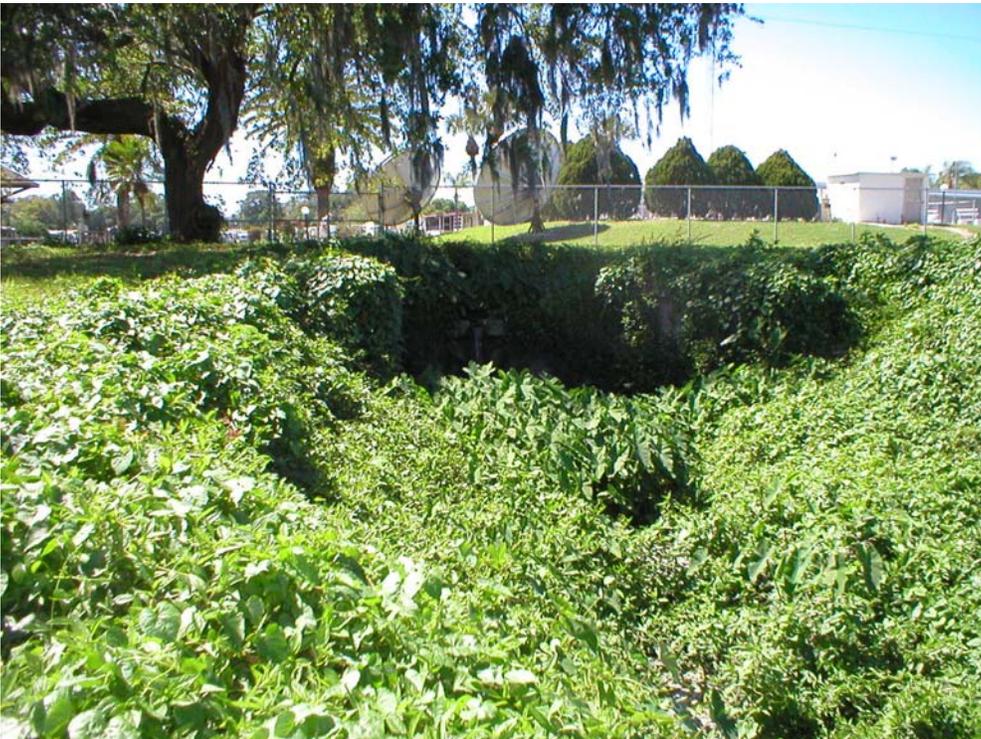
Figure 7.
Depression at Outfall PI2

This drainage basin drains properties along Sara Lake Boulevard, Viola Drive and Joline Drive. There is a stormwater treatment pond that serves this basin and it discharges to the channel via outfall PI2. Due to the unstable condition of the channel side slopes near the outfall BHI recommends stabilization with riprap and/or other channel stabilization system to avoid further erosion.

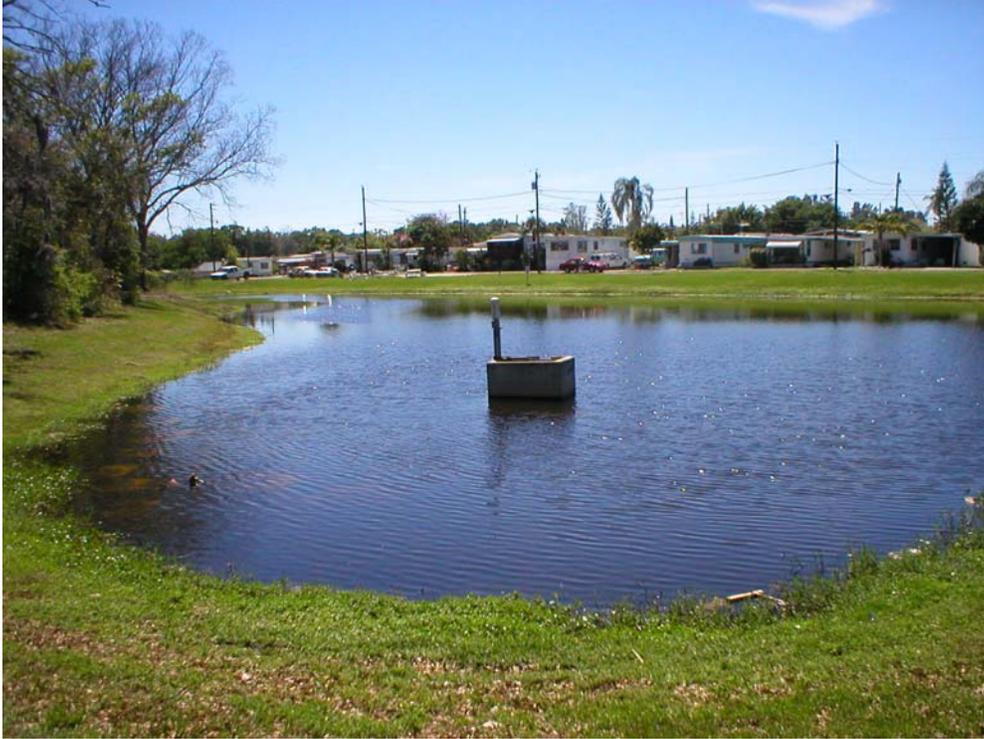
This drainage basin area consists of 88.6 acres of mostly single family residential property, but it also includes multi family residential and commercial properties. This is the second largest basin and it drains properties from Tuttle Avenue to the west and properties south of Bahia Vista Street and north of Hawthorne Street. There is a stormwater treatment pond (Figure 8) that partially serves this basin but there is also a large ditch, outfall PI3, that directly discharges to the middle portion of the channel. Erosion of the steep slopes of the ditch and sediment discharges were observed at this outfall (Figures 9 & 10).

Figure 8.
Stormwater pond in Basin B3

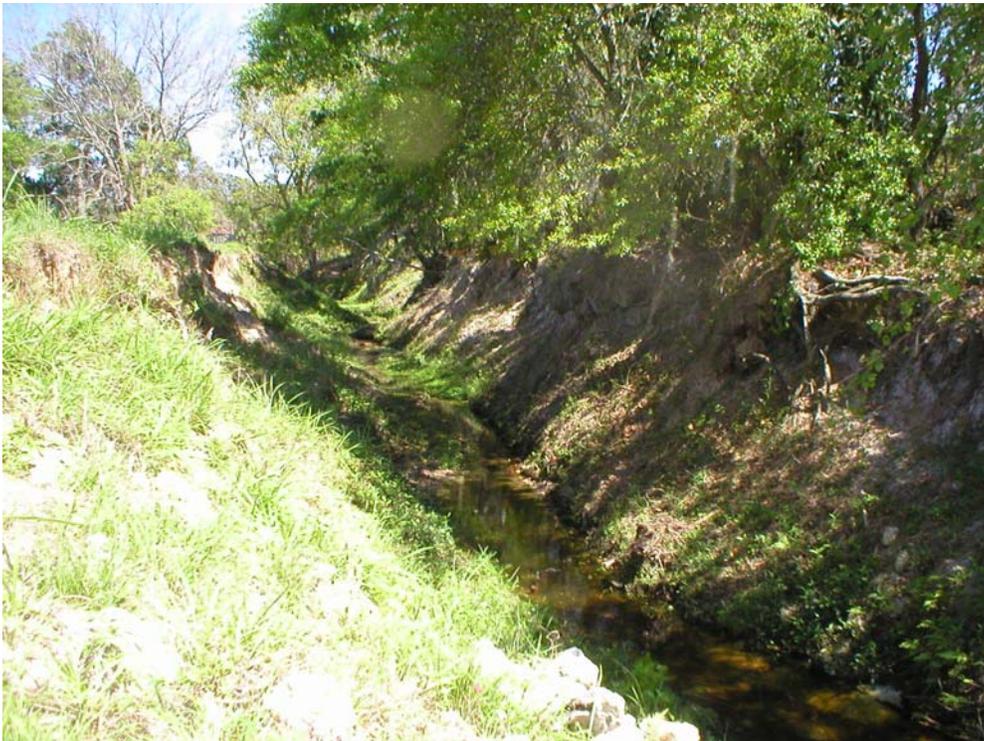
Figure 9.
Outlet ditch PI3. Note erosion of the steep slopes.

This drainage basin area, the second largest basin, drains properties from Tuttle Avenue to the west and properties south of Bahia Vista Street and north of Hawthorne Street. There is a stormwater treatment pond that partially serves this basin but there is also a large ditch, outfall PI3, that directly discharges to the middle portion of the channel. Due to the unstable condition of the ditch side slopes near the outfall BHI recommends stabilization with riprap and/or other channel stabilization system to avoid further erosion.

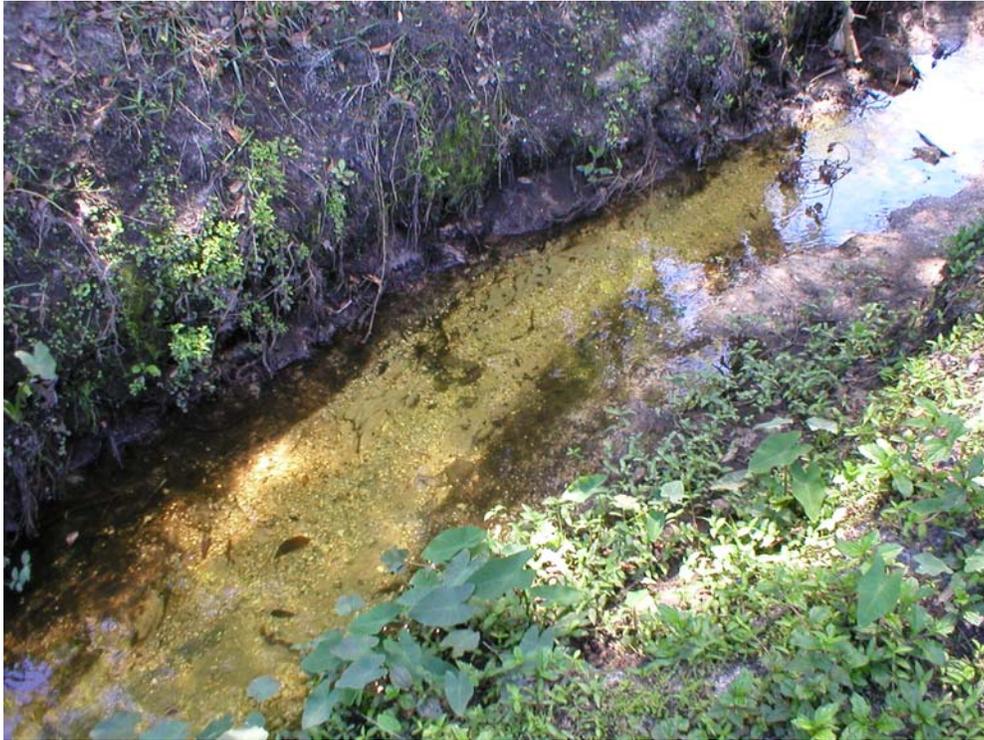
Figure 10.
Outlet PI3 ditch bed. Note sediments at bottom.

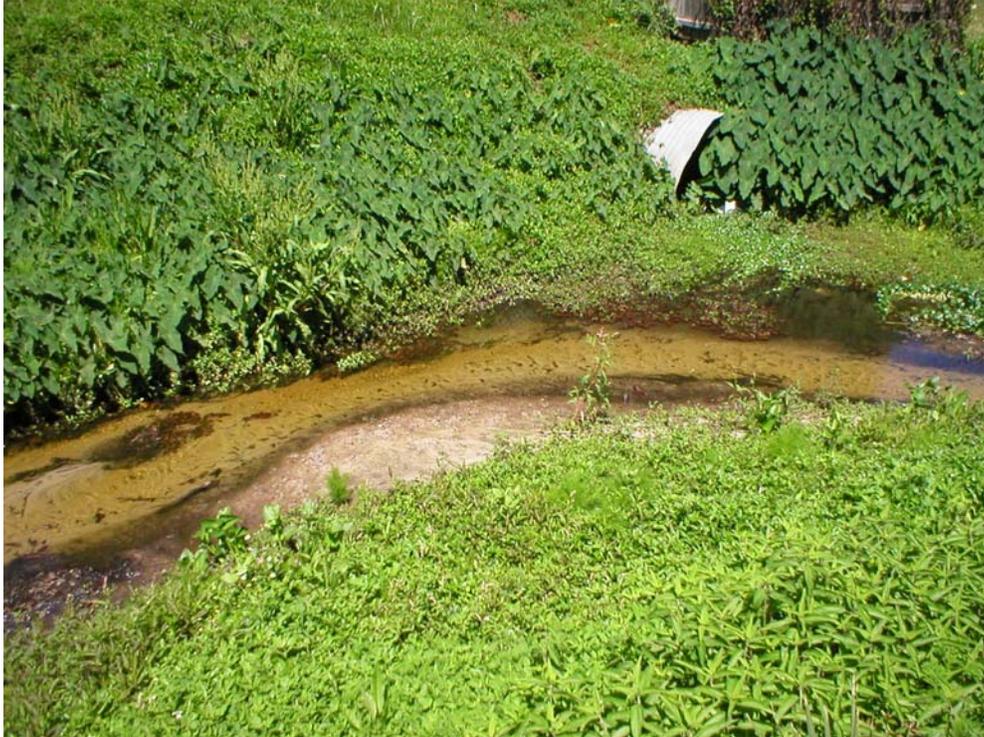
This drainage basin area consists of 296.3 acres of mostly single family residential property, but it also includes multi family residential and commercial properties, roadway and open space. This is the largest drainage basin discharging to the canal system and has no stormwater treatment systems. This basin drains properties from Bahia Vista Street to the north, Webber Street to the south, and Ingram Avenue to the east, and it splits into two systems just north of Sea View Street (Figures 11 & 12). The system to the south drains through a ditch, outfall PI4A (Figure 13), that runs through the preservation area south of Pinecraft Park, while the system to the north drains through a ditch, outfall PI4B (Figure 14), just south of Pinecraft Park. Erosion of the steep slopes of the ditch and sediment discharges were observed at both of these outfalls (Figures 15 & 16).

Figure 11.
Pipe at Basin 4 towards outfall PI4B. Note sediment island at turn.

This is the largest drainage basin discharging to the channel and has no stormwater treatment systems. This basin drains properties from Bahia Vista Street to the north, Webber Street to the south, and Ingram Avenue to the east, and it splits into two systems just north Sea View Street. The system to the south drains through a ditch, outfall PI4A, that runs through the preservation area south of Pinecraft Park, while the system to the north drains through a ditch, outfall PI4B, just south of Pinecraft Park. BHI recommends a series of BMPs and sediment and erosion measures to treat this basin. A dry offline detention pond is being proposed to treat the large untreated drainage area of Basin 4. A baffle box is being recommended for outfall PI4A to be installed under Brookhaven Drive just upstream of the preservation area. An enhanced nutrient separating baffle box, which has an added benefit of reducing nutrient loads by trapping grass, leaves, and organic debris and keeping this material dry so that the nutrients do not leach out into the stormwater would also be appropriate for this site (BHI, 2004). An added feature of using this BMP is that it would help the County achieve nutrient reductions recommended for Sarasota Bay. Finally due to the unstable condition of the ditch side slopes near the PI4B outfall BHI recommends stabilization with riprap and/or other channel stabilization system to avoid further erosion.

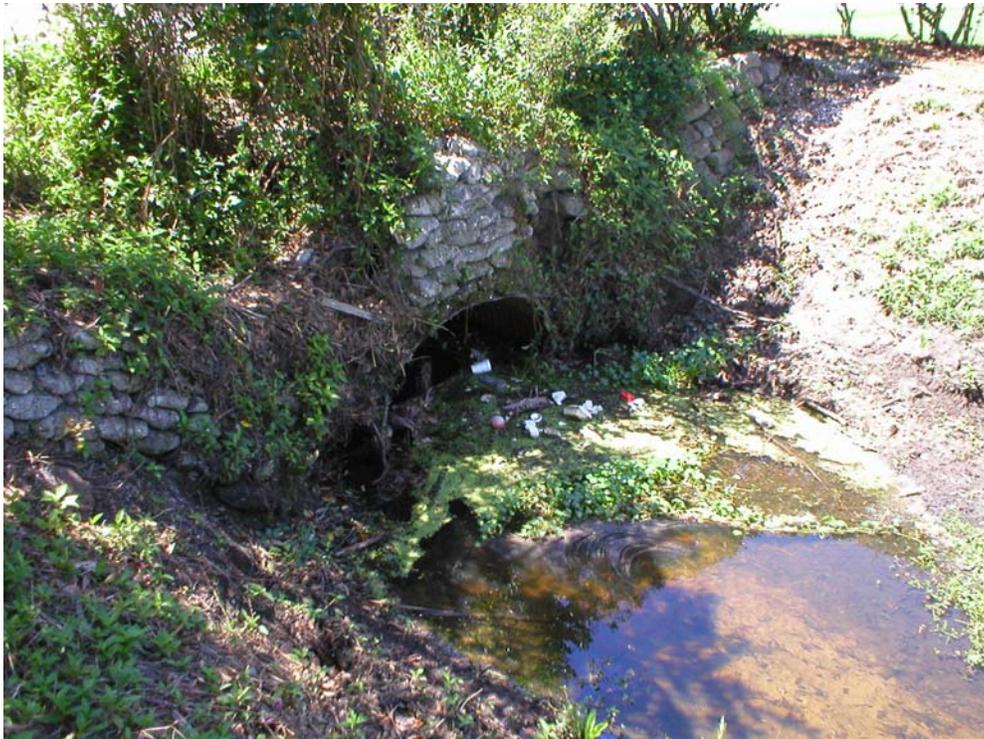
Figure 12.
Pipe under Sea View St. towards outfall PI4A in Basin B4.

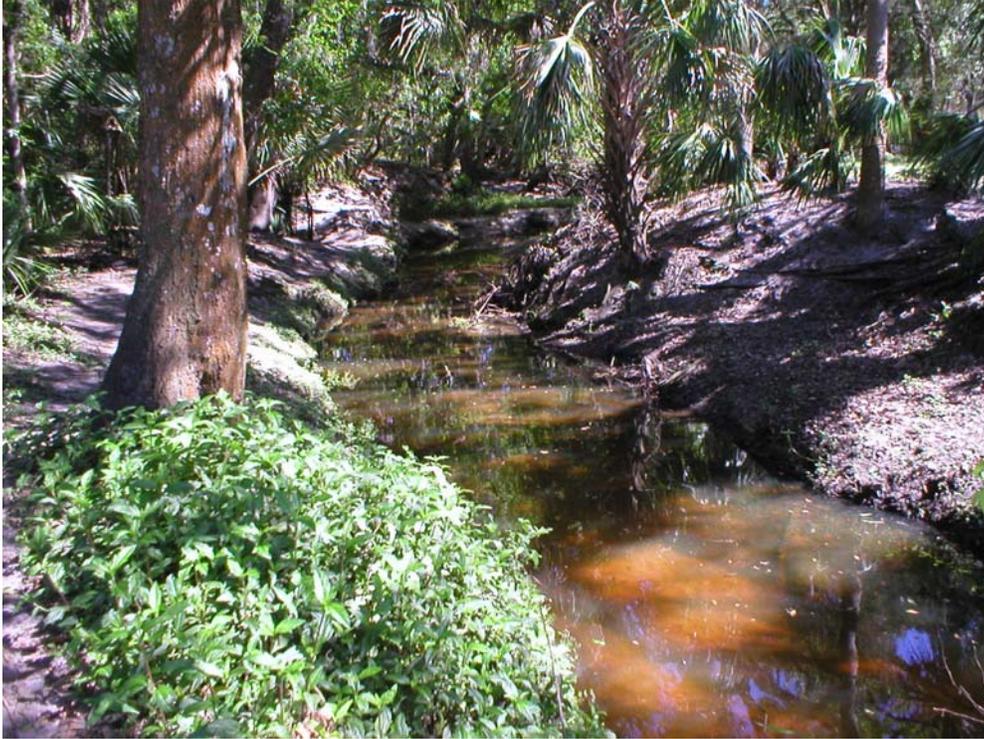
Figure 13.
Ditch of outfall PI4A in the preservation area

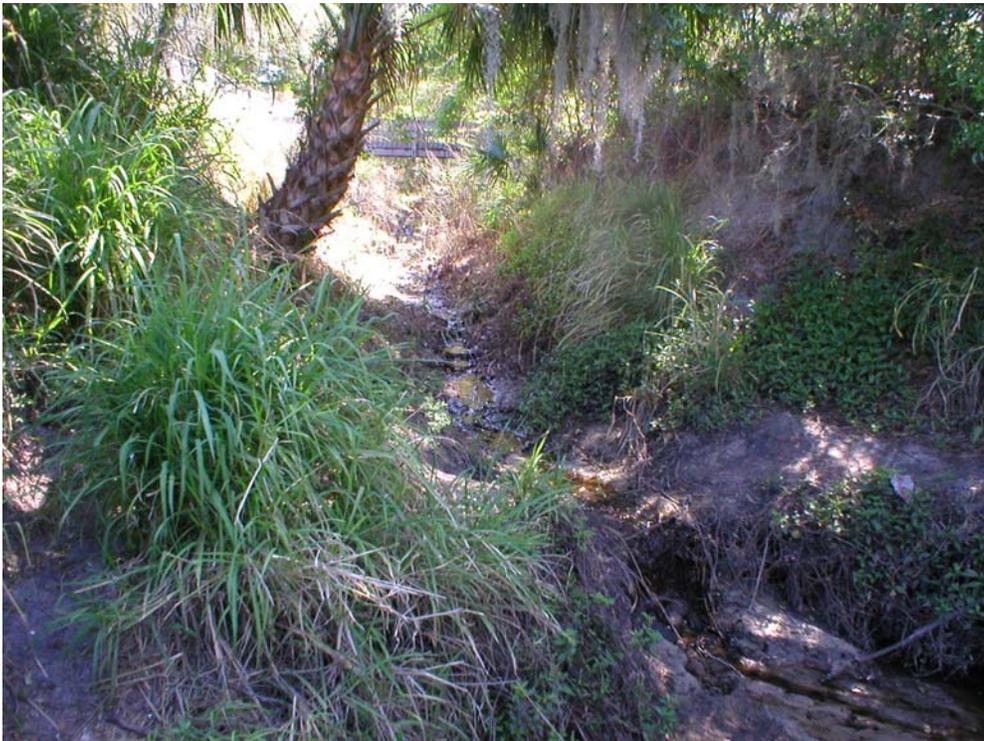
Figure 14.
Ditch of outfall PI4B. Note steep slopes

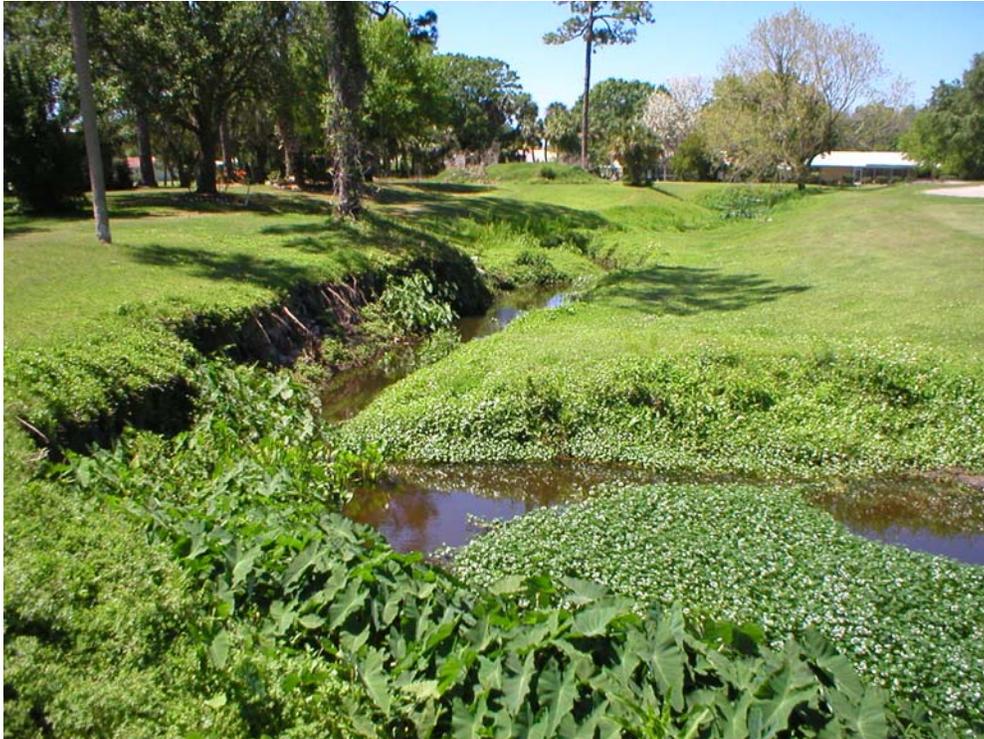
Figure 15.
Upstream of outfall PI4A at golf Course. Note eroded steep slopes.

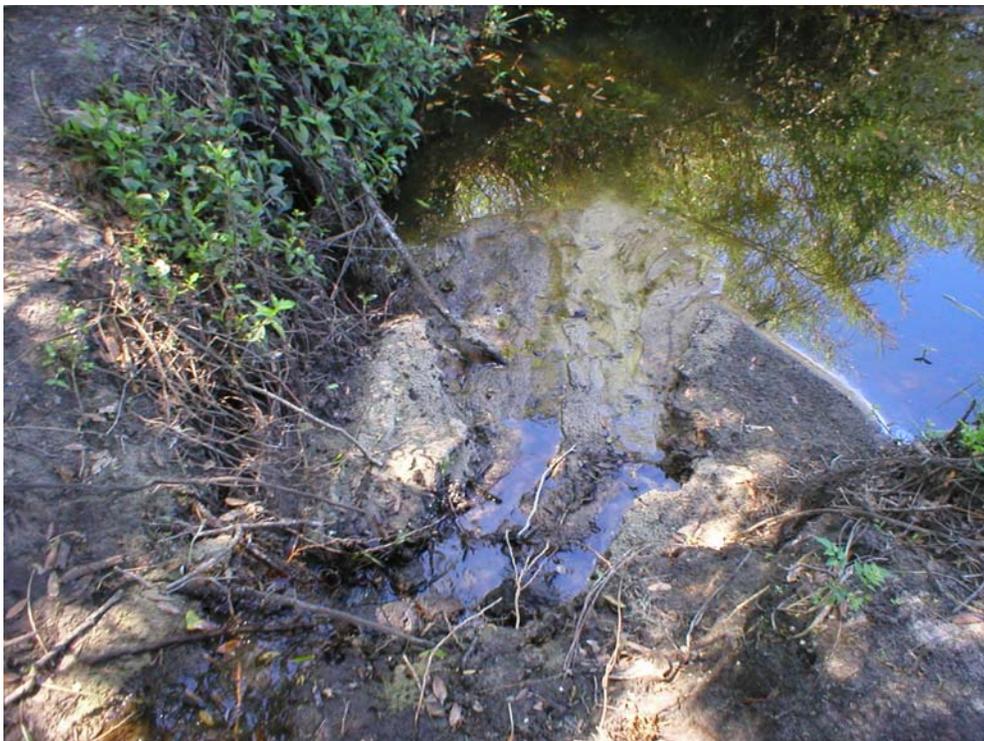
Figure 16.
Outfall PI4B eroded ditch bed.

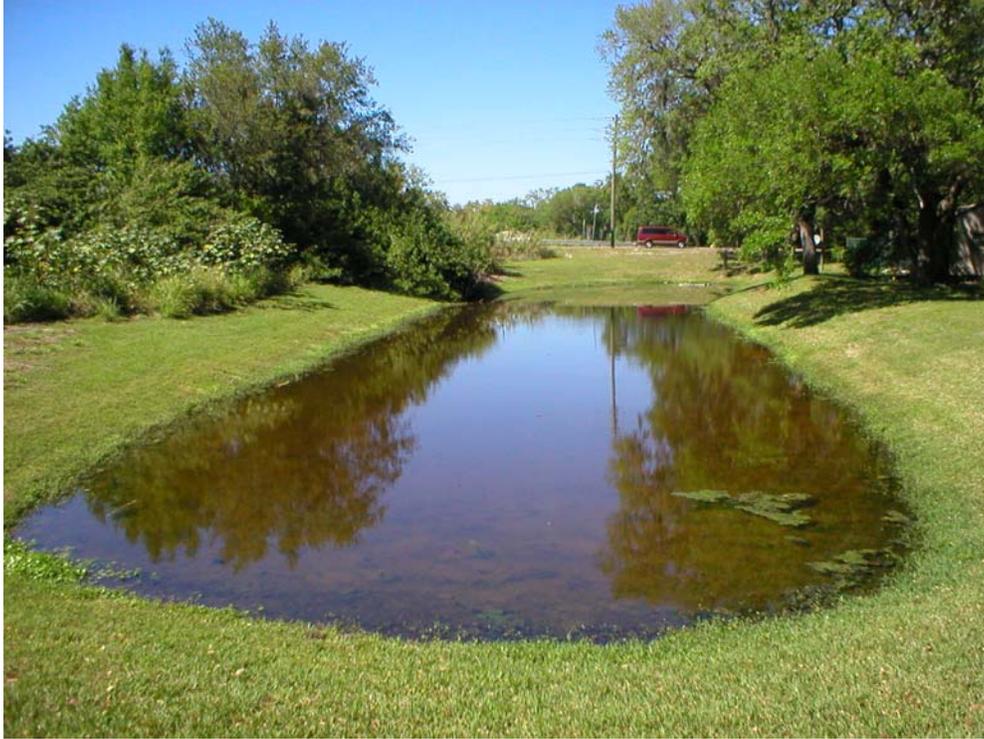
This drainage basin area consists of 26.8 acres of mostly single family residential property, but it also includes roadway and commercial properties, and drains properties along Bahia Vista Street east of Phillippi Creek. There is a stormwater treatment pond that serves this basin (Figure 17) and discharges to the upper portion via a 54" RCP pipe, outfall PI5. There was no sediment build up observed along the shoreline at this basin.

Figure 17.
Stormwater pond in Basin B5

This drainage basin drains properties along Bahia Vista Street east of Phillippi Creek. It is treated by a stormwater treatment pond that discharges to the upper portion of the channel via a 54" RCP pipe, outfall PI5. No new BMPs are recommended for this outfall because of the basin size and because the existing offsite stormwater pond is working properly.

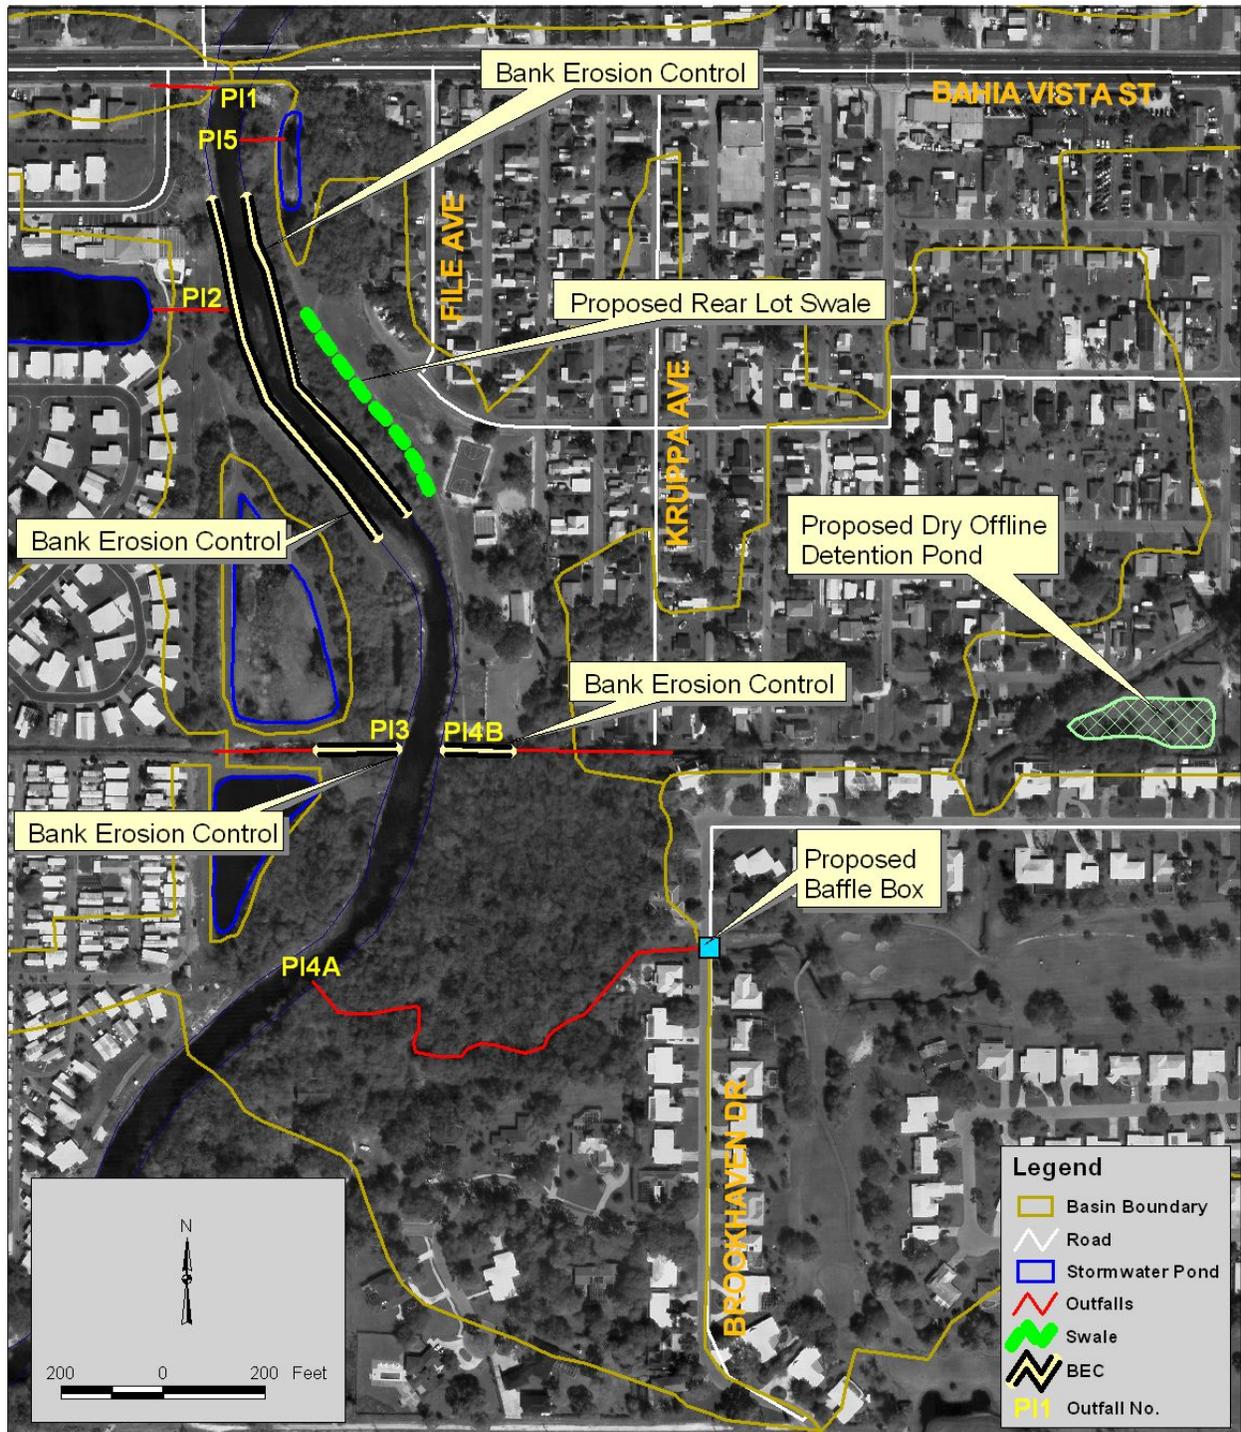
Figure 18

Recommended Sediment Abatement Facilities

To further examine potential pollution sources to the channel, a pollutant loading analysis of the stormwater runoff from the watershed was undertaken. TSS, TN, and TP loadings were estimated using a spreadsheet calculation accounting for the land areas, land uses, pollutant loadings, and existing stormwater treatment systems. This analysis suggests that the highest pollutant loadings originate in basin B4, the largest basin. Most of the residential basins were smaller and had treatment systems in place. Recommendations are summarized in Figure 18.

There are six stormwater outfalls to the channel. Based on the field investigations and analysis in this report, it is recommended that a dry offline detention pond will be constructed to treat the large untreated drainage area of Basin 4 (Figure 19), a baffle box be constructed, upstream of outfall pipe PI4A, and rear lot swales be constructed next to the paved trail in Pinecraft Park. These proposed added structures would provide a higher level of treatment to runoff by detaining a volume of runoff and by preventing much debris and sediment from entering the channel. Finally due to the unstable condition of the ditches side slopes near PI3 and PI4B outfalls, and on the channel steep side slopes near outfall PI2 and west of Pinecraft Park, BHI recommends stabilization with riprap and/or other channel stabilization system to avoid further erosion.

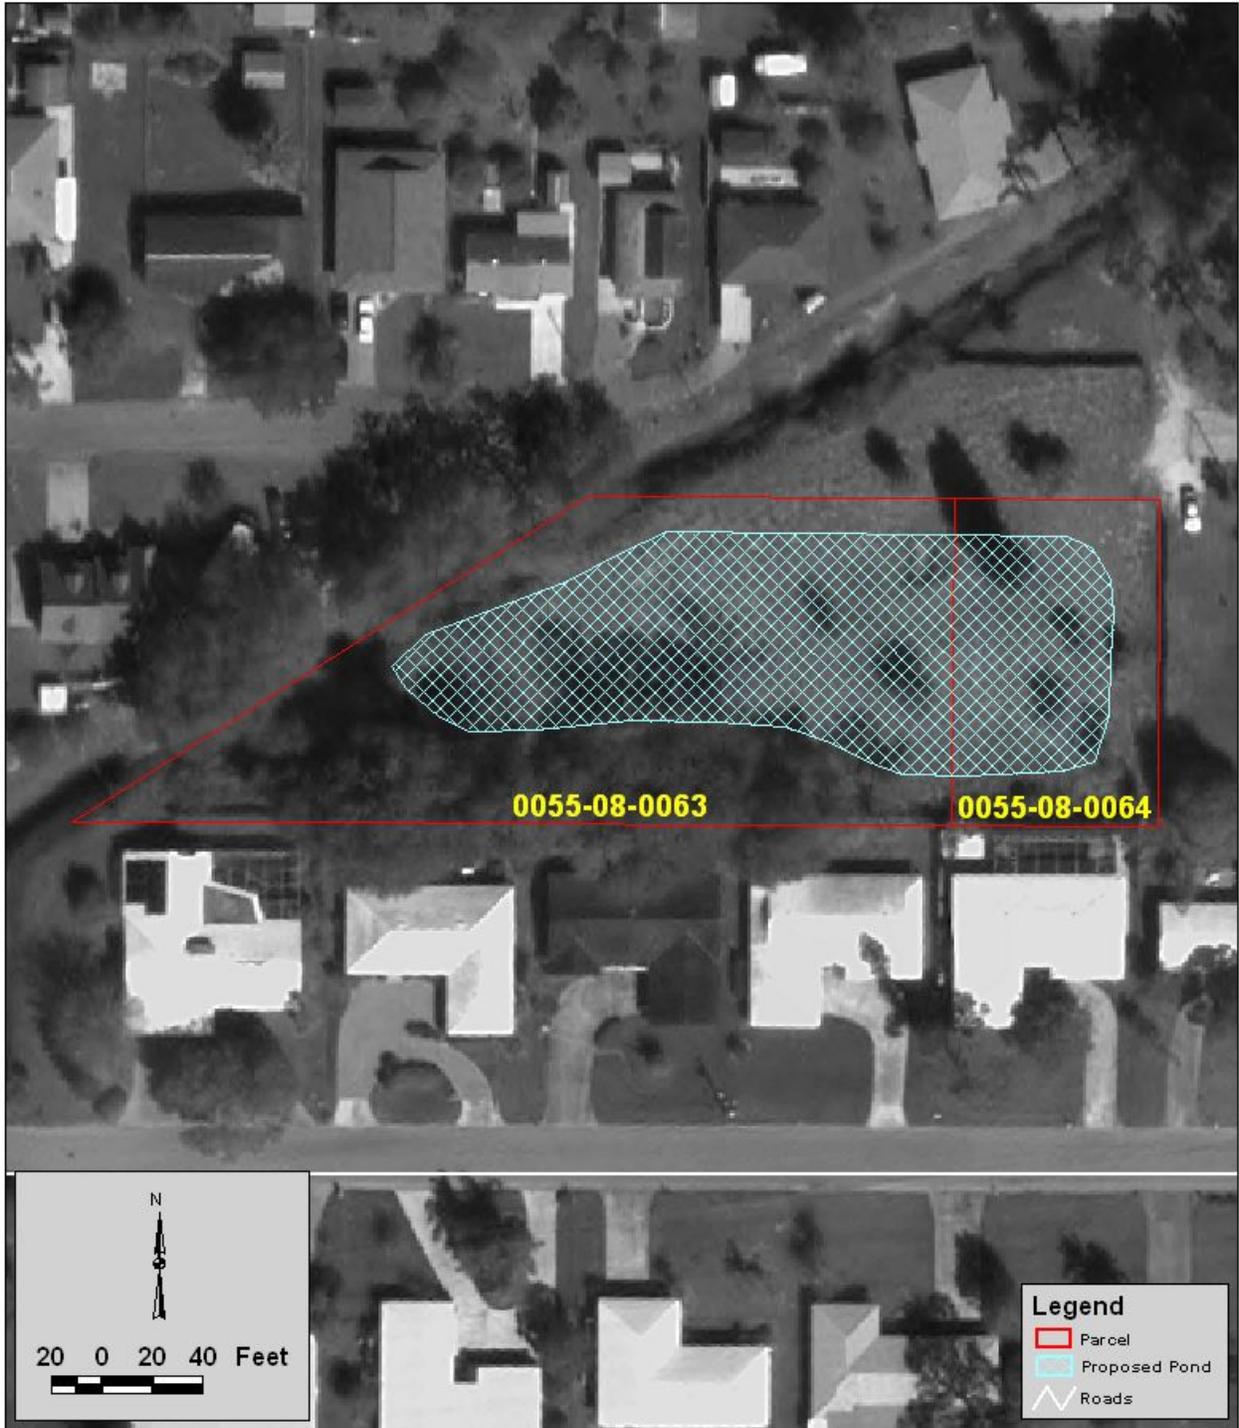
Figure 19

**Proposed Pond
Parcels Map**
