# **PHILLIPPI COVE SEDIMENT ABATEMENT STUDY**

**Sarasota County  
Water Resources**

**Berryman & Henigar, Inc.  
1412 Tech Blvd  
Tampa, Florida 33619-7865**

**February 2005**

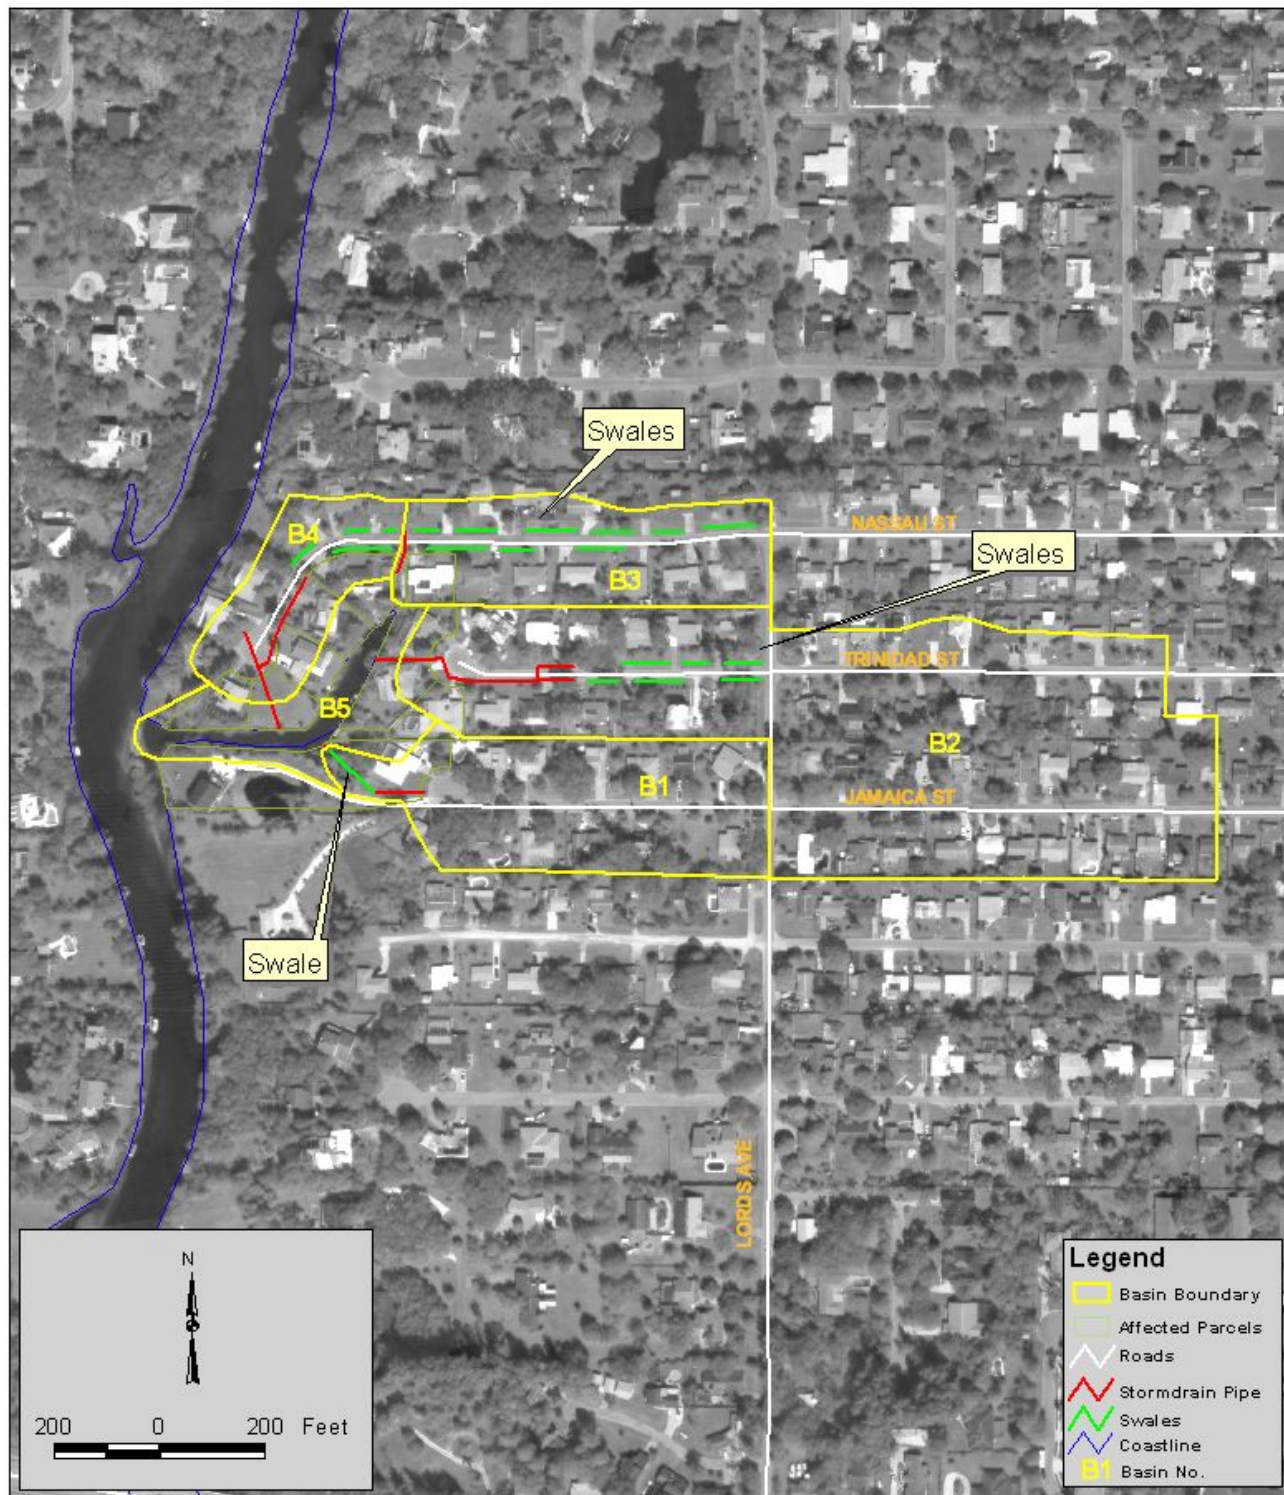
**Figure 2**

The drainage basin for the cove is generally bordered by Phillippi Creek on the west, Swift Road on the east, Nassau Street on the north, and Jamaica Street on the south. The overall drainage basin consists of 24 acres of single-family residential. See Figure 2, which shows subbasins within the study area.

**Existing Features Map**

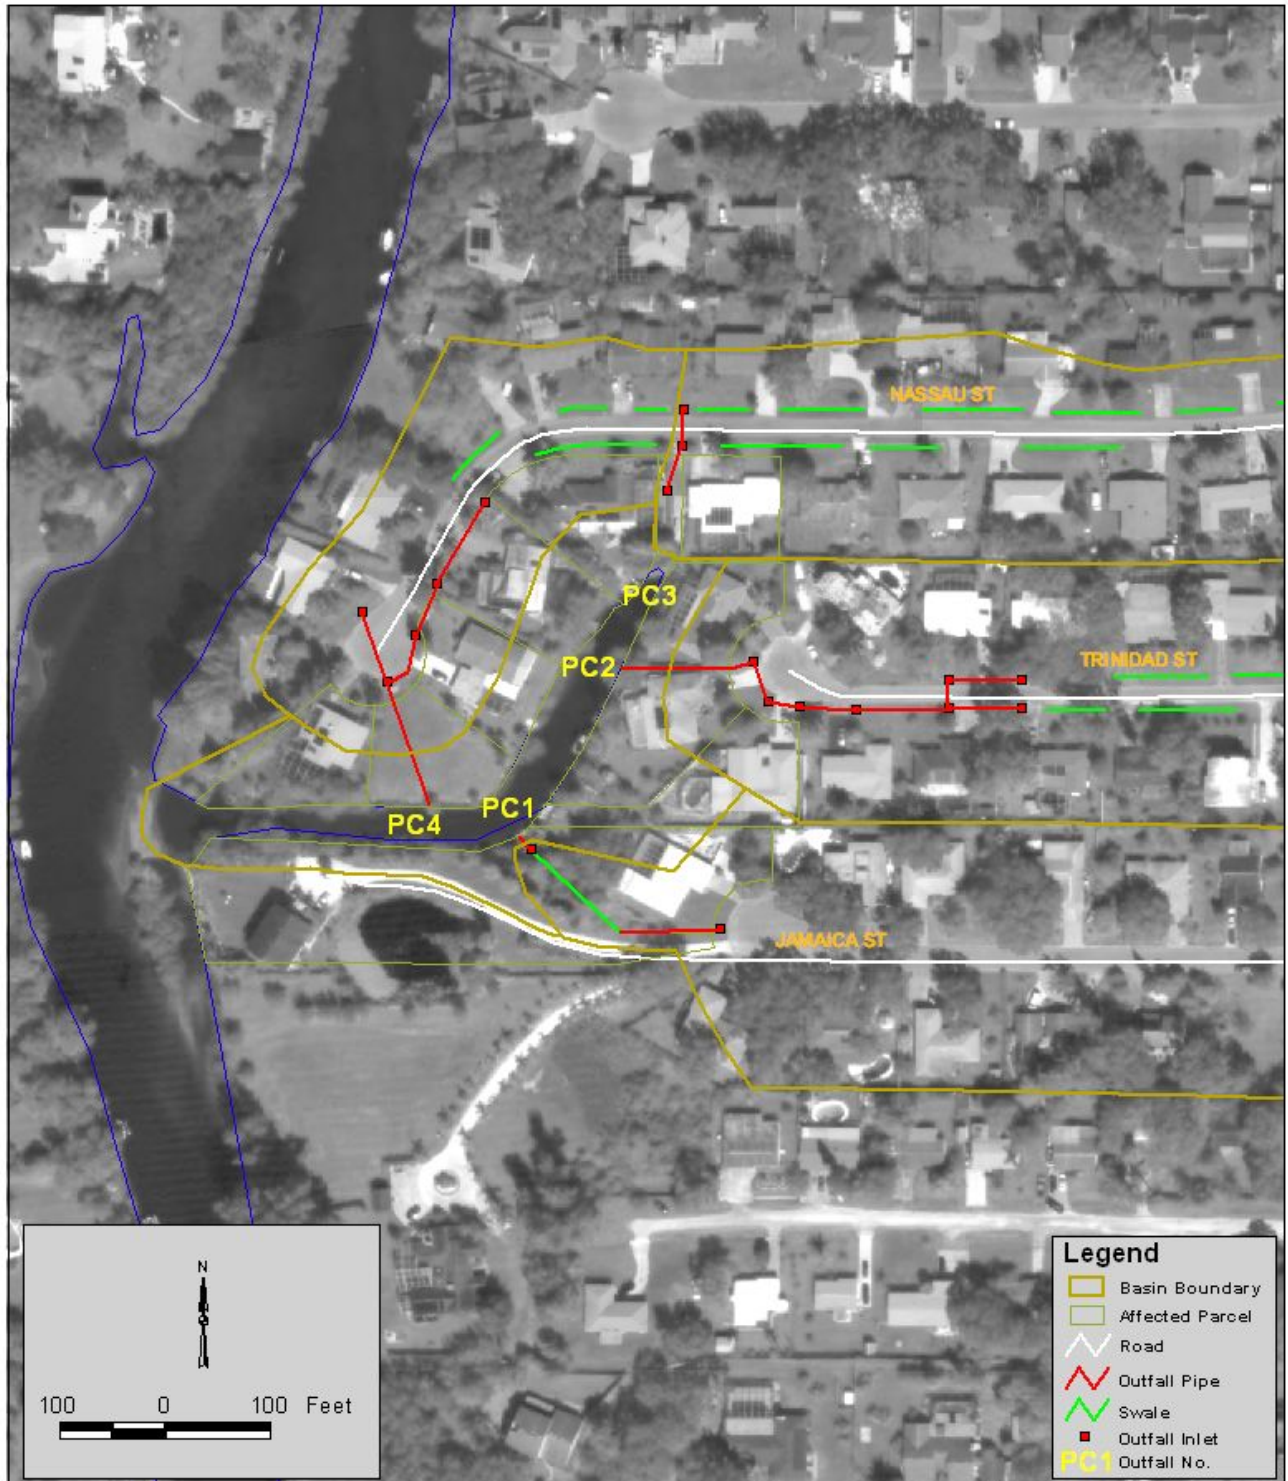
**Figure 3**

There are four stormwater pipes that discharge to the cove. The pipes are shown on the Existing Conditions Outfall Map, Figure 3. Each outfall is identified and discussed below.

## Existing Conditions Outfall Map
